**COLORADO DIVISION OF RECLAMATION, MINING AND SAFETY**  
**MINERALS PROGRAM INSPECTION REPORT**  
**PHONE: (303) 866-3567**

<b>MINE NAME:</b> Adams Pit	<b>MINE/PROSPECTING ID#:</b> M-1983-177	<b>MINERAL:</b> Sand and gravel	<b>COUNTY:</b> Bent
<b>INSPECTION TYPE:</b> Monitoring	<b>INSPECTOR(S):</b> Tyler V. O'Donnell	<b>INSP. DATE:</b> February 27, 2014	<b>INSP. TIME:</b> 11:45
<b>OPERATOR:</b> Bent County	<b>OPERATOR REPRESENTATIVE:</b> Robert Darnell	<b>TYPE OF OPERATION:</b> 110c - Construction Limited Impact

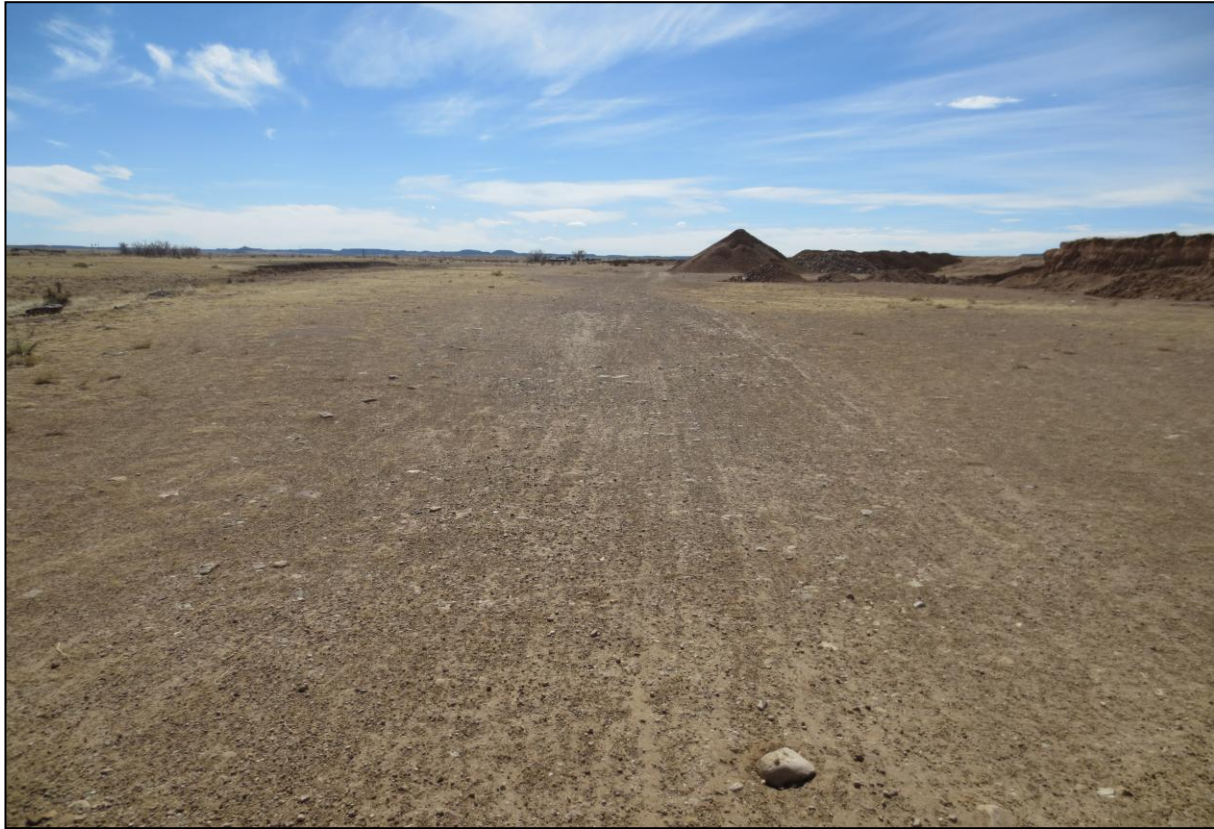
**Photo 1:** View looking south, taken from the access road. Johnny Creek runs along the left hand side of the photo, road-base stockpile in the background.

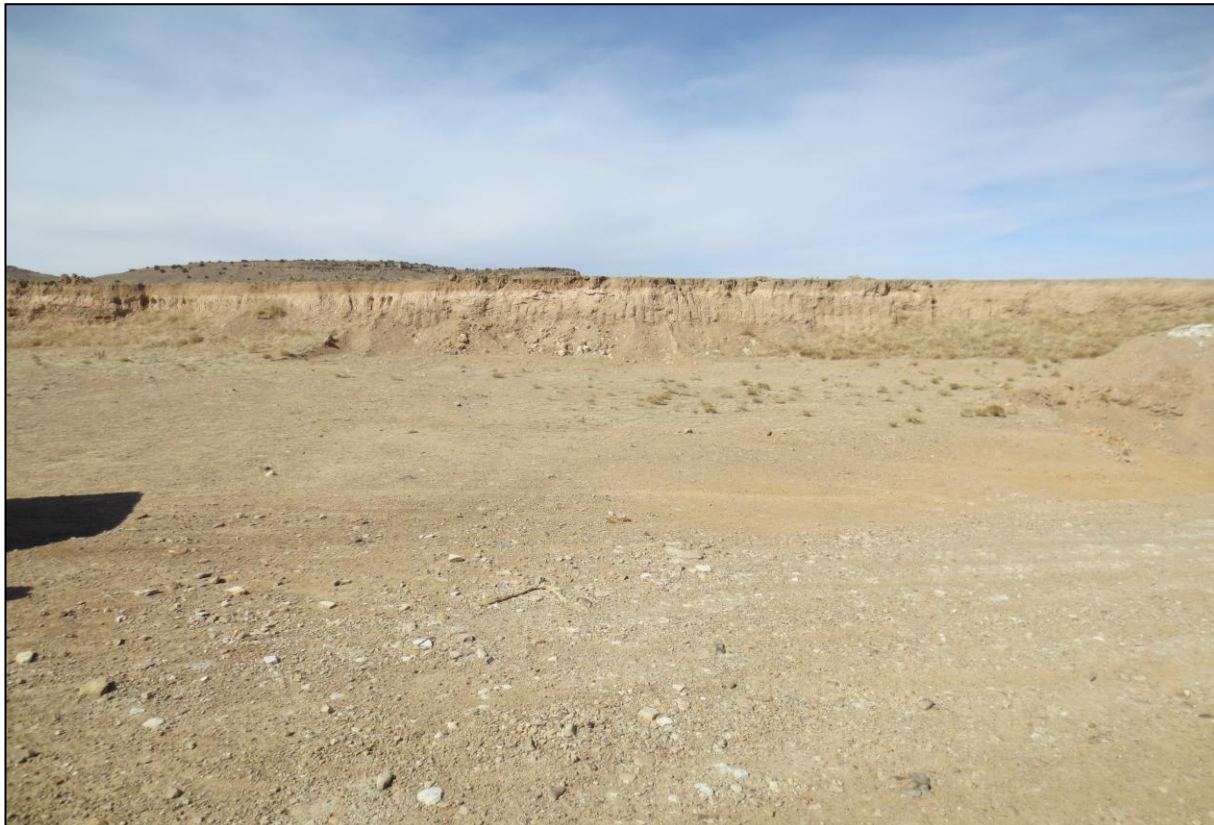
There was a highwall that was approximately 900 feet long that had an average height of approximately 10 feet. The slope of the highwall was near vertical.

**Photo 2:** View looking west, highwall in the background.

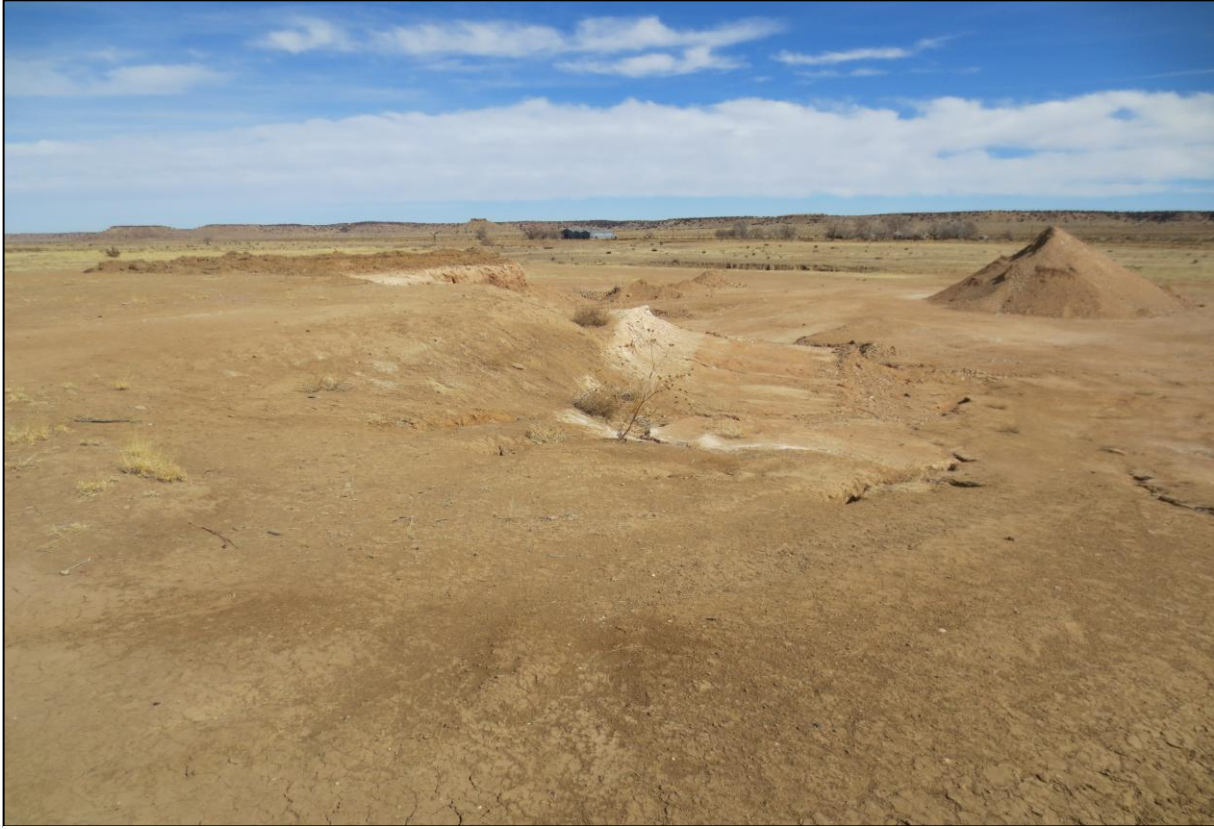
**Photo 3:** View looking northeast taken from on top of the highwall. Road-base stockpile along the left hand side of the photo.

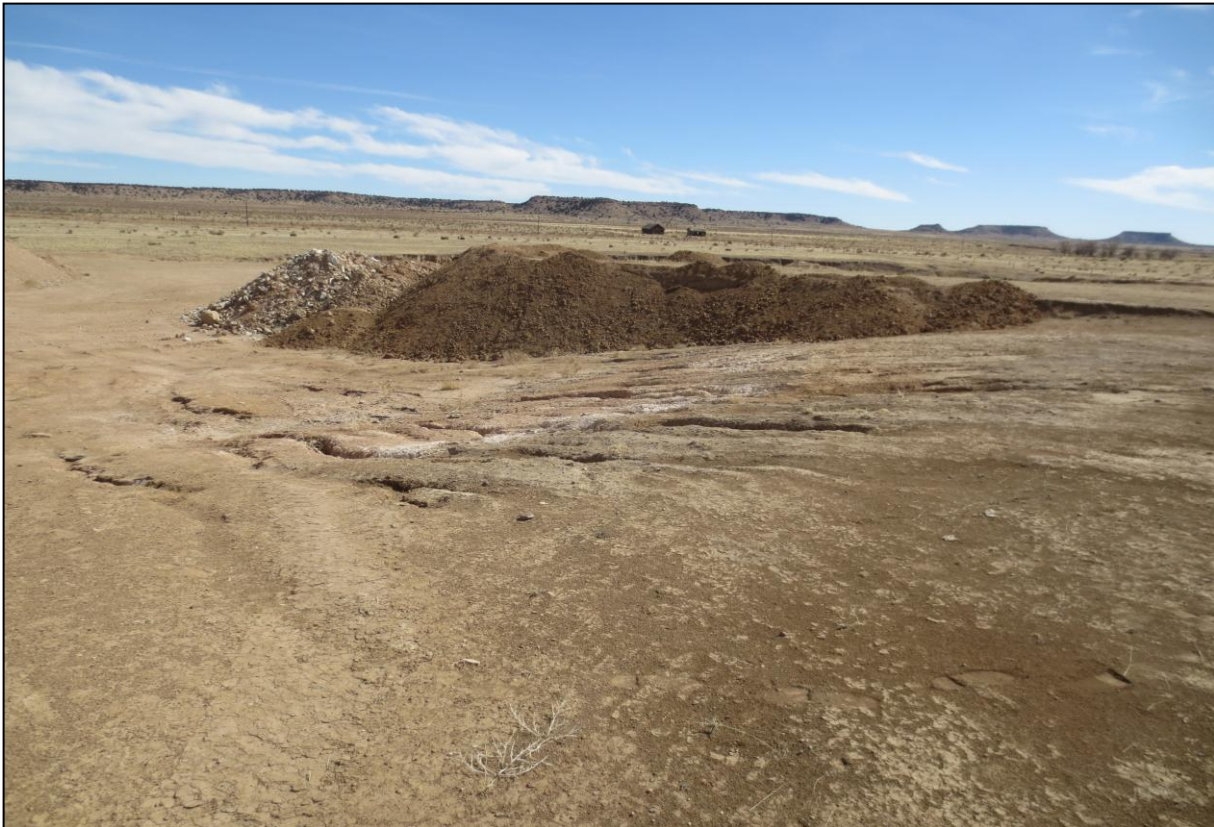
There appeared to be an adequate amount of topsoil to reclaim the site. The Operator was salvaging the top 2 feet of growth medium for use in reclamation. The Operator should consider salvaging the top 6 to 8 inches and separating that material from the rest of the growth medium. The Operators efforts in salvaging growth medium are commendable.

**Photo 4:** Topsoil stockpile.
