COLORADO DIVISION OF RECLAMATION, MINING AND SAFETY
MINERALS PROGRAM INSPECTION REPORT
PHONE: (303) 866-3567

MINE NAME: Fork Horn Mesa Subdivision	MINE/PROSPECTING ID#: M-2008-044	MINERAL: Gravel	COUNTY: La Plata
INSPECTION TYPE: Monitoring	INSPECTOR(S): Kate A. Pickford	INSP. DATE: March 12, 2014	INSP. TIME: 15:00
OPERATOR: Palmer Pipe & Construction, LLC	OPERATOR REPRESENTATIVE:	TYPE OF OPERATION: 110c - Construction Limited Impact

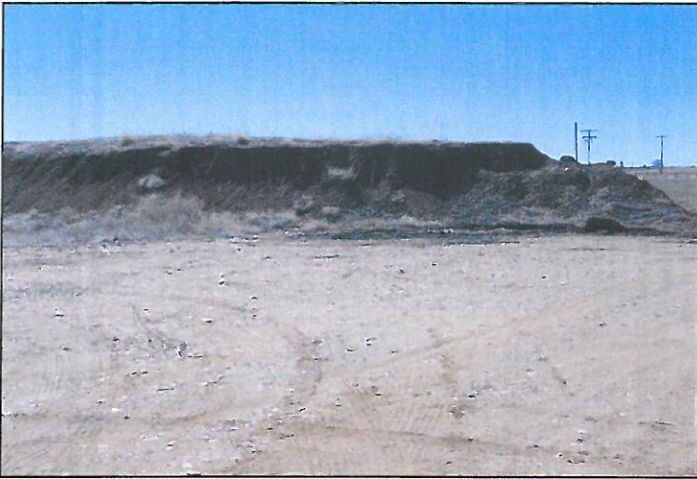
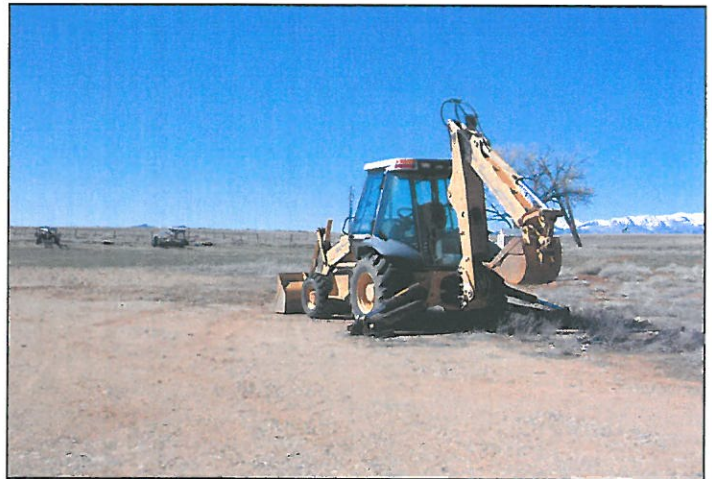
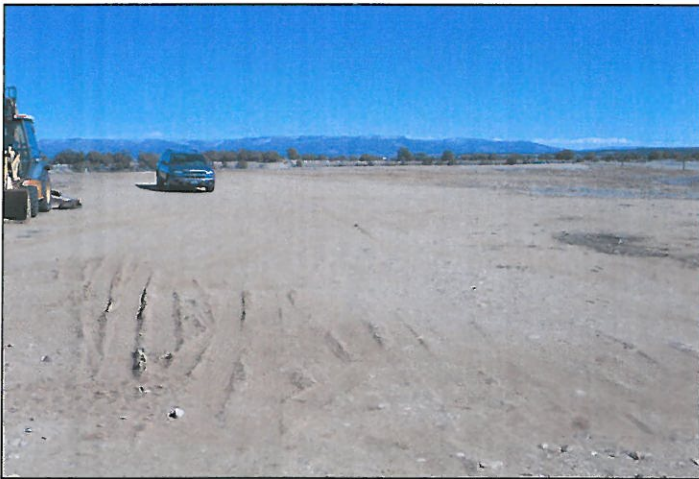
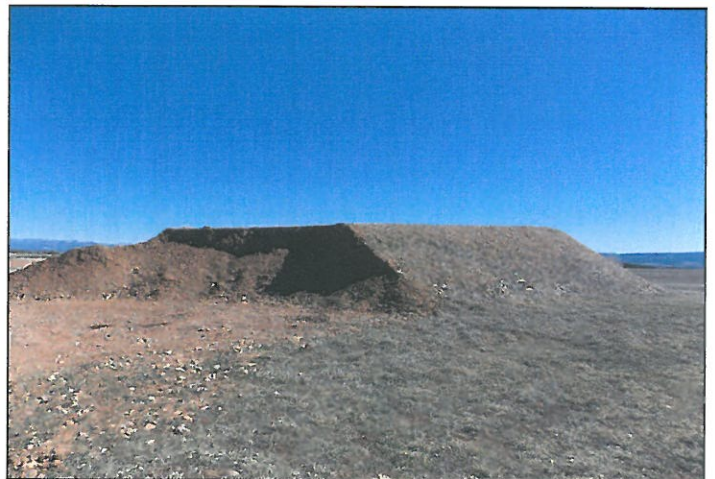
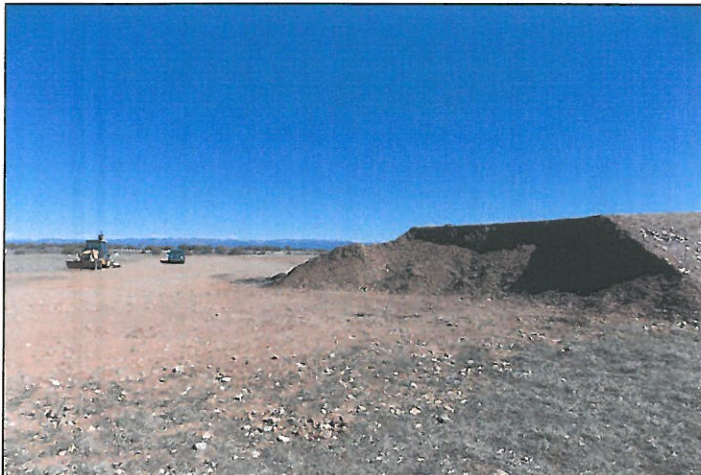
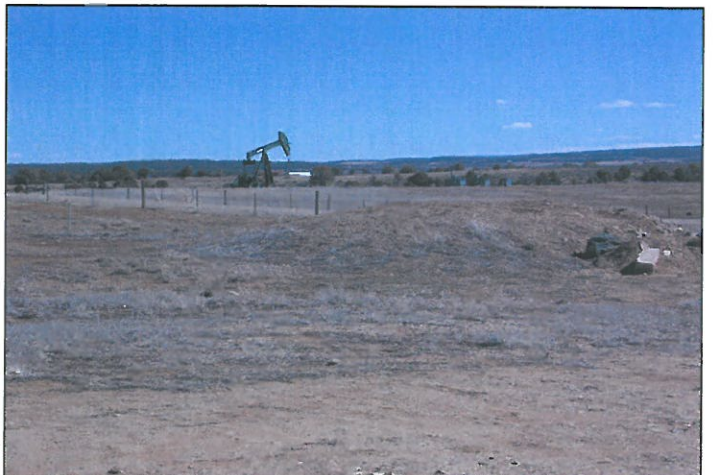
PHOTOGRAPHS

The site is accessed through the Fork Horn subdivision. The site consists of a flat area where a stockpile of material is piled. Much of the original material has been removed from the site. A topsoil stockpile is present. Reclamation will consist only of ripping the affected acreage and revegetation.
