COLORADO DIVISION OF RECLAMATION, MINING AND SAFETY
MINERALS PROGRAM INSPECTION REPORT
PHONE: (303) 866-3567

MINE NAME: Hess Pit	MINE/PROSPECTING ID#: M-1986-033	MINERAL: Sand and gravel	COUNTY: La Plata
INSPECTION TYPE: Monitoring	INSPECTOR(S): Kate A. Pickford	INSP. DATE: March 12, 2014	INSP. TIME: 12:00
OPERATOR: Sunnyside Gravel & Excavation	OPERATOR REPRESENTATIVE:	TYPE OF OPERATION: 110c - Construction Limited Impact

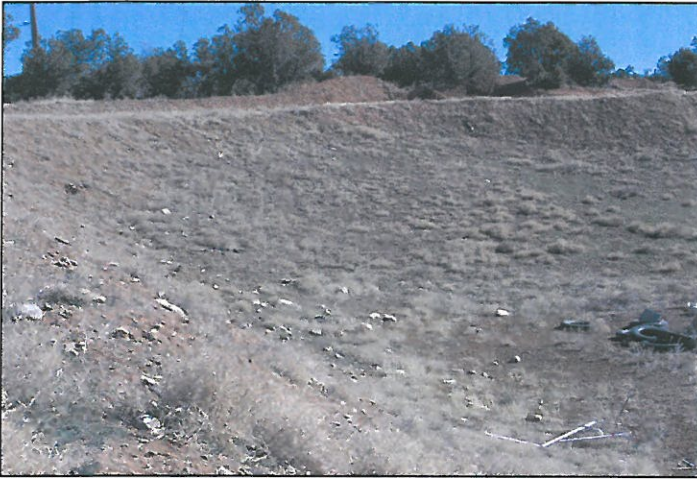
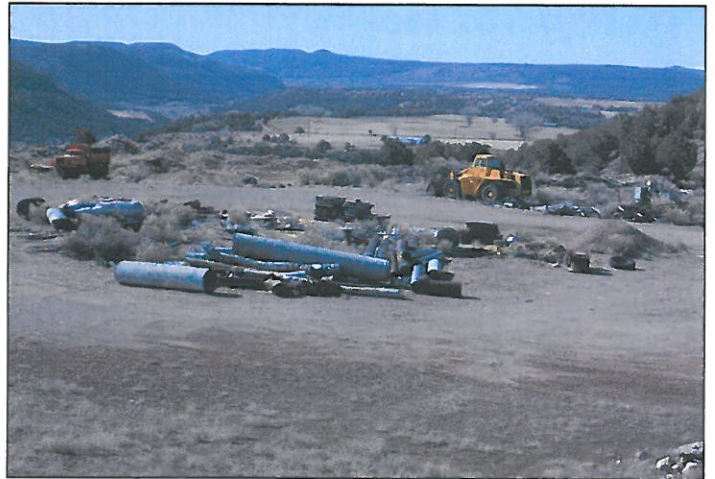
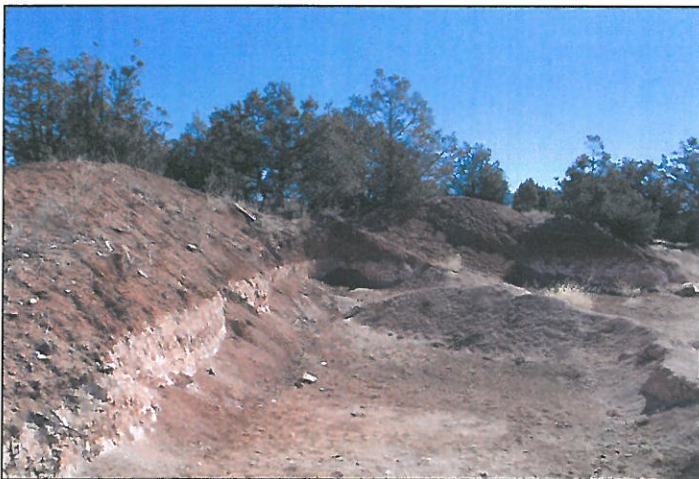
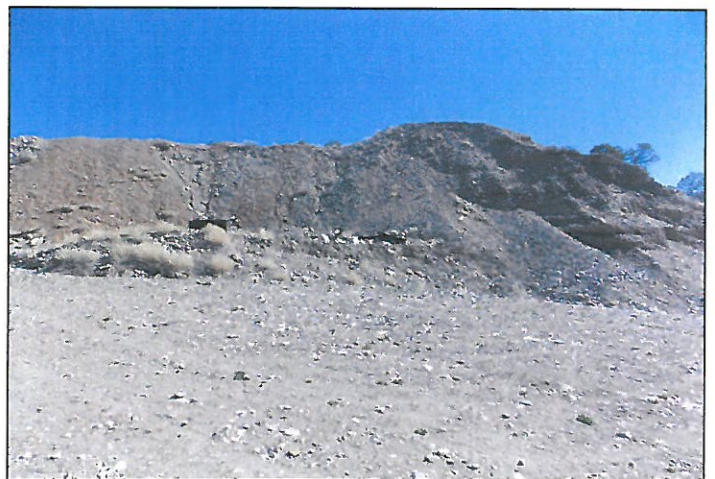
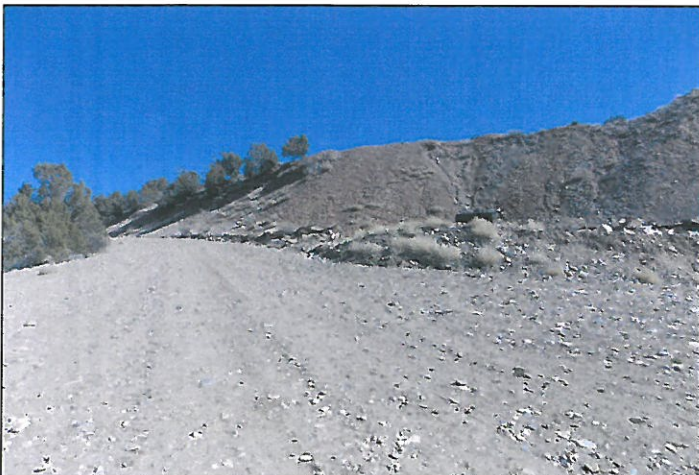
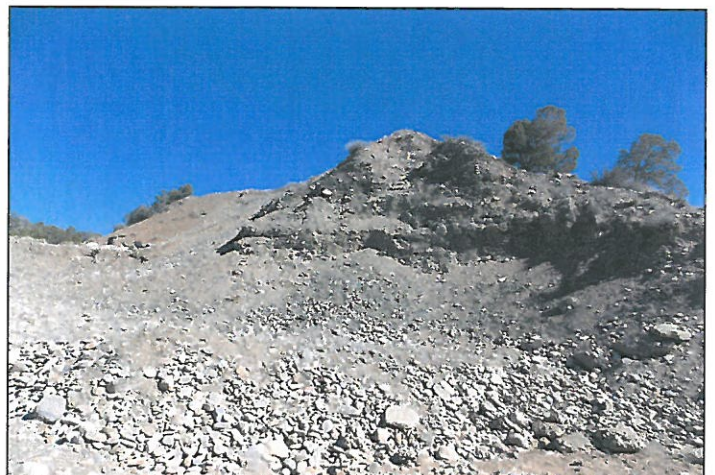
PHOTOGRAPHS

The upper portion of the site is relatively unchanged from the time of the previous inspection. Much of the upper highwall, which is currently at a 1H:1V slope, requires additional grading to reduce the slope to 3H:1V. The newly graded slope will also require topsoil and seeding for reclamation. There is a large amount of accumulated debris stored in the upper area, including slash piles and corrugated culverts. The lower area has been mined, resulting in a second highwall requiring grading, topsoil and seeding for reclamation.

The current bond held by the Division is inadequate for reclamation of the site. A new bond amount has been calculated and the information regarding the bond increase is included in this report.
