COLORADO DIVISION OF RECLAMATION, MINING AND SAFETY
MINERALS PROGRAM INSPECTION REPORT
PHONE: (303) 866-3567

MINE NAME: Horvath Pit No 1	MINE/PROSPECTING ID#: M-1977-546	MINERAL: Sand and gravel	COUNTY: La Plata
INSPECTION TYPE: Monitoring	INSPECTOR(S): Kate A. Pickford	INSP. DATE: March 18, 2014	INSP. TIME: 10:15
OPERATOR: Brice F Lee & Phyllis J Lee	OPERATOR REPRESENTATIVE: Brice Lee	TYPE OF OPERATION: 110c - Construction Limited Impact

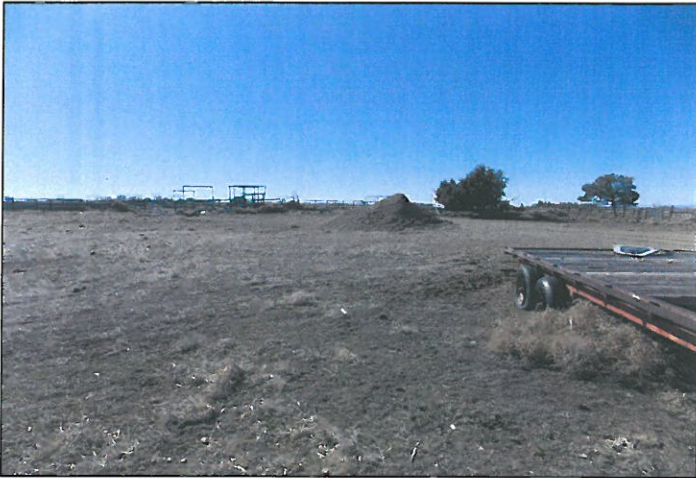
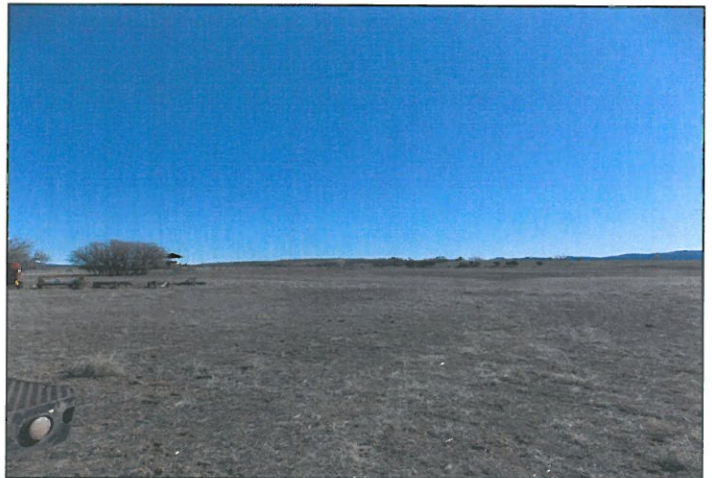
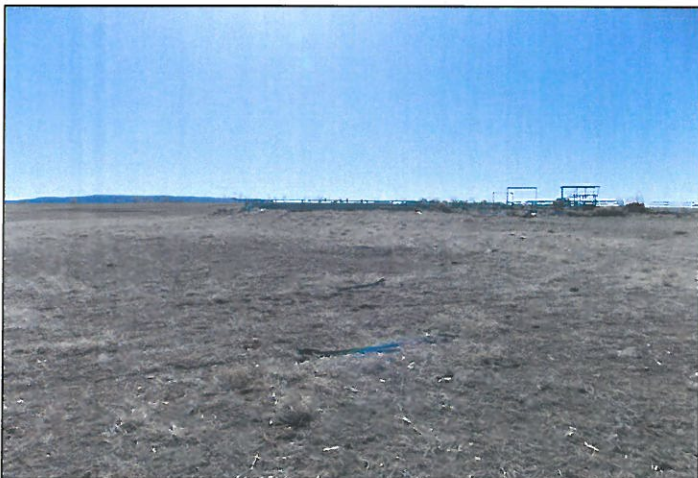
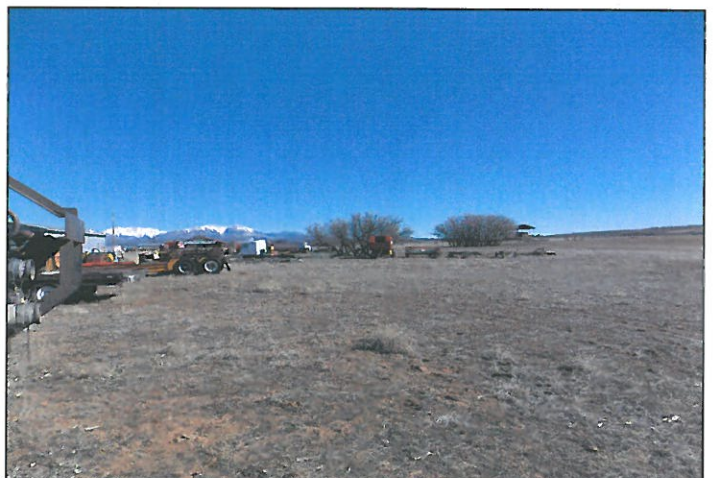
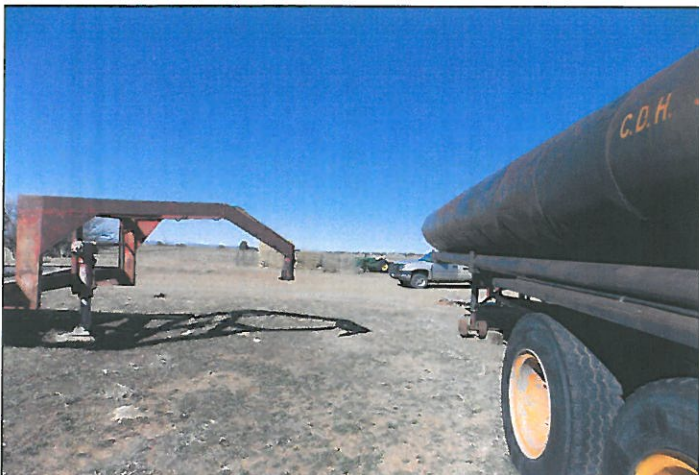
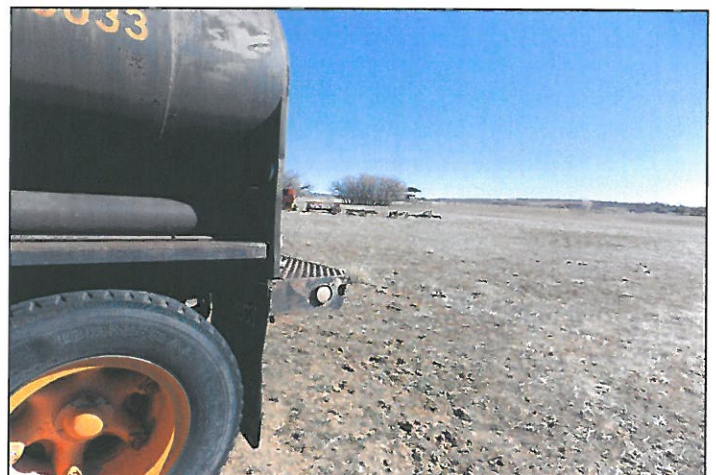
PHOTOGRAPHS

The site is fully reclaimed, being adequately graded and seeded. The vegetation, however, has not become adequately established. The operator continues to make efforts to establish the proper vegetation for the reclaimed site. If the goal of the operator is to continue mining of the site at some point in the future, the site must be placed into Temporary Cessation. Please see Rule 1.13 of the Construction Materials Rules and Regulations for guidelines as to submitting a request for Temporary Cessation.
