COLORADO DIVISION OF RECLAMATION, MINING AND SAFETY MINERALS PROGRAM INSPECTION REPORT

MINE NAME: Craig Pit	MINE/PROSPECTING ID#: M-1976-027	MINERAL: Sand and gravel	COUNTY: La Plata
INSPECTION TYPE: Monitoring	INSPECTOR(S): Kate A. Pickford	INSP. DATE: March 12, 2014	INSP. TIME:
OPERATOR: Skanska USA Civil West Rocky Mountain Di	OPERATOR REPRESENTATIVE:	TYPE OF OPERATION: 112c - Construction Regular Operation

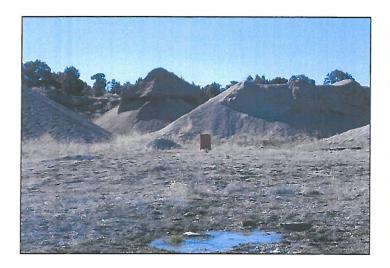
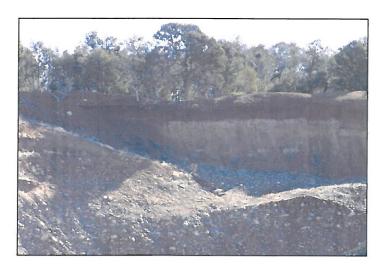
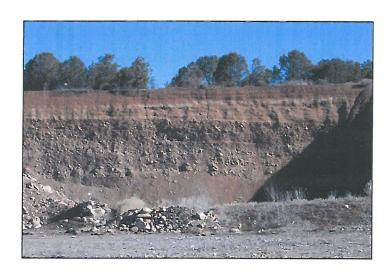
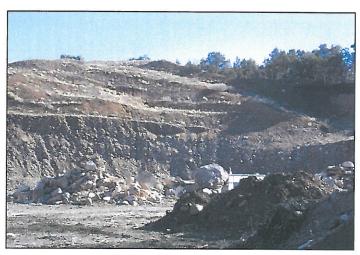
PHOTOGRAPHS

There is a large amount of disturbance at the site. Stockpiles are present along the pit floor. There is a highwall over 70 feet in height located very close to a ranch road on top that is not to be disturbed. This requires backfilling some of the highwall from below. At the base of the highwall is an even deeper pit. Skanska plans to fill the pit with construction by products from other sites. The operator must comply with Rule 3.1.5 (9) when importing materials from offsite to use as backfill in the pit.
