COLORADO DIVISION OF RECLAMATION, MINING AND SAFETY
MINERALS PROGRAM INSPECTION REPORT
PHONE: (303) 866-3567

MINE NAME: Cedar Point Picture Rock Quarry	MINE/PROSPECTING ID#: M-2004-048	MINERAL: Stone	COUNTY: San Miguel
INSPECTION TYPE: Monitoring	INSPECTOR(S): Bob Oswald	INSP. DATE: March 20, 2014	INSP. TIME: 11:30
OPERATOR: Robert Daugherty	OPERATOR REPRESENTATIVE: None	TYPE OF OPERATION: 110c - Construction Limited Impact

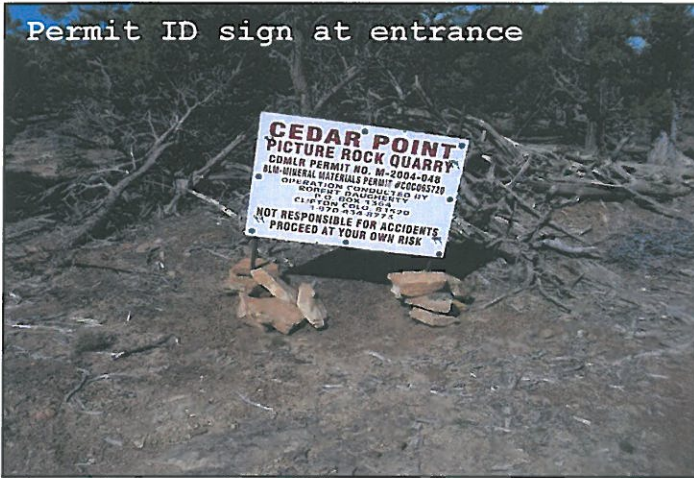
The required permit ID sign was observed posted at the entrance to the permitted area. Permit boundary markers (metal T-posts) were installed along the permit boundary. The operator has been careful to limit the amount of disturbance and to ensure that mining-related activity remains inside the permit boundary. There is an onsite road that forms a loop within the permitted area, which is unimproved but which provides access to the entire site.

Permit ID sign at entrance

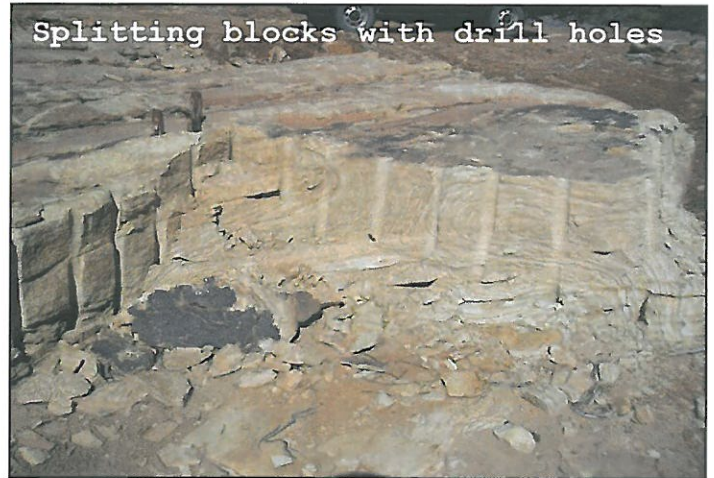
There has been some mining activity since the Division's last inspection in 2012. Most activity has occurred along the northern side of the permit. Numerous large sandstone blocks, and portions of blocks, have been removed from the site. There are still many naturally outcropping boulders onsite, several of which exhibit linear patterns of drill holes made by the operator to create the blocks to be removed from the site and processed. (Inspectors observed one drilled slab at grade near the entrance which still contained the pins and feathers used to split the blocks.)

Splitting blocks with drill holes

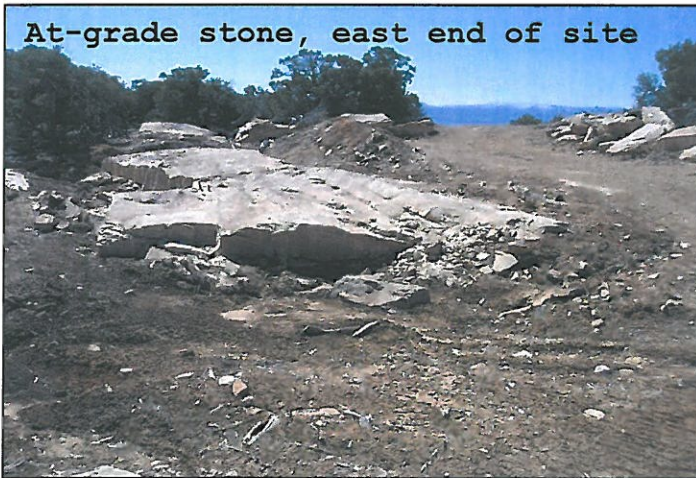
At-grade stone, east end of site

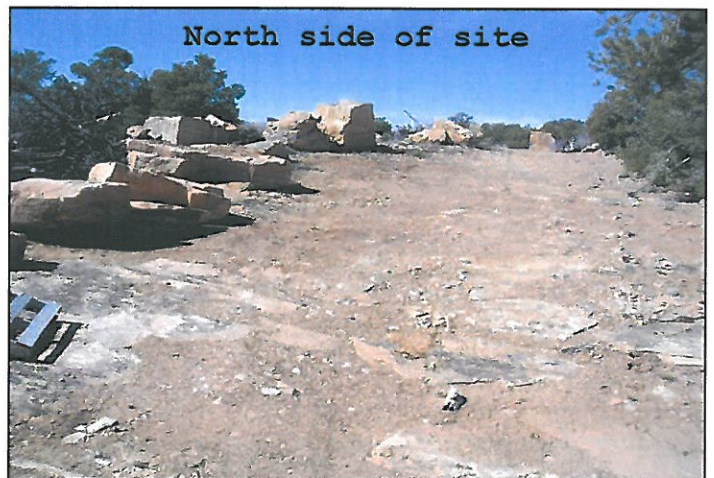
North side of site

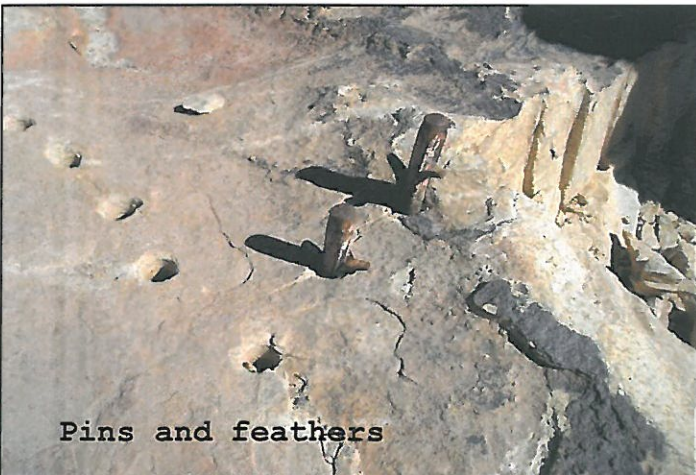
Pins and feathers
