COLORADO DIVISION OF RECLAMATION, MINING AND SAFETY
MINERALS PROGRAM INSPECTION REPORT
PHONE: (303) 866-3567

MINE NAME: H & H Quarry #2	MINE/PROSPECTING ID#: M-1998-080	MINERAL: Sandstone (silica, st quartzite)	COUNTY: Dolores
INSPECTION TYPE: Surety-Related Inspection	INSPECTOR(S): Kate A. Pickford	INSP. DATE: March 13, 2014	INSP. TIME: 14:00
OPERATOR: H & H Stone	OPERATOR REPRESENTATIVE:	TYPE OF OPERATION: 110c - Construction Limited Impact

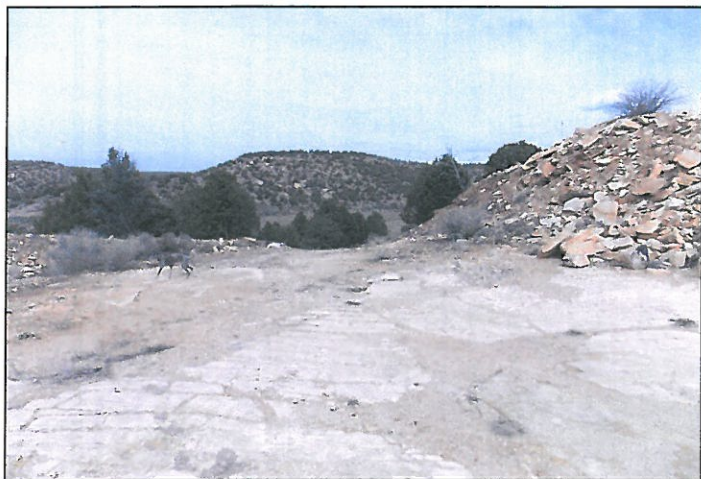
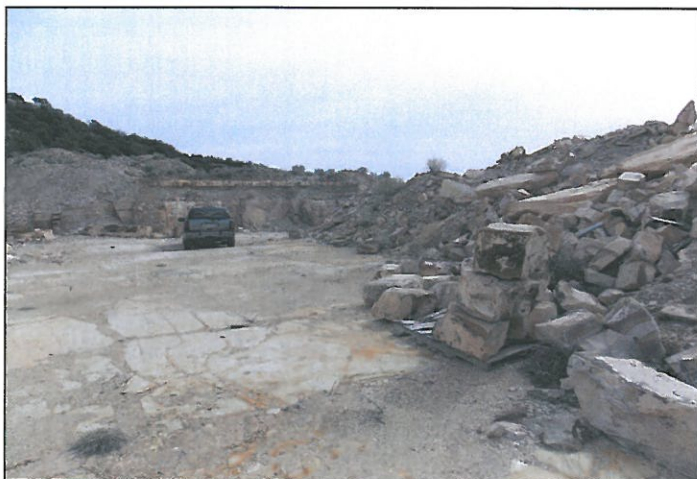
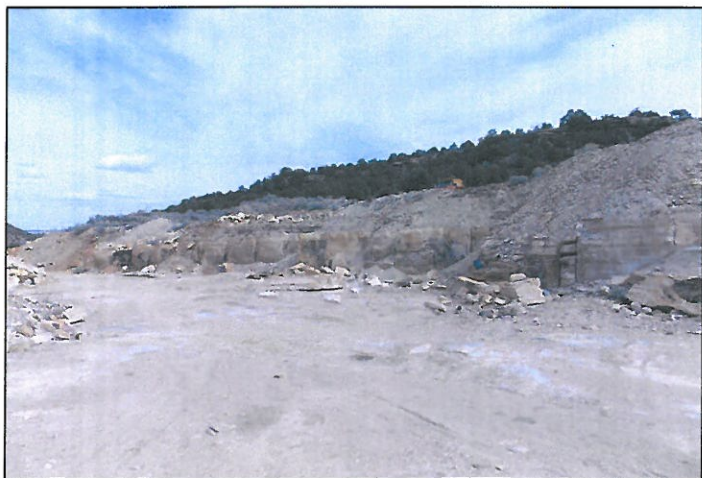
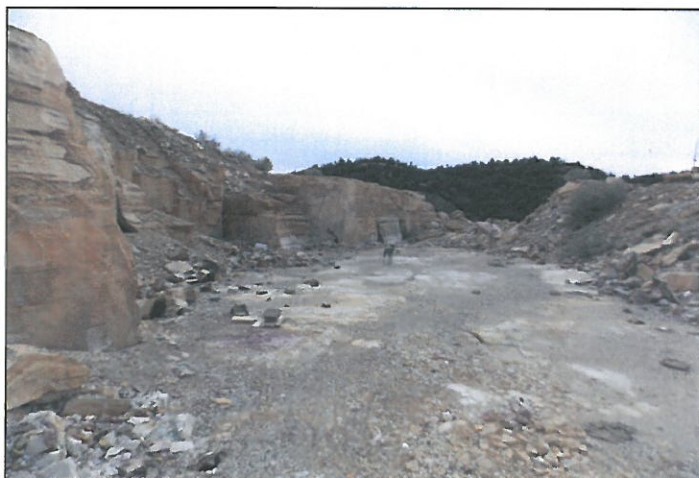
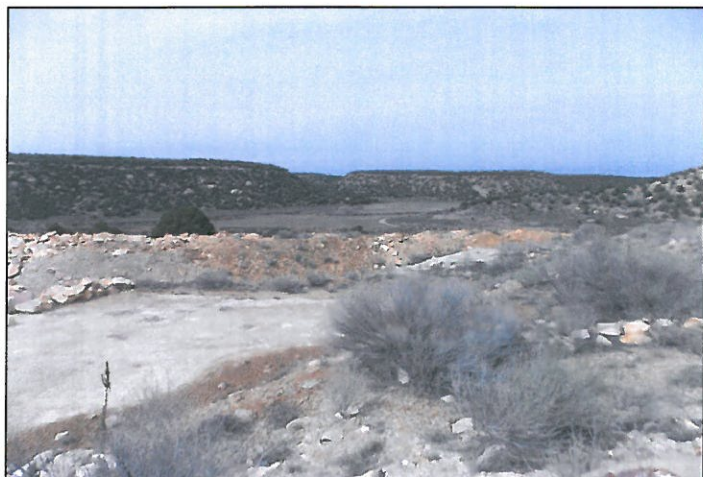
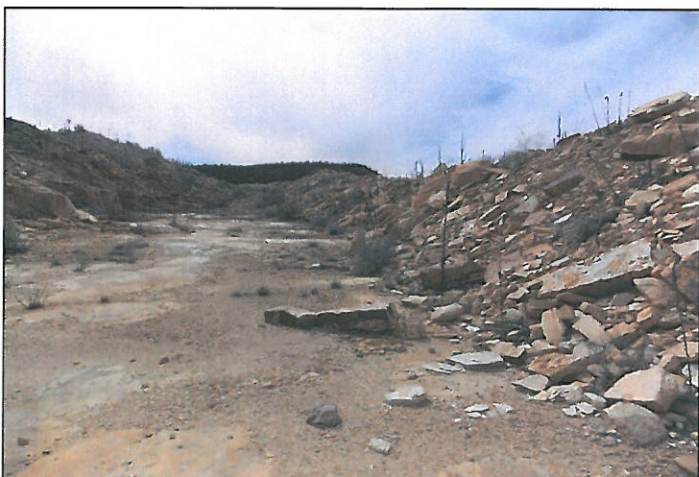
PHOTOGRAPHS

The site is accessed from a road cut into the side of a hill. Surrounding vegetation consists of Pinon/Juniper. The site itself consists of a vertical highwall cut into the sandstone. The highwall is approximately 315 feet in length and 12 feet high. There were no indications that explosives were used in any of the mining process. Along the edge of the mine floor, at the top of the embankment, a large amount of sandstone rubble is stockpiled. Total length of the stockpiles is approximately 530 feet and it ranges in height, with an average of 12 feet. Near the access road, the stockpiles fan out and become considerably wider. There is less material stockpiled above the high wall, but a stockpile approximately 8 feet high runs along approximately 300 feet of the length of the high wall.

The reclamation plan calls for pushing material from above the highwall to backfill the rock cut, resulting in a 3H:1V slope. In that the bulk of the material is stockpiled on the mine floor away from the foot of the highwall, much of the reclamation will involve pulling the material away from the edge of the embankment and backfilling from below. Additionally, since these stockpiles are located along the top of the embankment, some of the material will have to be pulled back with an excavator in order to avoid having it slough down the hill.

No sign is posted at the entrance to the site and no boundary markers were visible. This problem needs to be resolved by the date noted under the Problem section of this report.

CORRECTIVE ACTIONS: The operator must post a sign at the entrance to the mine site which shall be clearly visible from the access road and specify the following; the name of the operator, indicate that a reclamation permit for the operation has been issued by the Colorado Mined Land Reclamation Board, and the permit number. The boundaries of the affected area must be marked by monuments or other markers that are clearly visible and adequate to delineate such boundaries.
