**COLORADO DIVISION OF RECLAMATION, MINING AND SAFETY**  
**MINERALS PROGRAM INSPECTION REPORT**  
**PHONE: (303) 866-3567**

<b>MINE NAME:</b> Hazeltine Mine	<b>MINE/PROSPECTING ID#:</b> M-2004-031	<b>MINERAL:</b> Sand and gravel	<b>COUNTY:</b> Adams
<b>INSPECTION TYPE:</b> Monitoring	<b>INSPECTOR(S):</b> Tyler V. O'Donnell	<b>INSP. DATE:</b> March 27, 2014	<b>INSP. TIME:</b> 16:00
<b>OPERATOR:</b> Aggregate Industries - WCR, Inc.	<b>OPERATOR REPRESENTATIVE:</b> Connie Davis	<b>TYPE OF OPERATION:</b> 112c - Construction Regular Operation

**INSPECTION TOPIC:** Hydrologic Balance

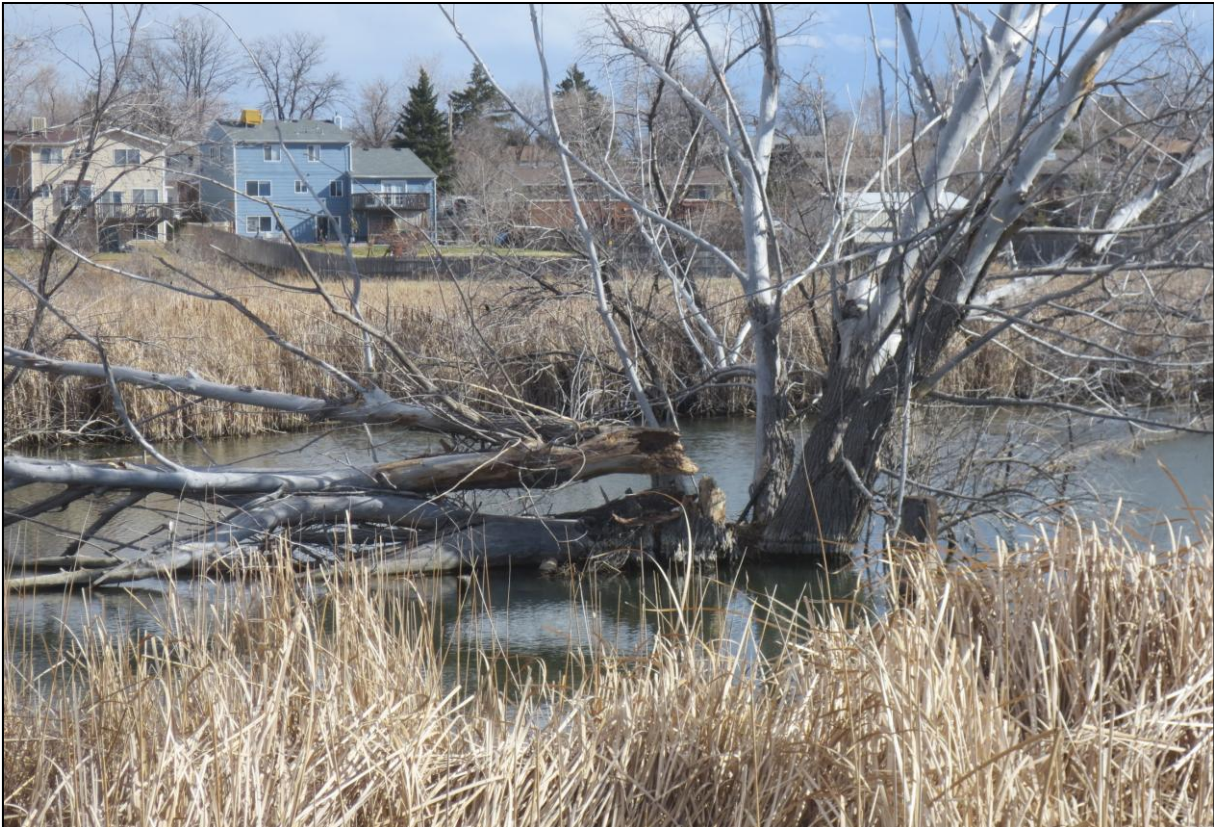
The inspection began at the Orr property. The inspection consisted of a visual examination of the Orr property and a discussion of the ongoing issues detailed in the written complaint. The visual inspection of the Orr property found that the land surface was wet. Portions of the Orr property were supporting hydrophytic vegetation. The Division believes the lowest point of the Orr property is located in the northwest corner with an approximate elevation of 5038.5 feet. The northwest corner of the Orr property was submerged (see photo 1). Based on visual estimates portions of the Orr property was covered by 1 to 2 feet of water

**Photo 1:** View looking east/southeast from the west side of the bull seep. The tree in the center of the photo is near the northwest corner of the Orr property.

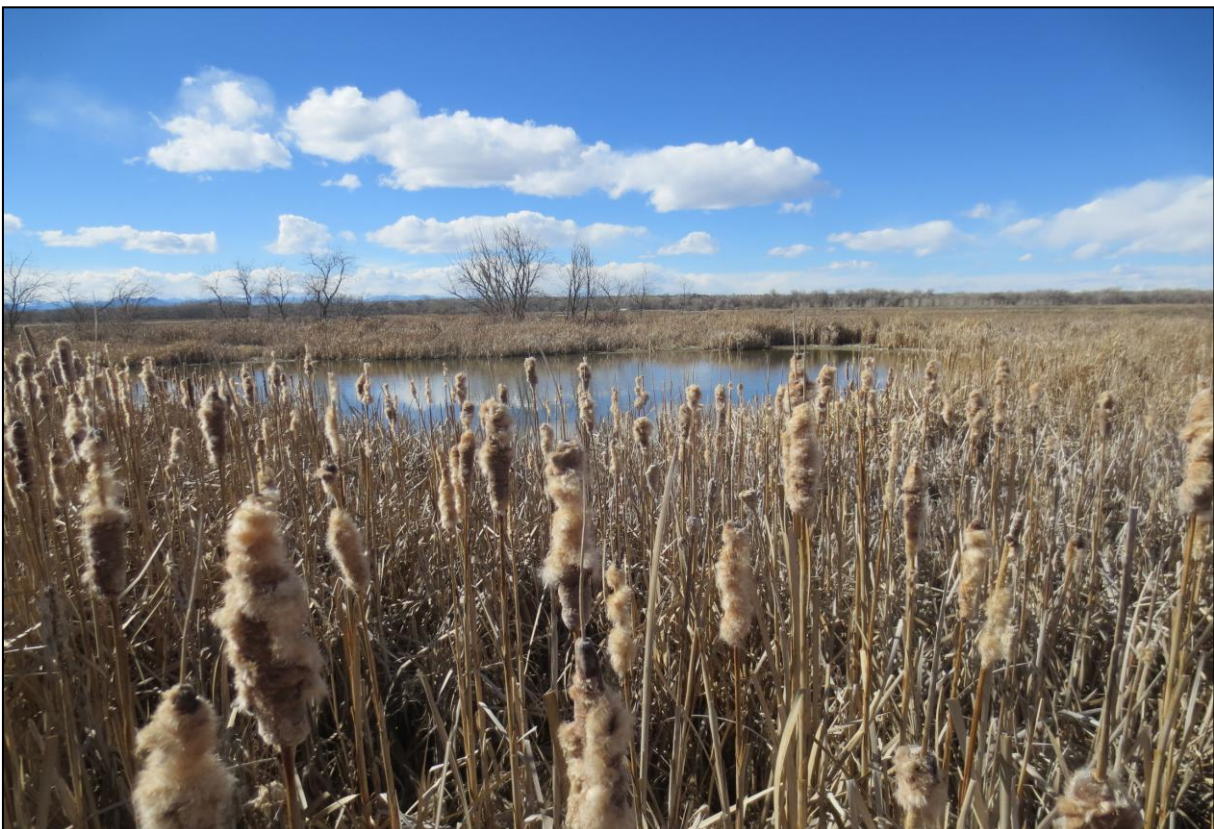
**Photo 2:** View looking west from north central part of the Orr property.

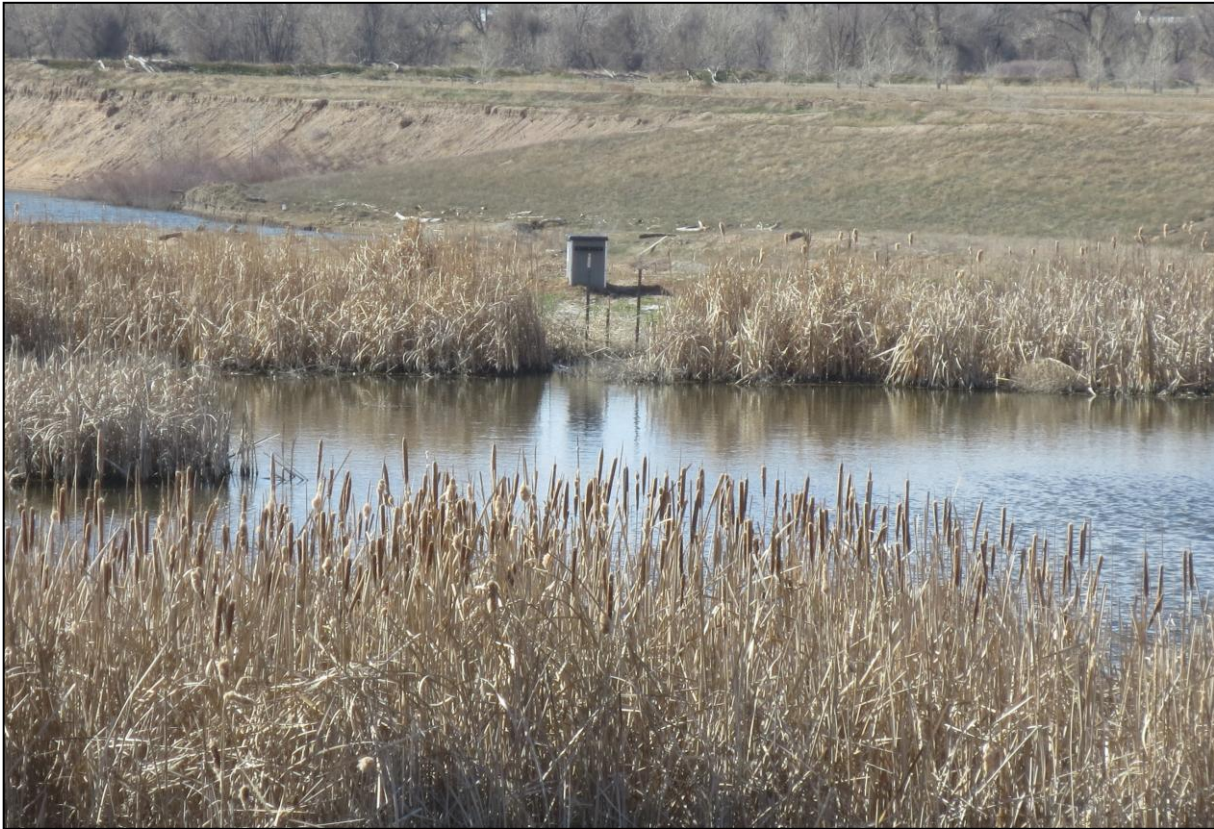
**Photo 3:** View looking northwest from the ditch access road. The Agridrain is near the center of the photo.

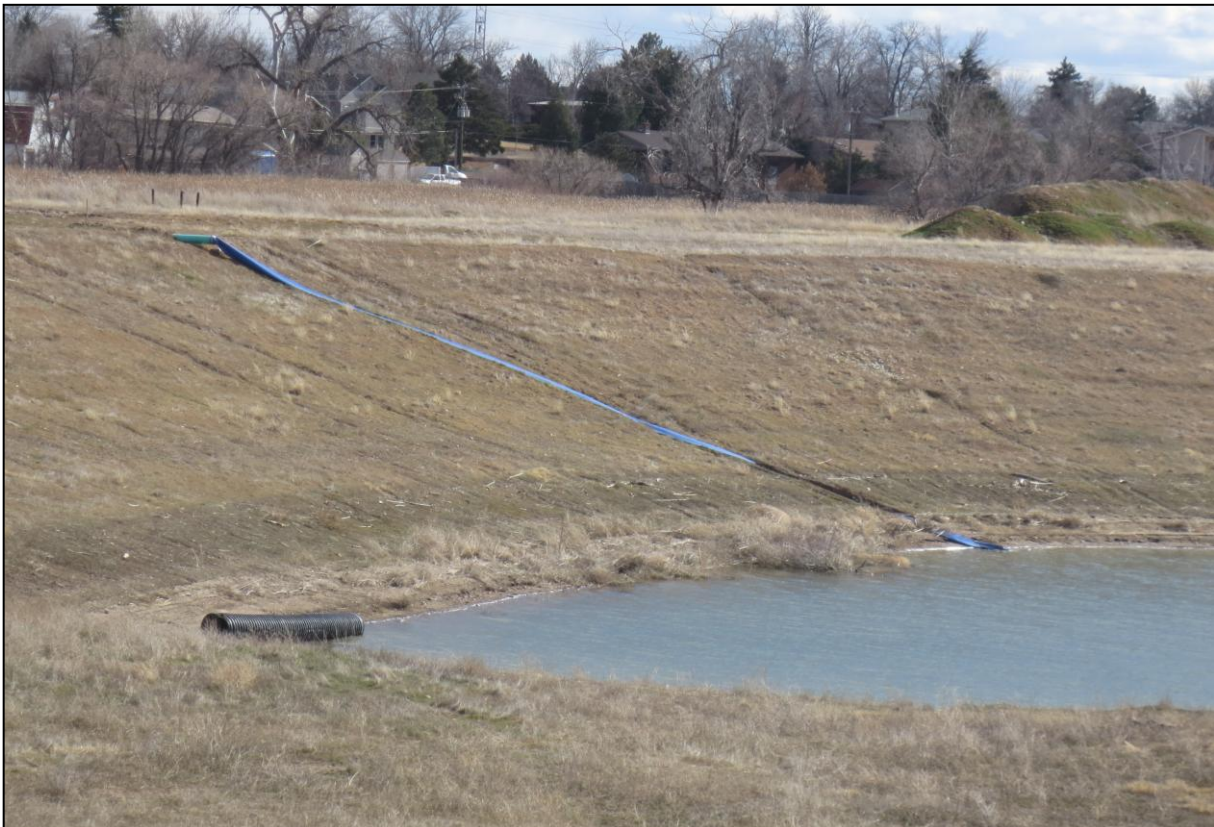
**Photo 4:** The Agridrain outlet on the inside of the Slurry wall.

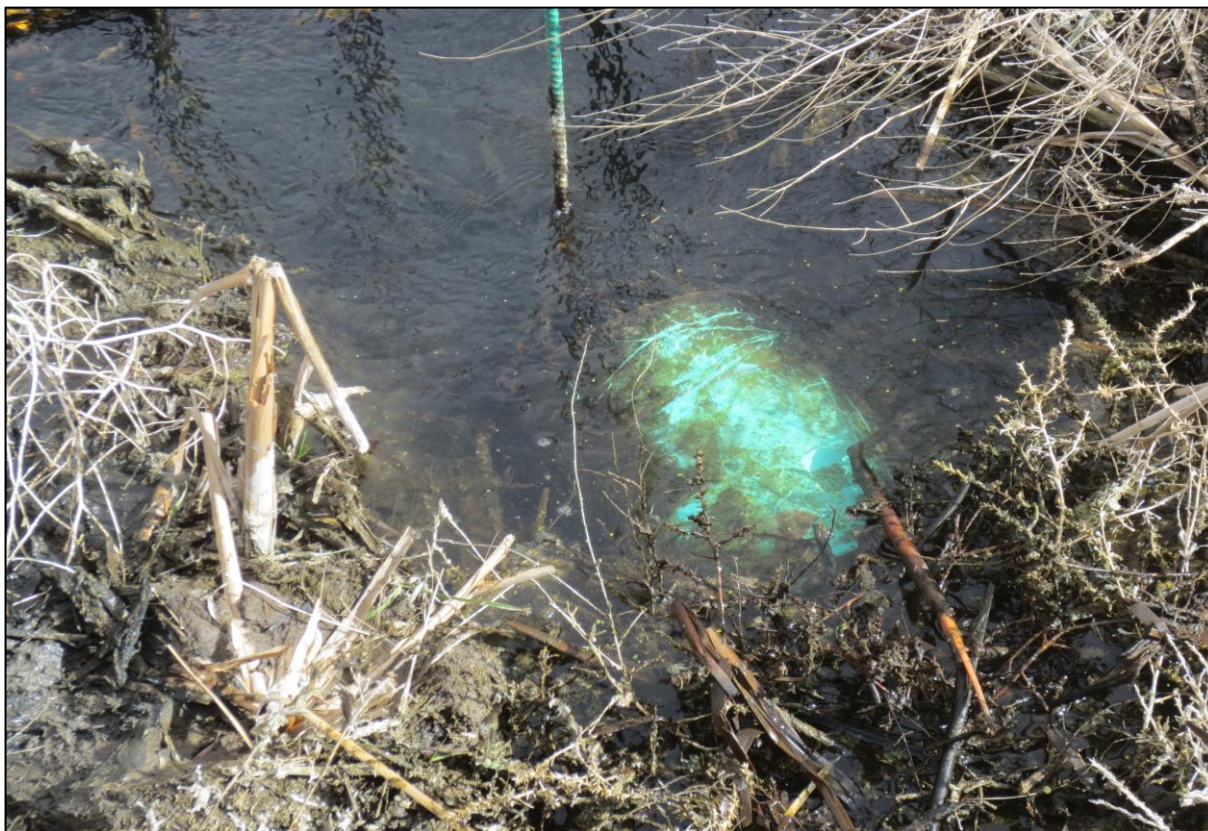
Following the investigation at the Orr property, the Division entered the mine site to observe the operation of the Agridrain. Water was flowing through the Agridrain, but the screen on the inlet pipe was clogged. The Operator's contractor cleared debris from the inlet screen of the Agridrain, resulting in an increased flow through the Agridrain. The Operator's contractor stated that the Agridrain would function better when the inlet screen is cleared of debris. The Operator's contractor committed to providing photos to the Division of the water level at the inlet pipe within a few days after the inspection. The contractor stated that a lower water level will be evident in the photos he plans to provide to the Division. The photos will be compared to the photos the Division took during the inspection (see photos 5 and 6.)

**Photo 5:** Agridrain inlet on the outside of the slurry wall. This photo was taken after the inlet was cleared of debris. Water depth is estimated to be 2 to 4 inches above the inlet pipe.

**CORRECTIVE ACTIONS:** The Operator shall submit a Technical Revision within 30 days of the date of this report. The Operator must provide a plan to the Division with a weekly monitoring and maintenance plan for the Agridrain which will be reported annually to the Division. The revision shall also include a revised inlet screen design to prevent the Agridrain from excessive clogging. The monitoring plan must also contain an evaluation of the Agridrain's performance at relieving impacts to the prevailing hydrologic balance.

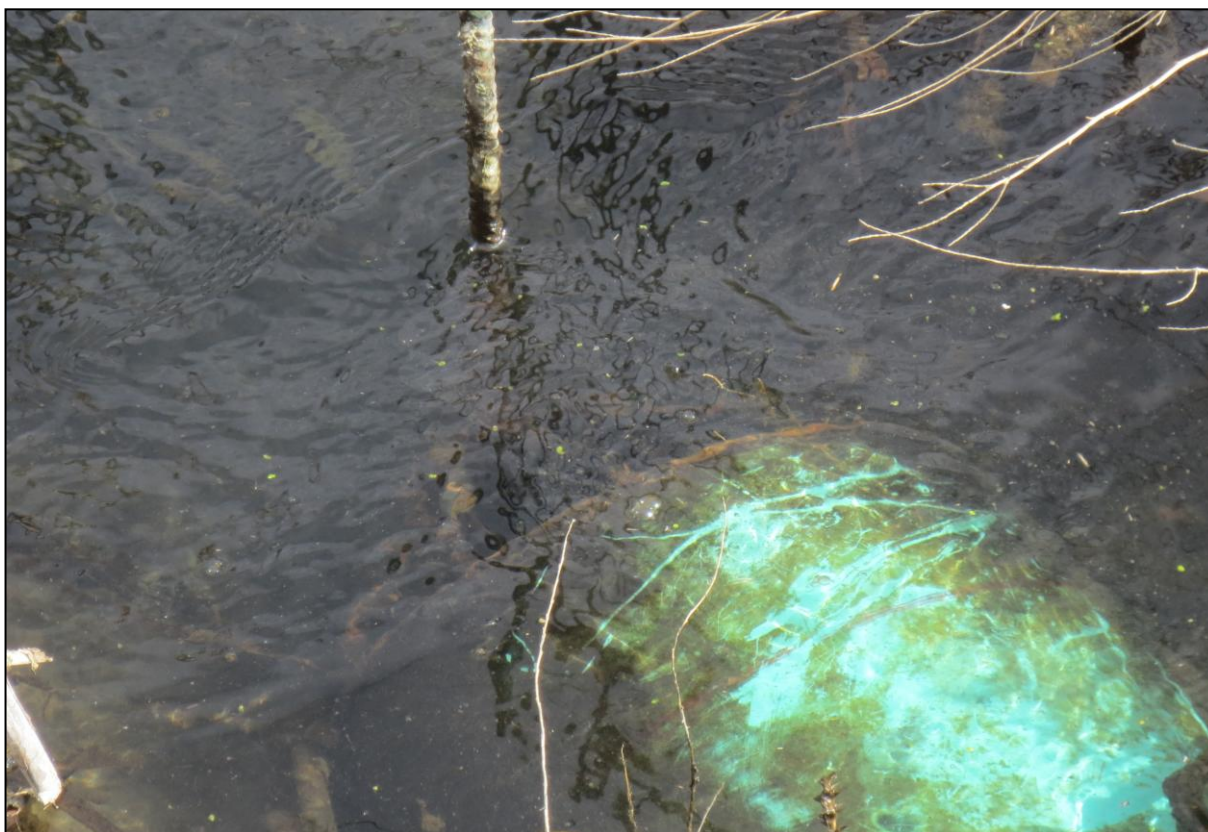
**Photo 6:** Agridrain inlet close up. This photo was taken after the inlet was cleared of debris.
