COLORADO DIVISION OF RECLAMATION, MINING AND SAFETY
MINERALS PROGRAM INSPECTION REPORT
PHONE: (303) 866-3567

| MINE NAME: Friederichs Pit | MINE/PROSPECTING ID#: M-2010-080 | MINERAL: Gravel and sand | COUNTY: Prowers |
| INSPECTION TYPE: Monitoring | INSPECTOR(S): Amy Eschberger | INSP. DATE: April 4, 2014 | INSP. TIME: 11:30 |
| OPERATOR: Riverside Aggregates, LLC | OPERATOR REPRESENTATIVE: Rudy Torres | TYPE OF OPERATION: 110c - Construction Limited Impact | |

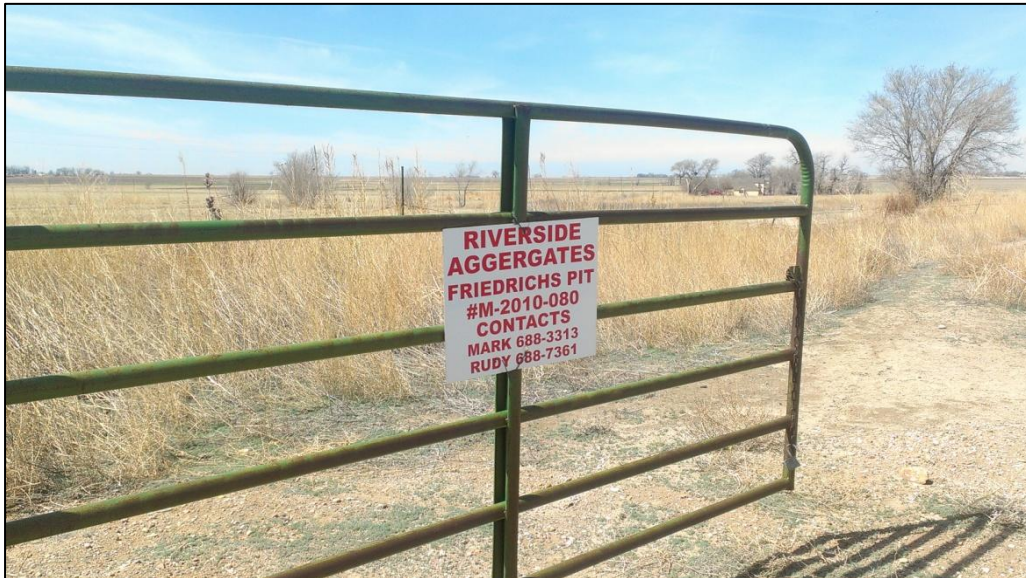
At the time of the inspection it was clear and windy, and the ground was dry. The permit sign was posted at the entrance to the site (see attached Photo 1) and the permit boundary was delineated with rebar stakes (Photo 2). No mining was taking place during the inspection and no equipment was present. The affected area is comprised of an excavated pit with a 10 foot high wall along the northern pit boundary at an approximate 1:1 slope, three main material stockpiles toward the center of the pit, a topsoil stockpile that extends along the northern pit boundary, and a dirt haul road that encircles the pit. The approved permit area does not include the approximately 675 foot long access road to the southeast, which is described in the permit as an existing pasture access road that will remain after reclamation. Material was mined from the south/southeast toward the north/northwest.

Photo 1. Permit sign posted at entrance to site from the southeast.

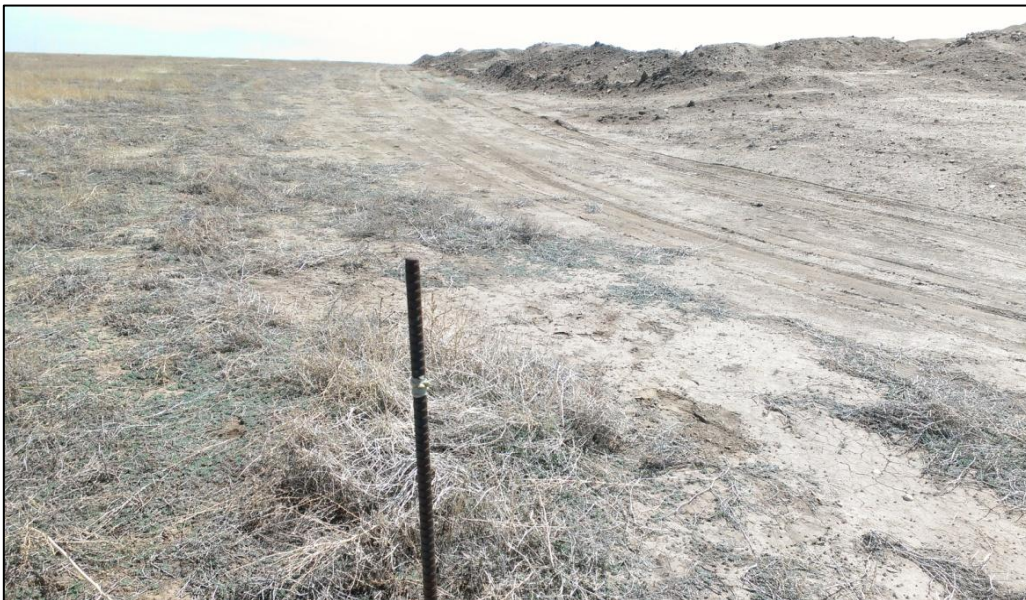
Photo 2. Rebar stake marking northwest corner of permit area, looking east, showing part of topsoil stockpile in the distance.

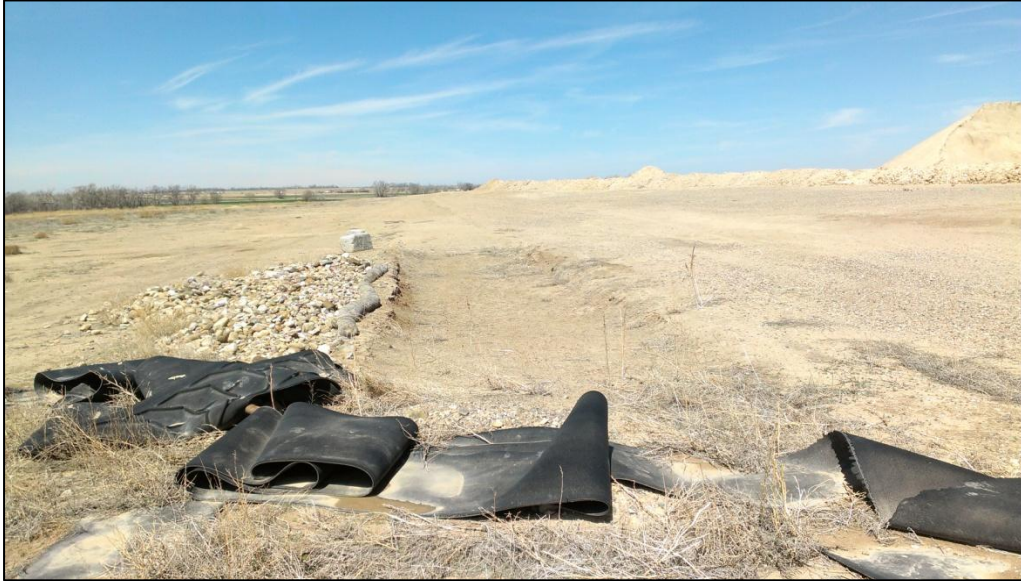
The southern edge of the permit area has been graded to a nearly flat surface, and a storm water rock filter with an erosion wattle has been created and placed along this boundary (Photo 3), which is the lowest point in the mining area. The gravel berm measures approximately 30 feet long by 3 feet wide at the base. The design and placement of this storm water management structure is commendable.

Photo 3. View looking northwest from southwest part of permit area, showing storm water rock filter with erosion wattle.

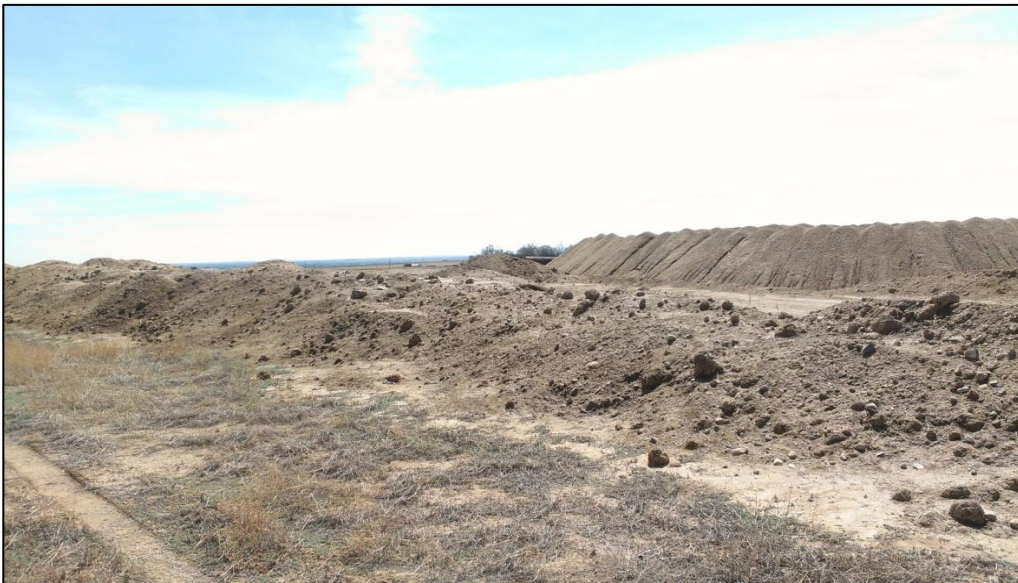
The approved Mining Plan states that the Operator will seed the topsoil stockpile to help stabilize it from wind and water erosion. During inspection, no evidence of seeding or vegetation was seen on the topsoil pile that lines the northern rim of the pit (Photo 4). The Operator shall work on seeding the topsoil stockpile with the approved seed mixture as soon as possible.

Photo 4. View looking southeast from northwest part of permit area, showing topsoil stockpile in foreground bordering northern rim of pit, and a material stockpile in the background located at center of pit.

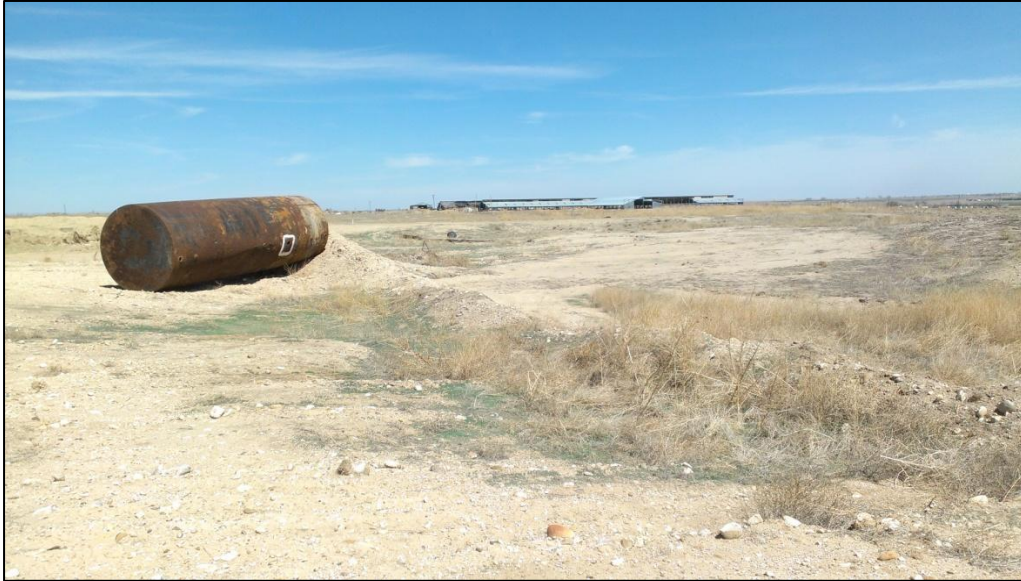
The approved permit does not include an existing inactive pit approximately one acre in size, immediately adjacent to its eastern boundary. The approved permit stated that this area would be clearly delineated from the current mining operation and that it would not be disturbed. During inspection, this area was seen to be recently disturbed, and was difficult to distinguish from the permit area (Photos 5 and 6). The Operator indicated that he had helped the landowner remove debris from this inactive pit area, and that the disturbance was not related to current mining activity. Because of the difficulty in delineating this area from

Photo 5. View looking northwest from southeastern part of permit area, showing existing inactive pit approximately one acre in size, immediately adjacent to the eastern boundary of the permit area. The tank shown at the left of the photo is part of the debris that was left in the inactive pit.

the affected permit area, the Division included this one acre of recently disturbed land in our estimate of total affected area (approximately 12.09 acres; see Figure 1), but not in our estimate of affected area outside of the approved permit boundary (approximately 1.5 acres; see above). The Operator agreed to submit to the Division more information about this inactive mine area, including any recent disturbances, to prevent confusion in future inspections over its separation from the permit boundary.

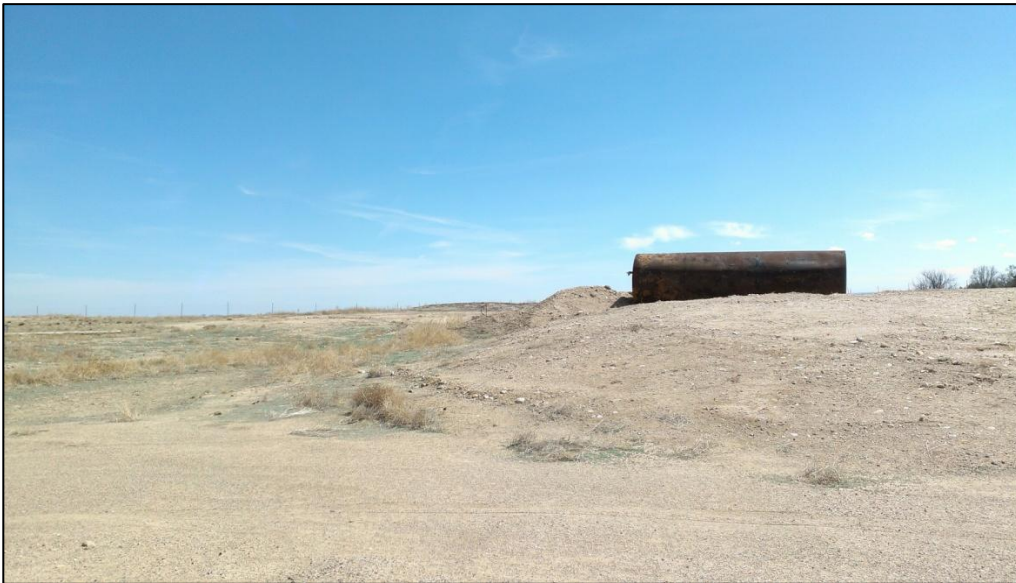
Photo 6. Another view of the inactive pit area, looking northeast from southeastern part of permit area, off the access road. At the right of the photo, the ground is clearly disturbed, and no markers are shown to delineate this area from the approved permit area located immediately to the left.

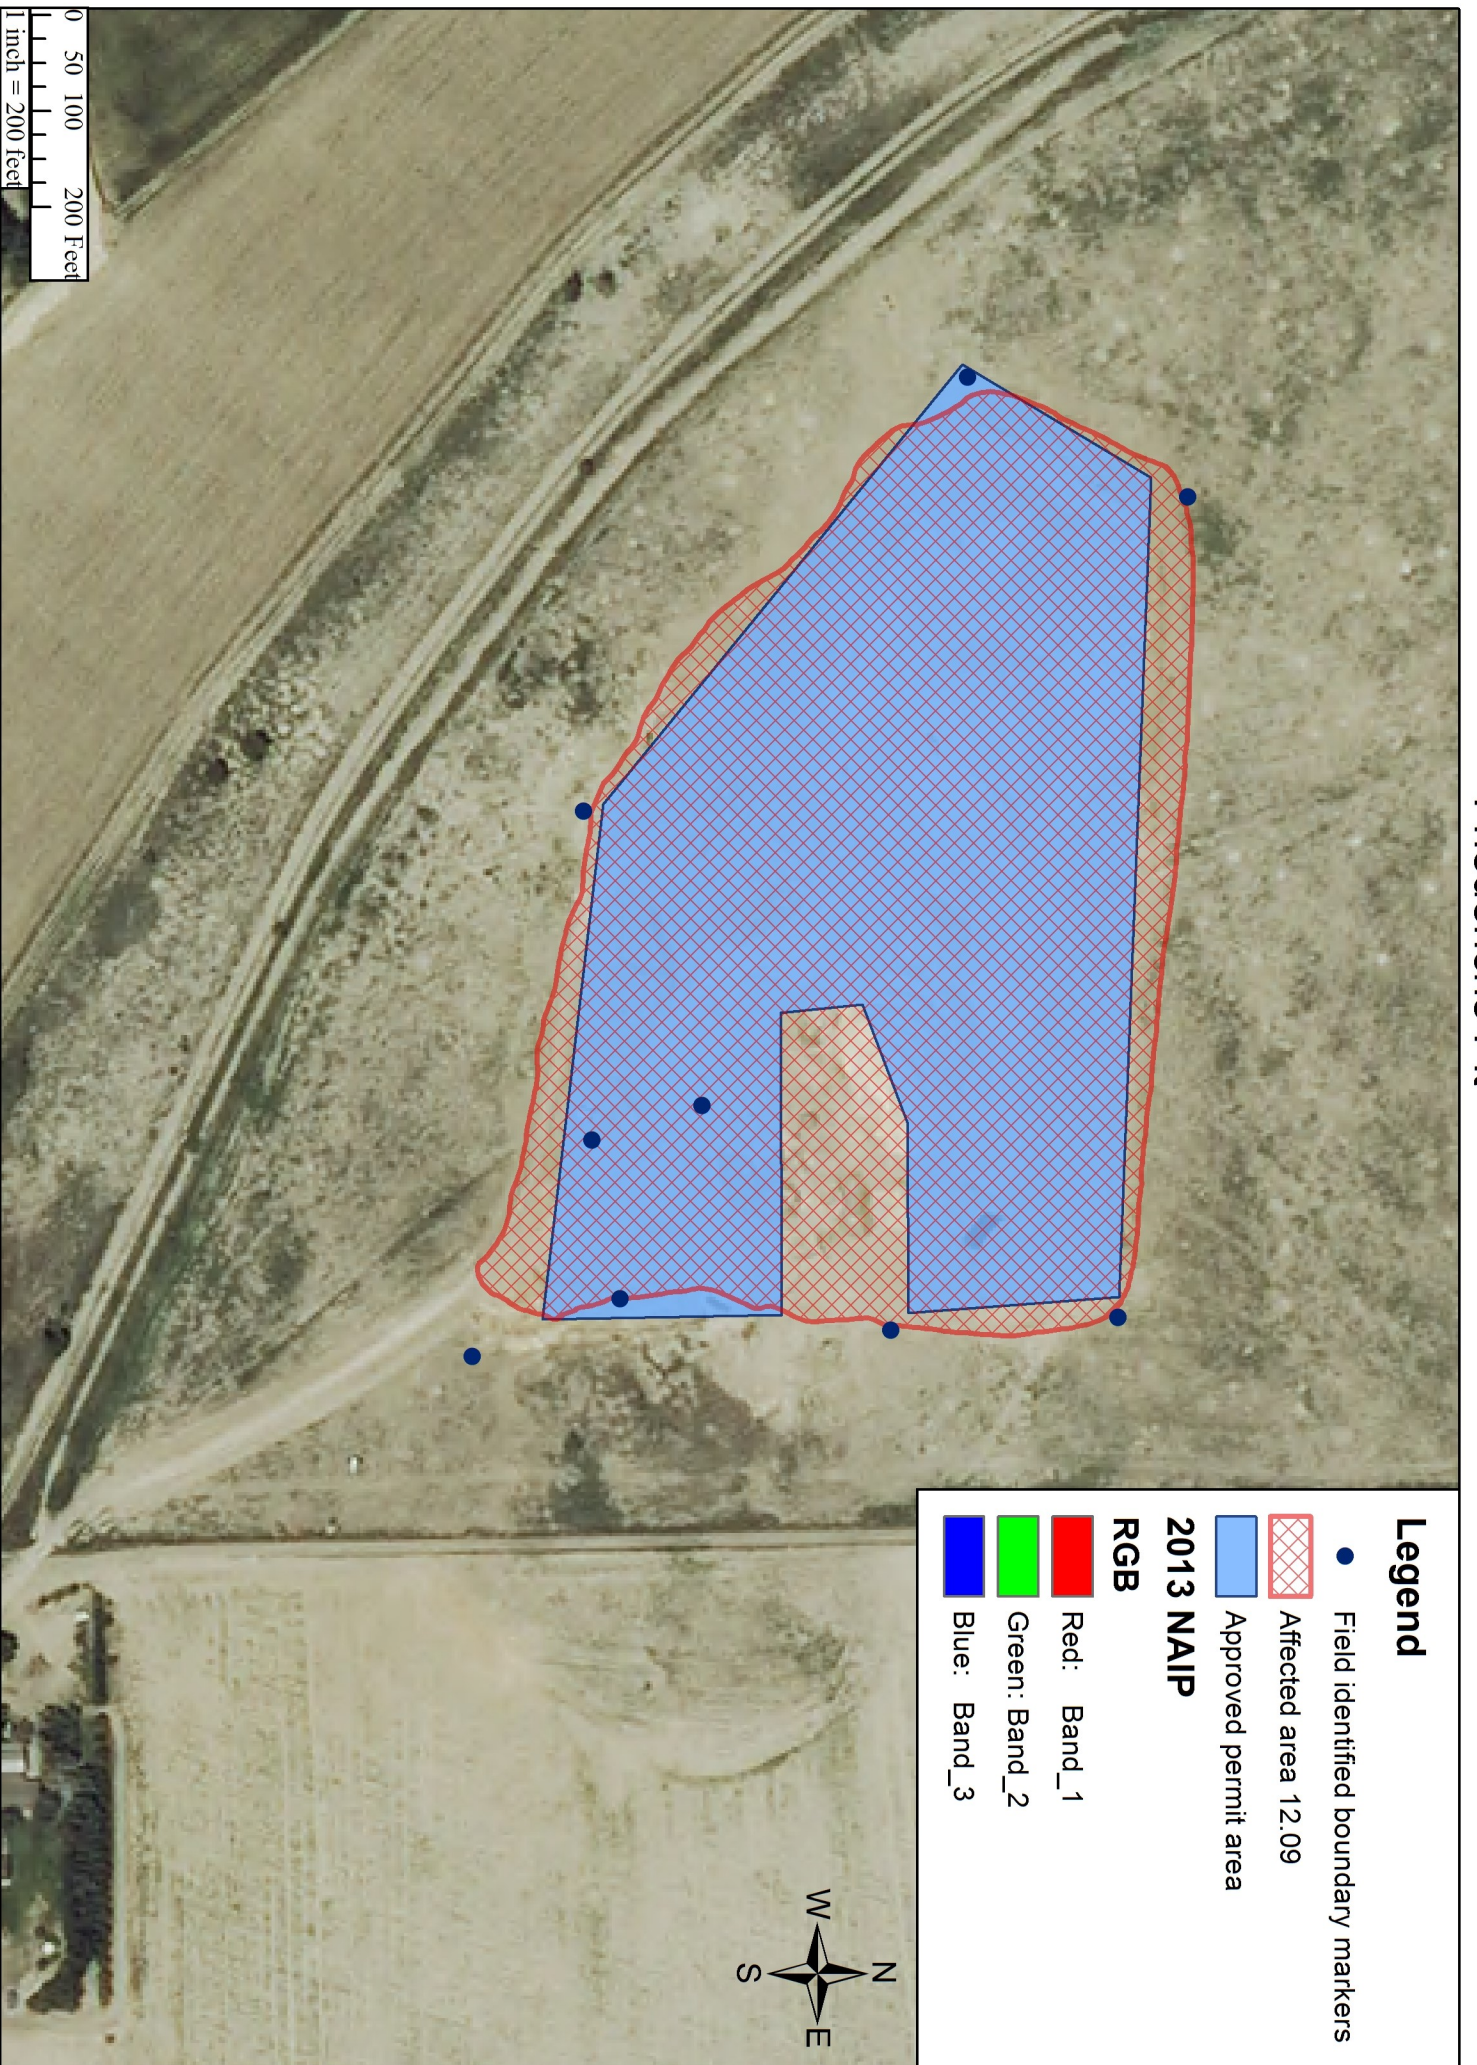
PROBLEM/POSSIBLE VIOLATION: Possible Violation: Land has been affected outside of the approved permit boundary. This is a possible violation at this time pursuant to C.R.S. 34-32.5-116(4)(i) for failure to protect areas outside of the affected land from slides or damages occurring during the mining operation.

During inspection, the Division obtained perimeter coordinates of actual affected area and GPS points from boundary markers. This data was later compared to the approved permit boundary (Figure 1) which showed: a.) the marked boundary to not correlate with the approved permit boundary, and b.) the actual affected area to be approximately 1.5 acres outside of the approved permit area of 9.9 acres. The affected area outside of the approved permit boundary mainly consists of a dirt haul road that encircles the pit and a storm water rock filter located just south of the pit, and includes approximately 0.7 acres outside of the northern marked boundary, 0.1 acres outside of the western boundary, 0.7 acres outside of the southern boundary, and approximately 0.1 acres outside of the eastern boundary.

Based on the data collected during this inspection, the Division estimates that approximately 1.5 acres of land have been affected outside of the approved permit boundary. This gives the Division reason to believe that a possible violation of C.R.S. 34-32.5-116(4)(i) has occurred for failure to protect areas outside of the affected land from slides or damage occurring during the mining operation. This possible violation will be scheduled for consideration by the Mined Land Reclamation Board during the Board's meeting on May 21-22, 2014. A notice of possible violation will be sent under separate cover to the Operator, Rudy Torres of Riverside Aggregates, LLC.

Figure 1: Map showing field identified boundary markers, affected area (approximately 12 acres), and approved permit area (9.9 acres) on a 2013 NAIP image.

CORRECTIVE ACTIONS: This possible violation will require a hearing before the Mined Land Reclamation Board. The matter will be scheduled for the May 21-22, 2014 Board meeting to occur at 1313 Sherman Street, Room 318, Denver, Colorado. The schedule and other details for the Board hearing will be provided under separate cover to be sent by certified mail to the Operator, Rudy Torres of Riverside Aggregates, LLC.
