COLORADO DIVISION OF RECLAMATION, MINING AND SAFETY
MINERALS PROGRAM INSPECTION REPORT
PHONE: (303) 866-3567

MINE NAME: Canyon Sand & Gravel	MINE/PROSPECTING ID#: M-1988-057	MINERAL: Sand and gravel	COUNTY: Archuleta
INSPECTION TYPE: Monitoring	INSPECTOR(S): Kate A. Pickford	INSP. DATE: April 10, 2014	INSP. TIME: 12:30
OPERATOR: Canyon Sand & Gravel	OPERATOR REPRESENTATIVE:	TYPE OF OPERATION: 110c - Construction Limited Impact

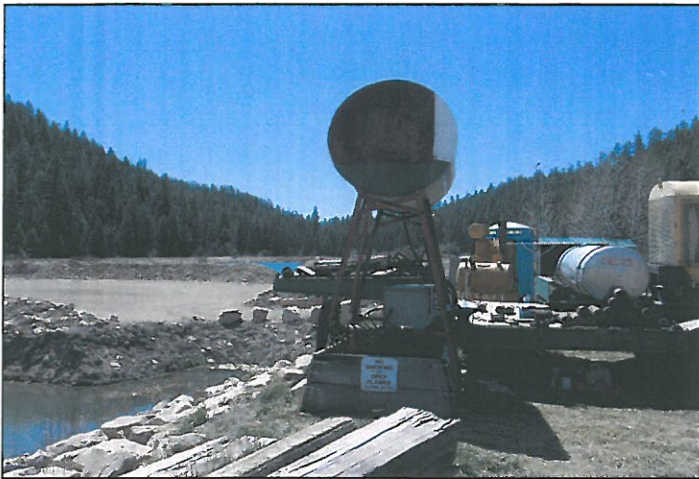
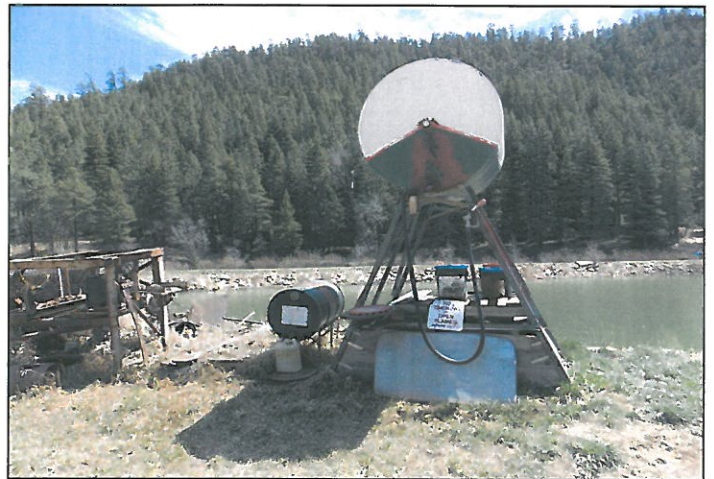
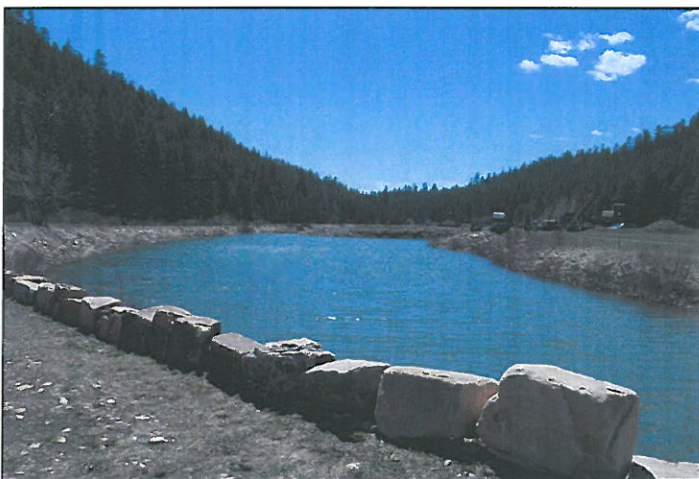
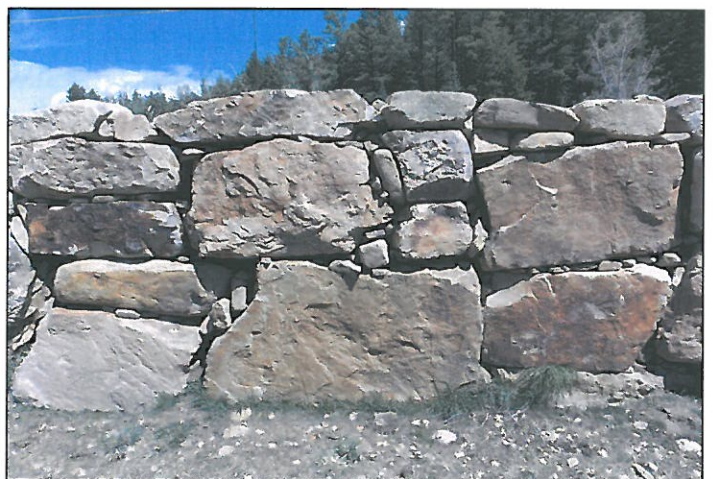
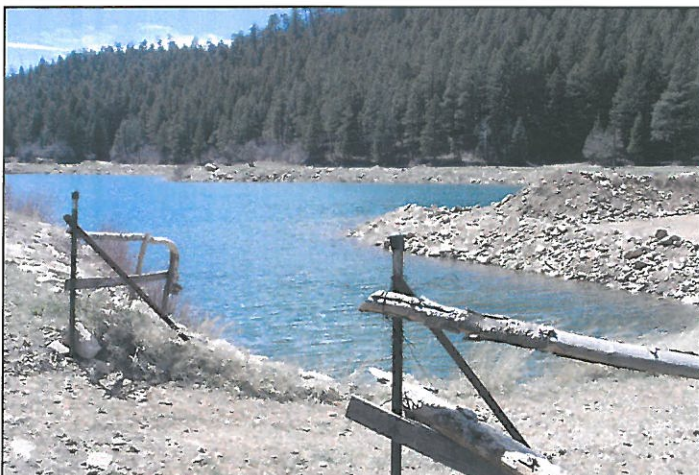
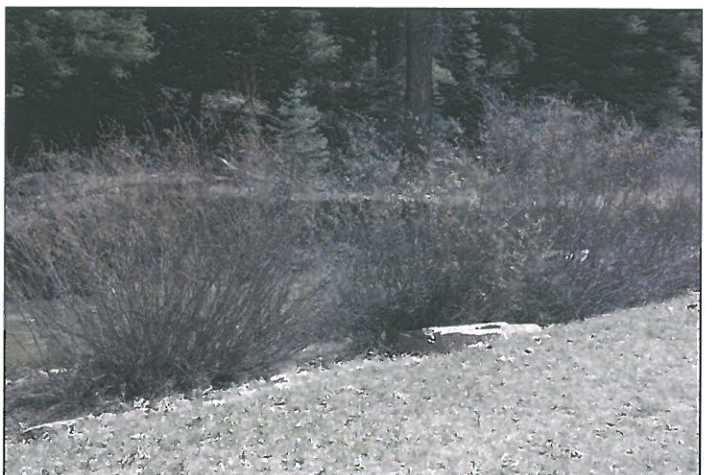
PROBLEM/POSSIBLE VIOLATION: Problem: The liners below the fuel and oil tanks at the site are missing, putting the surface and groundwater at risk of being contaminated in the event of a leak or spill.

During this inspection it was observed that the liners are missing beneath the two fuel tanks and the one oil tank. These must be replaced prior to using these tanks for storage, to prevent the possibility of a leak or spill. This is essential due to the location of these tanks, immediately adjacent to the pond.

CORRECTIVE ACTIONS: Replace the liners below the fuel tanks and place the oil tank into secondary containment prior to the noted deadline date and submit photos to the Division as evidence of completion of the corrective actions.
