**COLORADO DIVISION OF RECLAMATION, MINING AND SAFETY**  
**MINERALS PROGRAM INSPECTION REPORT**  
**PHONE: (303) 866-3567**

<b>MINE NAME:</b> Farmer Girl 2	<b>MINE/PROSPECTING ID#:</b> P-2008-018	<b>MINERAL:</b> Uranium and vanadium	<b>COUNTY:</b> Montrose
<b>INSPECTION TYPE:</b> Surety Release Inspection	<b>INSPECTOR(S):</b> Dustin M. Czaplá	<b>INSP. DATE:</b> April 10, 2014	<b>INSP. TIME:</b> 10:00
<b>OPERATOR:</b> Energy Fuels Resources Corporation	<b>OPERATOR REPRESENTATIVE:</b> None	<b>TYPE OF OPERATION:</b> MP - Mineral Prospecting

<b>REASON FOR INSPECTION:</b> Surety Release Requested	<b>BOND CALCULATION TYPE:</b> None	<b>BOND AMOUNT:</b> \$5,745.00
<b>DATE OF COMPLAINT:</b> NA	<b>POST INSP. CONTACTS:</b> None	<b>JOINT INSP. AGENCY:</b> None
<b>WEATHER:</b> Clear	<b>INSPECTOR'S SIGNATURE:</b>

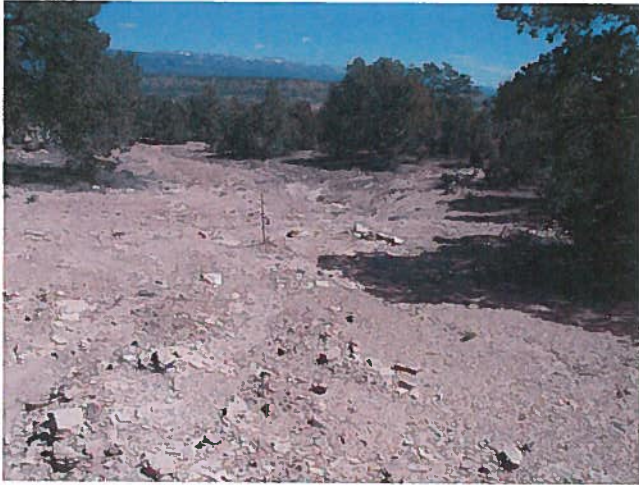
FG-08-A 0688692, 4251894 UTM NAD27

The operator supplied GPS coordinates for the 12 holes with the abandonment report that was submitted on October 20, 2010. The 12 sites were located during this inspection. Reclamation of the 12 holes appears to be adequate.

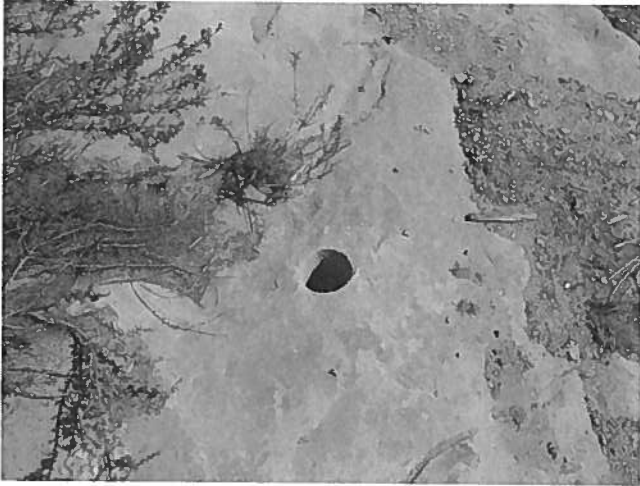
Open Hole 1 38.397975, -108.837588 WGS84

Three open holes were located during this inspection, within the project area, at the following GPS coordinates:

Open hole 1: 38.397975, -108.837588 WGS84

It was unclear whether any of these holes are associated with this NOI. The Division requests clarification from the operator prior to issuing a decision regarding the release request.

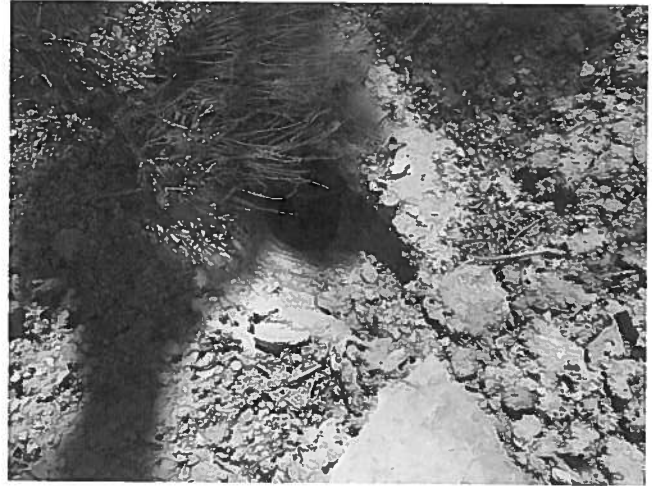
Open Hole 2 38.397437, -108.837544 WGS84

Open hole 2: 38.397437, -108.837544 WGS84

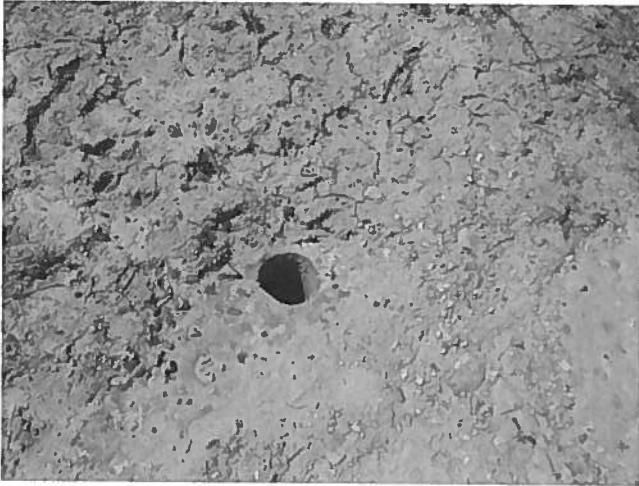
Open Hole 3 38.397138, -108.841948 WGS84

Open hole 3: 38.397138, -108.841948 WGS84
