**COLORADO DIVISION OF RECLAMATION, MINING AND SAFETY**  
**MINERALS PROGRAM INSPECTION REPORT**  
**PHONE: (303) 866-3567**

<b>MINE NAME:</b> MMM Partnership Gravel Pit	<b>MINE/PROSPECTING ID#:</b> M-2006-042	<b>MINERAL:</b> Sand/gravel/borrow	<b>COUNTY:</b> Logan
<b>INSPECTION TYPE:</b> Pre-Operation Inspection	<b>INSPECTOR(S):</b> Elliott R. Russell	<b>INSP. DATE:</b> April 10, 2014	<b>INSP. TIME:</b> 12:45
<b>OPERATOR:</b> MMM Partnership, LLP.	<b>OPERATOR REPRESENTATIVE:</b> Mark Kokes	<b>TYPE OF OPERATION:</b> 110c - Construction Limited Impact

<b>REASON FOR INSPECTION:</b> Pre-Operation Inspection	<b>BOND CALCULATION TYPE:</b> None	<b>BOND AMOUNT:</b> \$28,333.00
<b>DATE OF COMPLAINT:</b> NA	<b>POST INSP. CONTACTS:</b> None	<b>JOINT INSP. AGENCY:</b> None
<b>WEATHER:</b> Clear	<b>INSPECTOR'S SIGNATURE:</b> <i>Elliott R. Russell</i>	<b>SIGNATURE DATE:</b> April 18, 2014

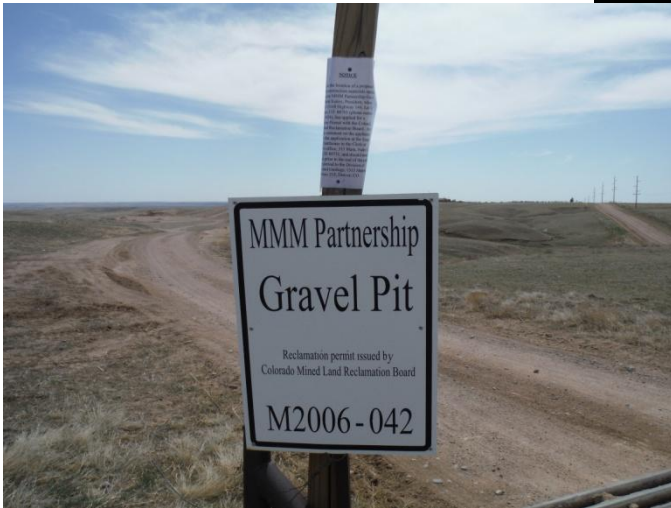
At 12:45, the Division met Mark and Kent Kokes at the mine site off of County Road 79. The notice sign was observed during the inspection as required by Rule 1.6.2(b). The 110c mine permit sign was also observed. The boundary markers for the new permit were installed. These markers were t-posts and the Applicant stated these would be replaced with more permanent posts once the permit was approved.

Permit sign and posted notice; looking south.

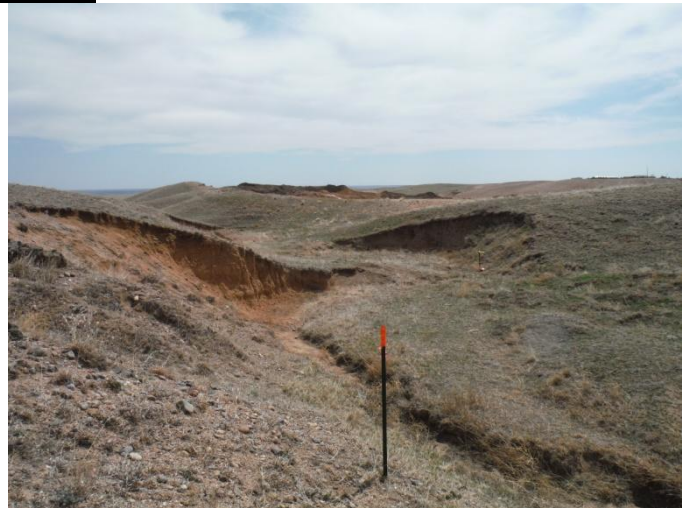
Northeast boundary marker; looking southeast down eastern drainage.

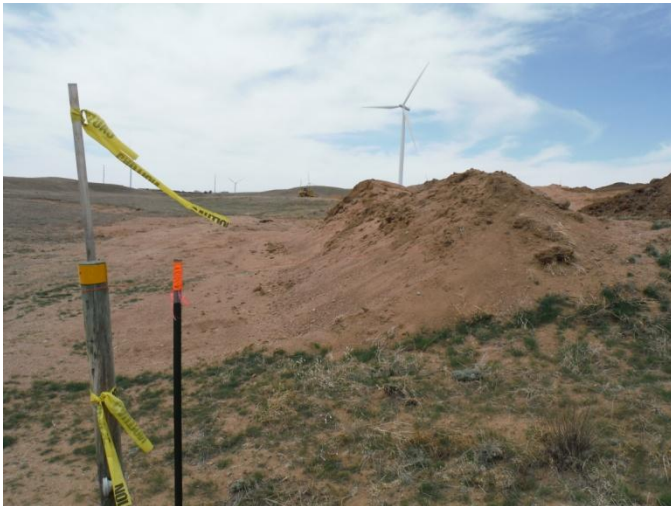
Boundary marker along western edge of permit, MMM Partnership Gravel Pit on right, Kokes Pit on left; looking Northwest.

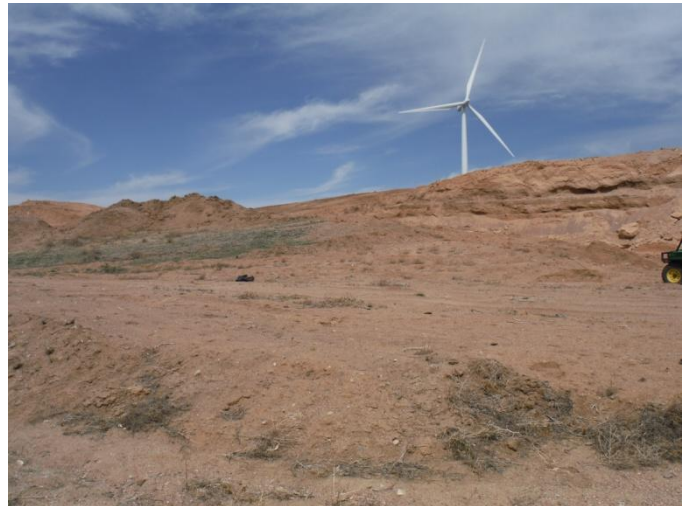
110c area; looking northeast/uphill from western drainage.

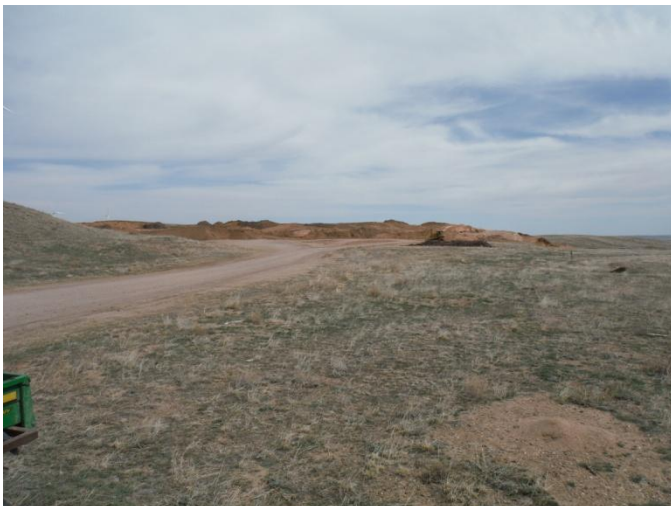
110c mine area; looking southeast.

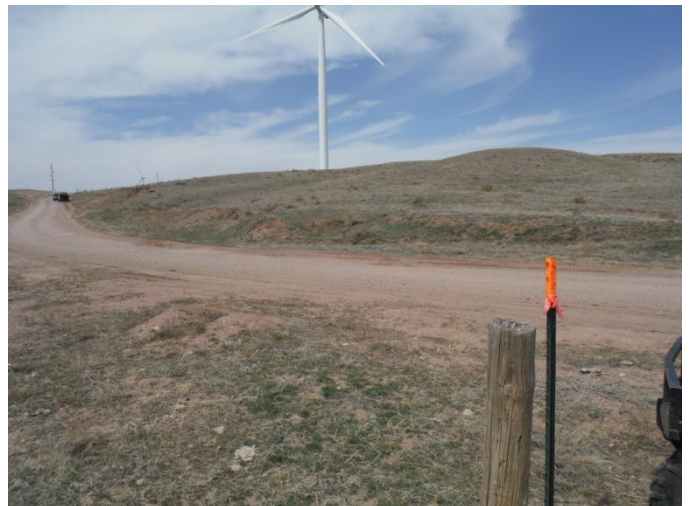
Permit access road; looking northwest.
