COLORADO DIVISION OF RECLAMATION, MINING AND SAFETY
MINERALS PROGRAM INSPECTION REPORT
PHONE: (303) 866-3567

MINE NAME: King Pit	MINE/PROSPECTING ID#: M-2004-036	MINERAL: Clay/sand/gravel	COUNTY: Washington
INSPECTION TYPE: Monitoring	INSPECTOR(S): Elliott R. Russell	INSP. DATE: April 11, 2014	INSP. TIME: 09:00
OPERATOR: Mason King	OPERATOR REPRESENTATIVE: Mason King	TYPE OF OPERATION: 110c - Construction Limited Impact

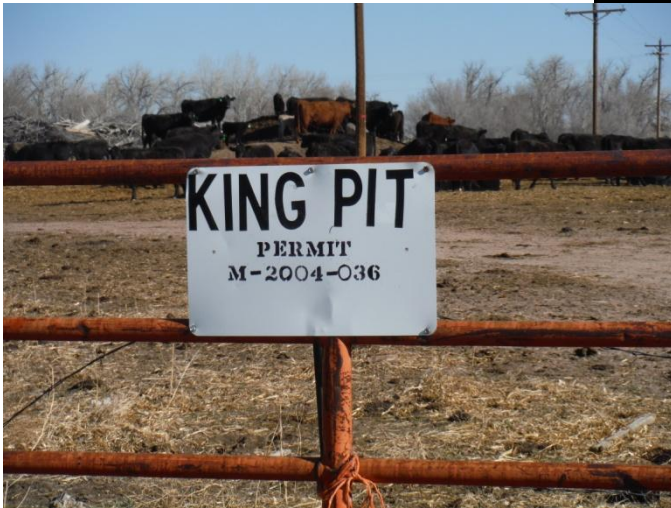
At 9:00, the Division met Mr. King at his residence along County Road Xx. At the time of the inspection it was sunny and the ground was dry. The mine site identification sign was observed at the entrance to the site just north of Mr. King's residence.

Permit sign at site entrance; looking north.

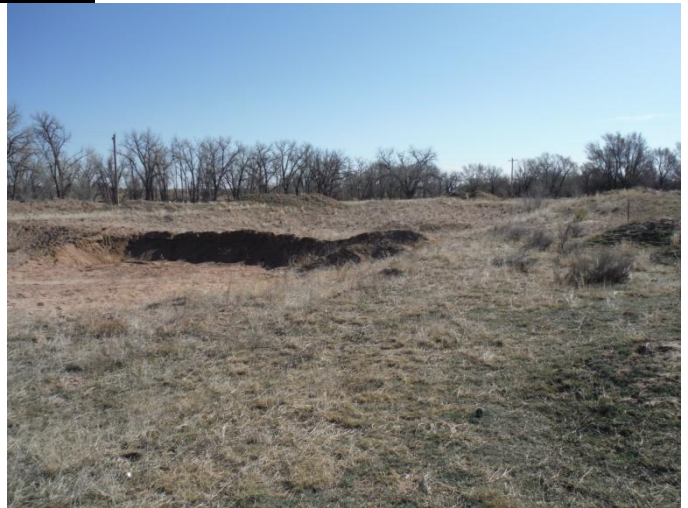
Recent excavation at southern pit; looking northeast.

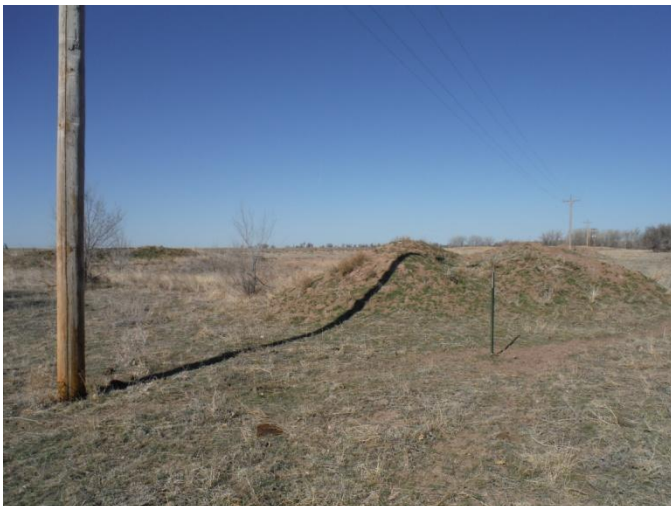
PROBLEM/POSSIBLE VIOLATION: Problem: There is an overhead powerline within 200 feet of the affected area boundary that is not an addressed structure within the permit. This is a problem for failure to comply with Rule 6.4.19.

An overhead power line was located on the north end of the southern pit. After further research, this structure was not mentioned in the original permit. It was unclear if the utility line was constructed sometime after the permit was issued. This overhead power line will now need to be accounted for within the permit. Please see the corrective action section of this report for further information.

Northeast boundary marker of southern pit, overhead powerline along northern edge; looking west.

CORRECTIVE ACTIONS: The applicant shall provide to the Division, by the corrective action date, either: a notarized agreement between the applicant and the person(s) having an interest in the structure, that the applicant is to provide compensation for any damages to the structure; or where such agreement cannot be reached, the applicant shall provide an appropriate engineering evaluation that demonstrates that such structure shall not be damaged by mine activities; or where such structure is a utility, the applicant may supply a notarized letter, on utility letterhead, from the owner(s) of the utility that the mining and reclamation activities, as proposed, will have "no negative effect" on their utility.

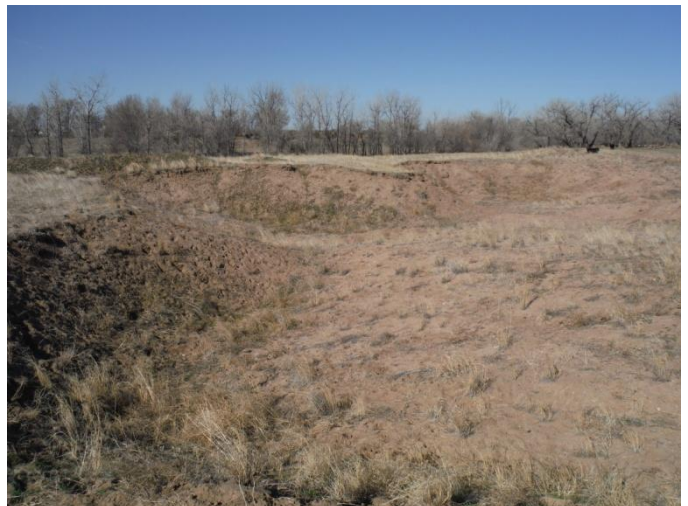
Excavated area in northern pit, looking southwest.

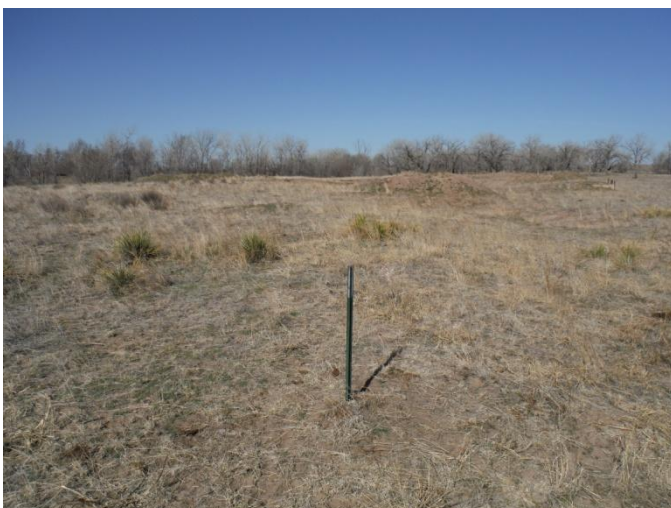
Northeast boundary marker of the northern pit; looking southwest.

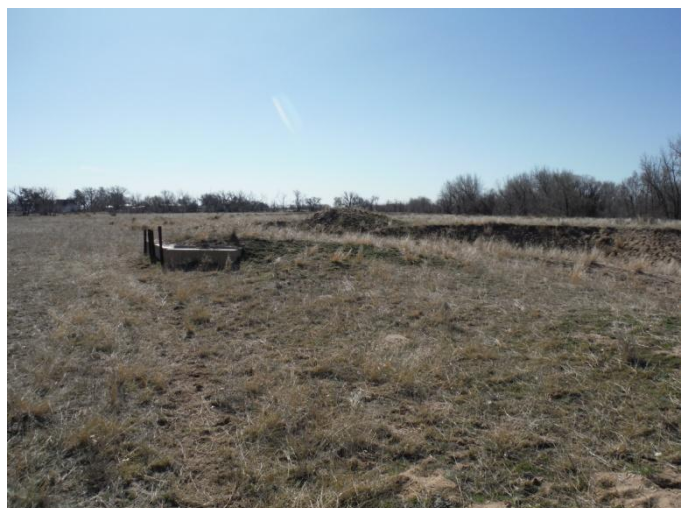
Load-out ramp on north side of the northern pit; looking east.
