COLORADO DIVISION OF RECLAMATION, MINING AND SAFETY
MINERALS PROGRAM INSPECTION REPORT
PHONE: (303) 866-3567

MINE NAME: Gaede Pit	MINE/PROSPECTING ID#: M-1978-051	MINERAL: Sand and gravel	COUNTY: Lincoln
INSPECTION TYPE: Monitoring	INSPECTOR(S): Amy Eschberger	INSP. DATE: April 3, 2014	INSP. TIME: 10:30
OPERATOR: Lincoln County	OPERATOR REPRESENTATIVE: John Dewitt	TYPE OF OPERATION: 110c - Construction Limited Impact

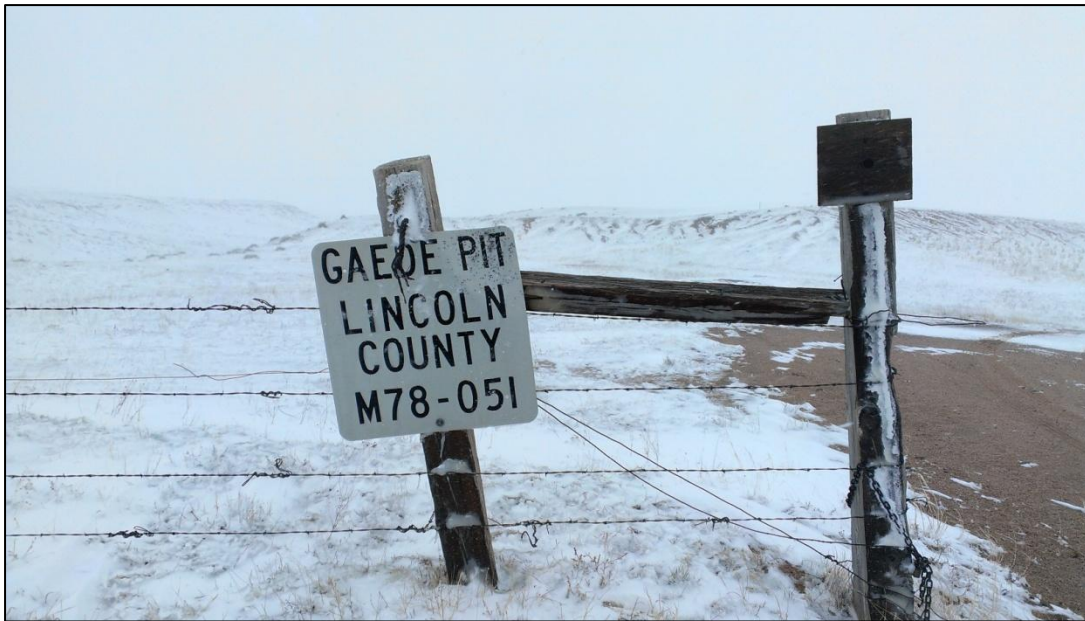
Photo 1. Permit sign posted at entrance to site, off County Road 3J.

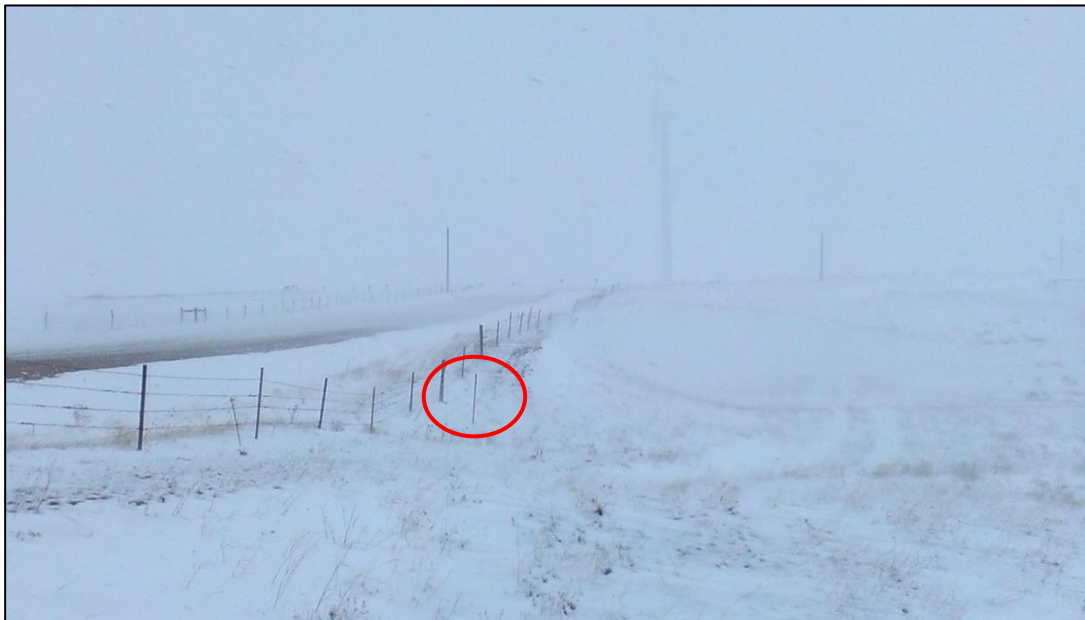
Photo 2. View looking west, showing rebar stake (circled in red) marking northeastern corner of permit area.

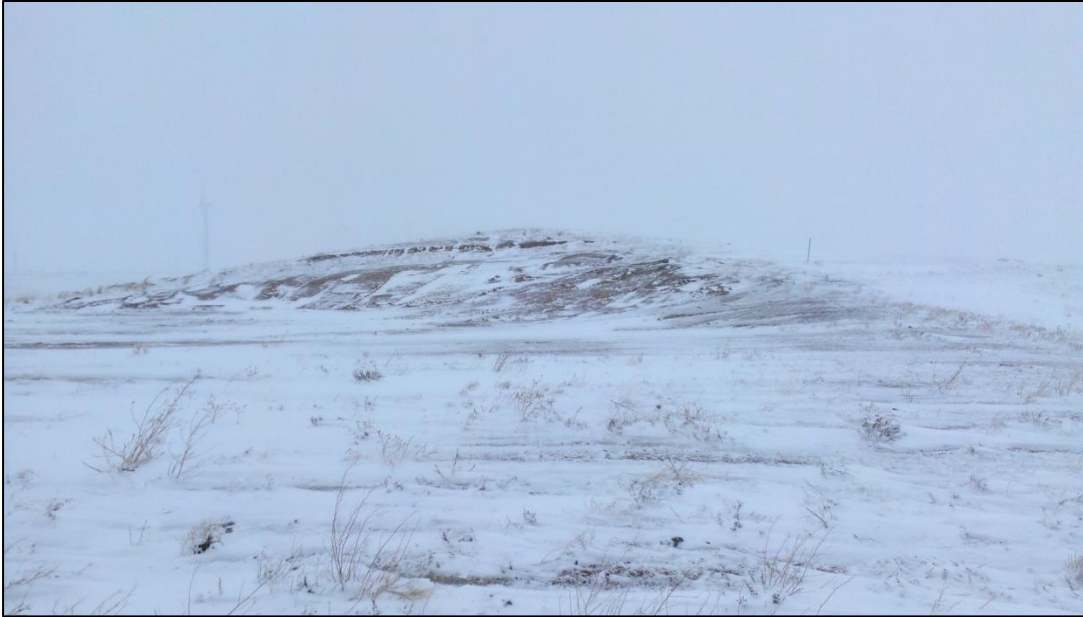
The site is permitted for 9.9 acres and is reported to have affected 5.9 acres to date. Material was initially removed east to west from a hillside located in the northwestern portion of the permit area, then proceeded in a west to east fashion, creating a generally level topography, except for the southern (north-facing) wall (Photo 3), which has been mostly graded to 3H:1V. The sand and gravel was mined for maintenance of Lincoln County roads. No mining activity was taking place during the inspection and no equipment was present. The last activity was reported to have occurred in October of 2012. This pit operates under intermittent status, as approved by the Division on April 5, 2013 under Technical Revision 3. During inspection, Mr. DeWitt stated that all available material has been exhausted in the permitted area, and the County plans to begin reclamation procedures this year. According to C.R.S. 34-32.5-116(4)(q)(I), final reclamation shall be completed within five years after mining has ceased.

Photo 3. View looking south at southern (north-facing) wall that has been regraded mostly to 3H:1V.

For reclamation, steeper portions of the southern wall will need to be regraded to 3H:1V. The approved seed mixture recommended by the NRCS should be used in efforts to revegetate the disturbed area. Because much of the ground was covered by snow during the inspection, the Division was unable to do a thorough investigation of vegetation; however, it appeared that natural vegetation has begun to establish on the southern wall (Photo 4), especially its eastern portion, and throughout much of the site (Photo 5), not including the access road. This vegetation will help stabilize the affected area until reclamation begins.

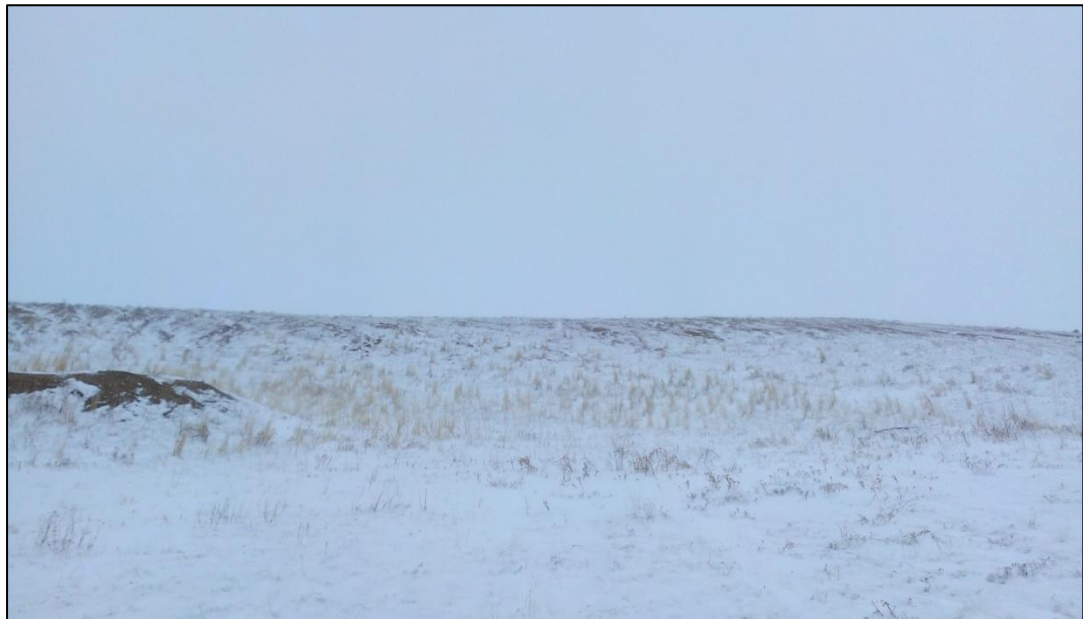
Photo 4. View looking south at southern (north-facing) wall (from further east than in Photo 3) showing some establishment of natural vegetation.

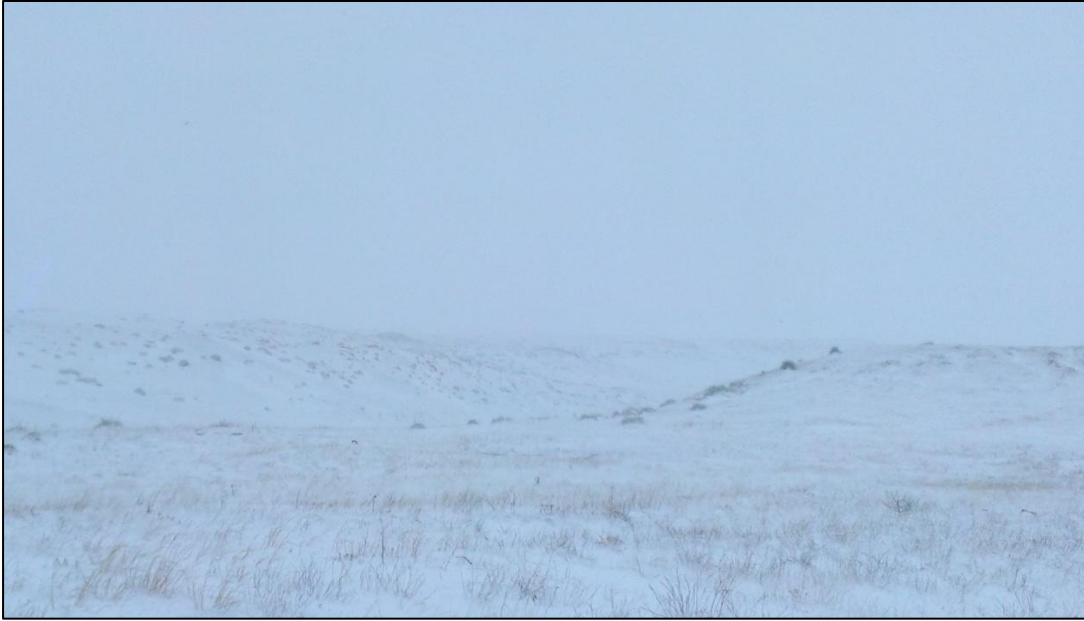
Photo 5. View looking west, showing some establishment of natural vegetation.
