COLORADO DIVISION OF RECLAMATION, MINING AND SAFETY
MINERALS PROGRAM INSPECTION REPORT
PHONE: (303) 866-3567

MINE NAME: Wiley Pit	MINE/PROSPECTING ID#: M-1977-223	MINERAL: Sand and gravel	COUNTY: Prowers
INSPECTION TYPE: Monitoring	INSPECTOR(S): Amy Eschberger	INSP. DATE: April 3, 2014	INSP. TIME: 14:30
OPERATOR: Five Rivers Ranch Cattle Feeding LLC	OPERATOR REPRESENTATIVE: Thane Milenski	TYPE OF OPERATION: 112c - Construction Regular Operation	
REASON FOR INSPECTION: Normal I&E Program	BOND CALCULATION TYPE: None	BOND AMOUNT: \$761,000.00	
DATE OF COMPLAINT: NA	POST INSP. CONTACTS: None	JOINT INSP. AGENCY: None	
WEATHER: Cloudy	INSPECTOR'S SIGNATURE: <i>Amy Eschberger</i>	SIGNATURE DATE: April 21, 2014

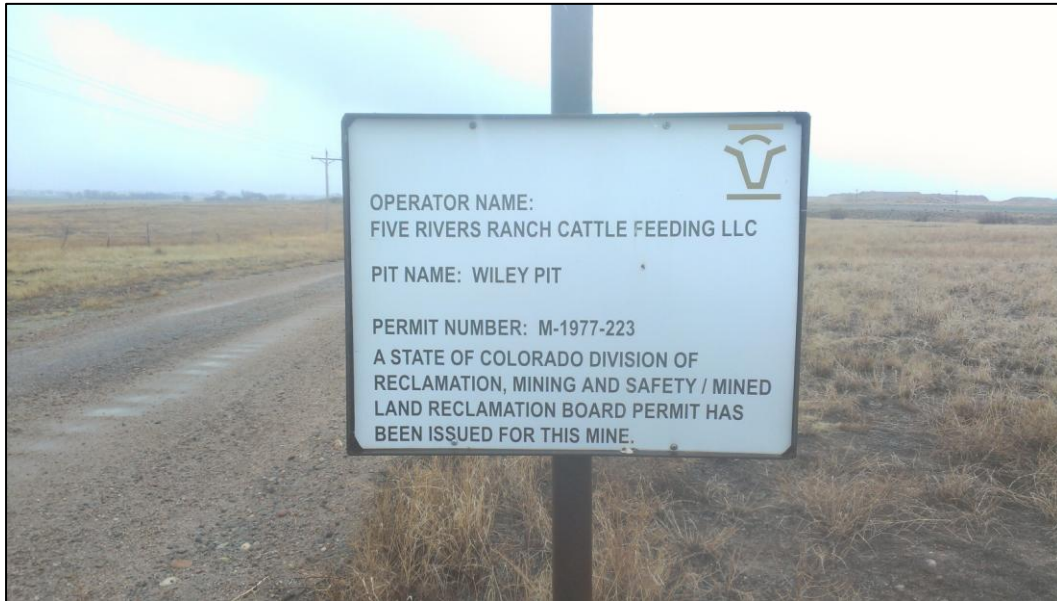
During inspection, a permit sign was posted on the existing service road off Highway 50 that leads to the site from the south entrance (Photo 1), and also on the existing service road off Highway 287 that leads to the site from the east entrance (Photo 2). The permit boundary of the affected area was delineated with rebar stakes; however, as discussed with Mr. Milenski during inspection, many of these stakes were difficult to find and to correlate with the approved map. This has been cited as a problem and will require corrective action by the Operator; please see Page 1 of this report for the required corrective action.

Photo 1. Permit sign posted on existing service road off Highway 50 that leads to the site from the south entrance.

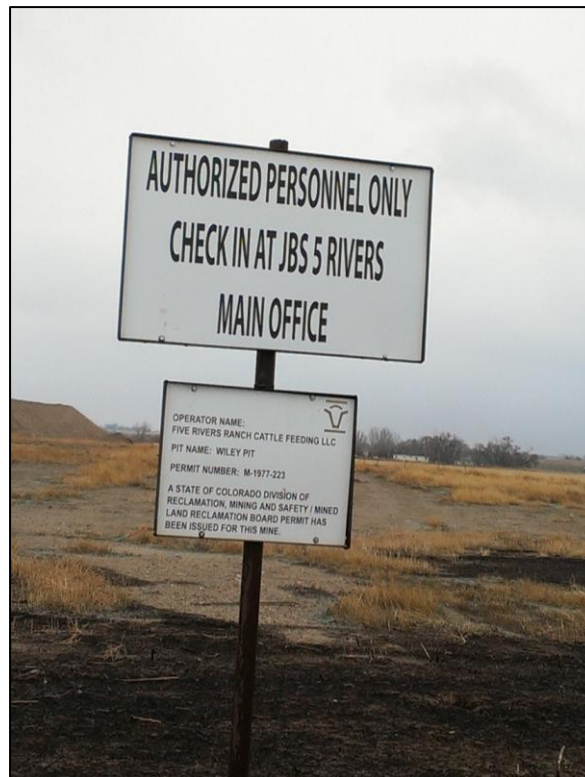
Photo 2. Permit sign posted on existing service road off Highway 287 that leads to the site from the east entrance.

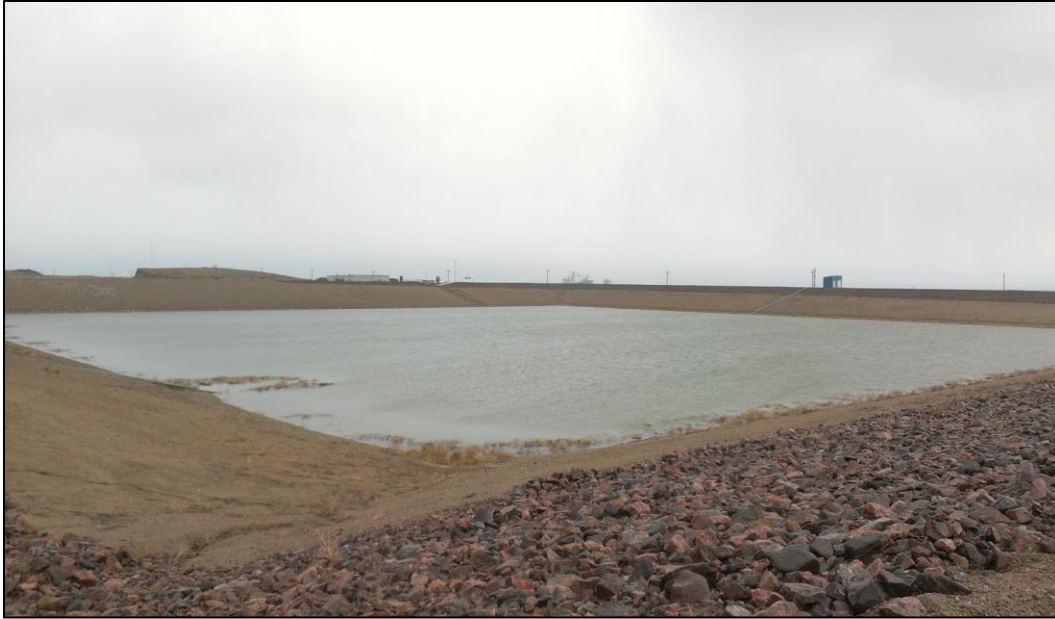
Mining at this site was permitted for the removal of construction materials to be used for the construction of a permanent, clay-lined water storage reservoir and for sale to the public. Construction of the water reservoir is complete (Photo 3), with a surface area of approximately 21 acres and a maximum depth of 30 feet, which is above groundwater levels in the area according to the preliminary geotechnical evaluation performed by Earth Engineering Consultants, Inc. (EEC). In accordance with the Reclamation Plan, the side slopes of the reservoir were graded to 4H:1V, with slopes other than the reservoir sidewalls graded to 3H:1V or flatter. A riprap layer approximately 30 feet in length surrounds the upper rim of the reservoir, except for the northeastern portion. The western part of the reservoir is composed of a compacted earth embankment dam approximately 16.8 feet in structural height and 3,600 feet in total length. A letter of acceptance of construction of the dam was issued to the Operator by the Office of the State Engineer on March 10, 2014.

Photo 3. View of water storage reservoir, looking southeast.

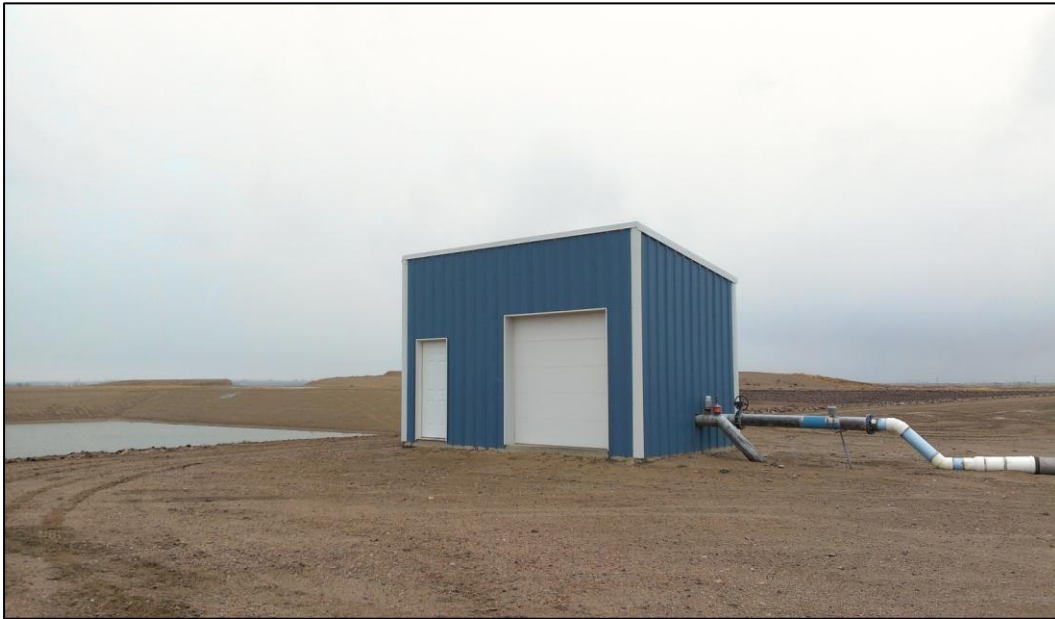
An open drainage channel was installed in accordance with the amended Reclamation Plan in order to capture and divert water from the west side of the permitted area to the reservoir. Water is conveyed from the reservoir to the JBS Five Rivers Cattle Feeding facility on the south side of US Highway 50 via pipeline that terminates at the Amity Canal. The water pipeline is included in the affected area. A pump house is located just south of the reservoir, inside the permitted area (Photo 4).

Photo 4. Pump house located south of reservoir which pumps water via pipeline to the JBS Five Rivers Cattle Feeding facility on the south side of US Highway 50.

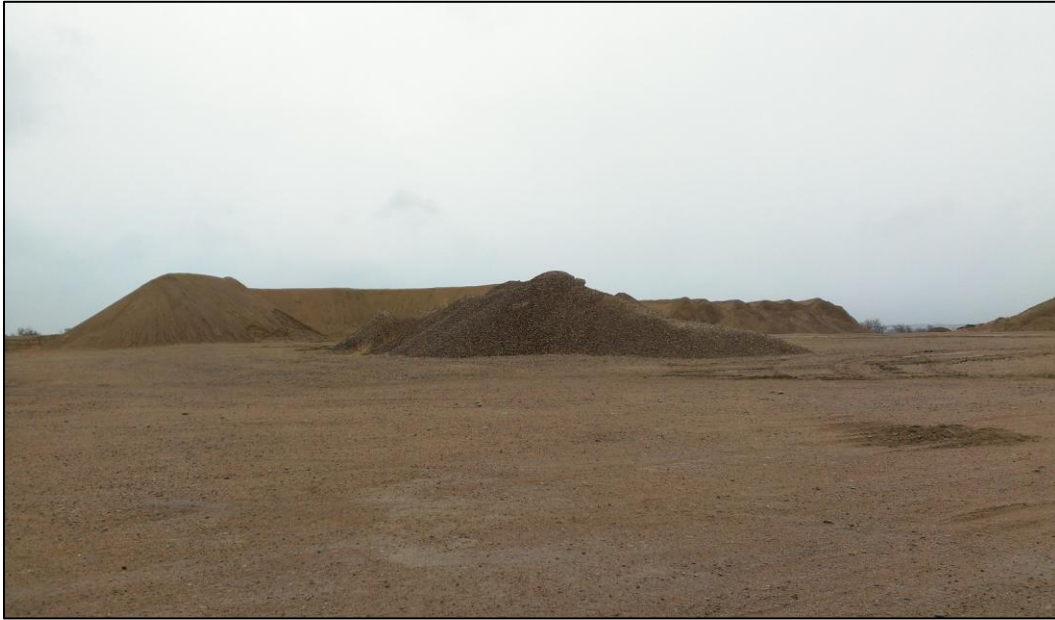
No active mining is occurring at this site, and no mining equipment was present during the inspection. The last activity at this site is reported to have occurred in January of 2013. Product stockpiles are located to the east and northeast of the reservoir (Photos 5 and 6). As discussed with Mr. Milenski during inspection, topsoil stockpiles shall be seeded in accordance with Rule 3.1.9(1), unless the topsoil is expected to be used for reclamation very soon. This has been cited as a problem and will require corrective action by the Operator; please see Page 1 of this report for the required corrective action. The Reclamation Plan for this permit states that topsoil stockpiles will be seeded with a wheatgrass to control erosion at a rate of 9 lbs per acre.

Photo 5. View of product stockpiles located east of the water storage reservoir, looking north.

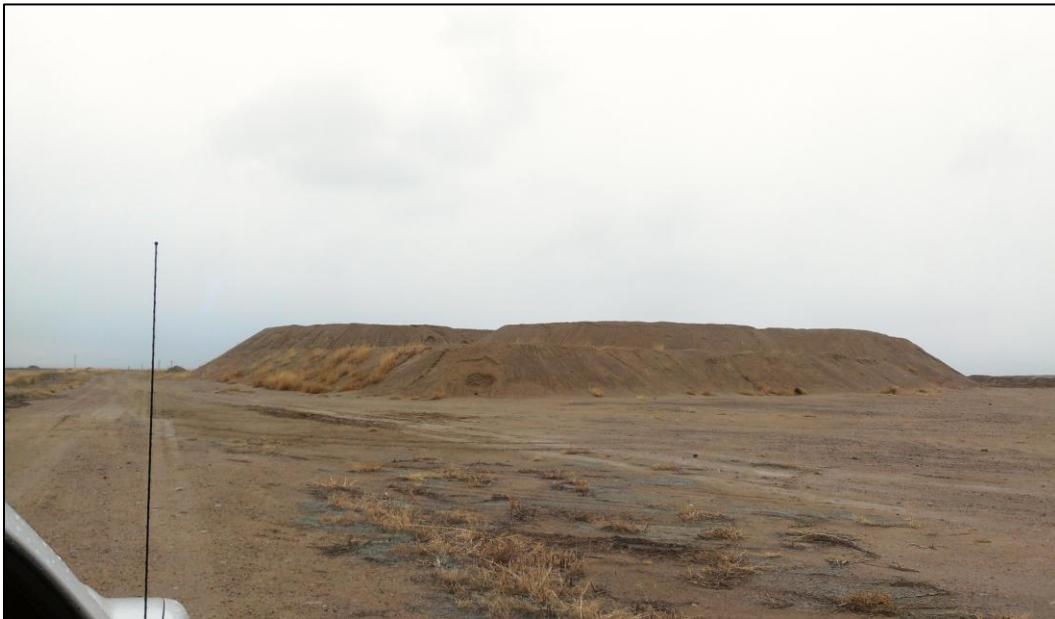
Photo 6. View of large product stockpile located east of the water storage reservoir, looking northwest.
