**COLORADO DIVISION OF RECLAMATION, MINING AND SAFETY**  
**MINERALS PROGRAM INSPECTION REPORT**  
**PHONE: (303) 866-3567**

<b>MINE NAME:</b> Cedar Creek Pit	<b>MINE/PROSPECTING ID#:</b> M-1977-407	<b>MINERAL:</b> Sand and gravel	<b>COUNTY:</b> Montrose
<b>INSPECTION TYPE:</b> Monitoring	<b>INSPECTOR(S):</b> Dustin M. Czaplá	<b>INSP. DATE:</b> April 15, 2014	<b>INSP. TIME:</b> 10:30
<b>OPERATOR:</b> Montrose County Public Works	<b>OPERATOR REPRESENTATIVE:</b> Norm David	<b>TYPE OF OPERATION:</b> 112c - Construction Regular Operation

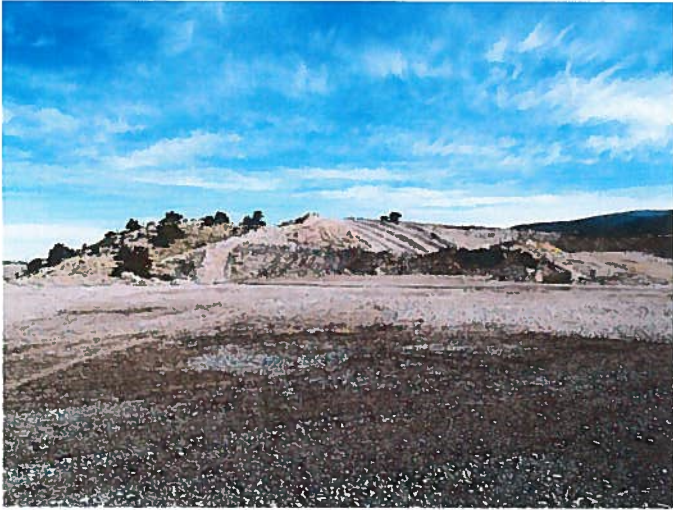
Figure 1: View towards north part of Phase 1a

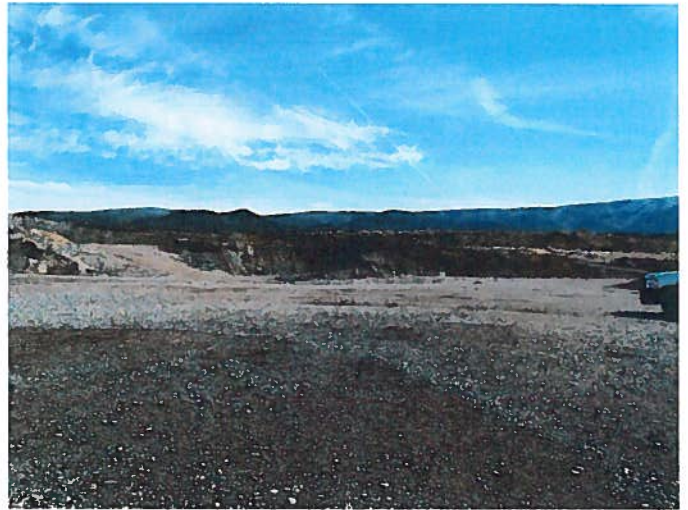
Figure 2: View towards north part of Phase 1a

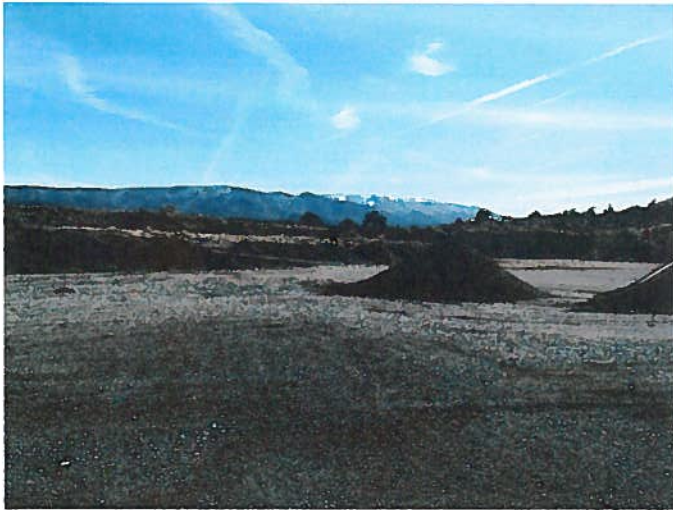
Figure 3: View towards east part of Phase 1a

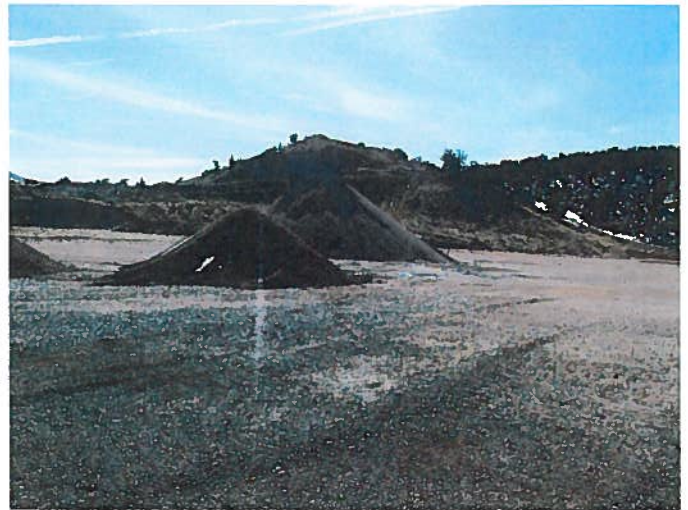
Figure 4: View towards southeast part of Phase 1a

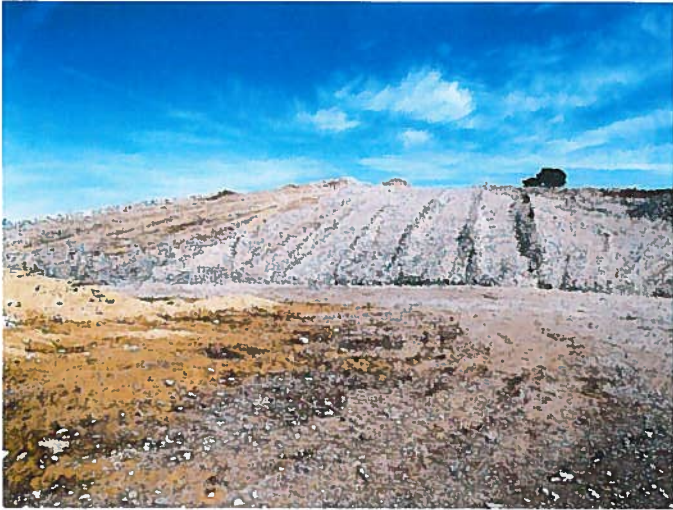
The site was inactive during this inspection. Gravel mining has occurred in the Phase 1a area, with some overburden removal occurring in the Phase 1c area. The mined slopes were left at approximately 2H:1V. Several materials stockpiles were located on the pit floor. There was no equipment stored on site.

Figure 5: Mined slope in north part of Phase 1a

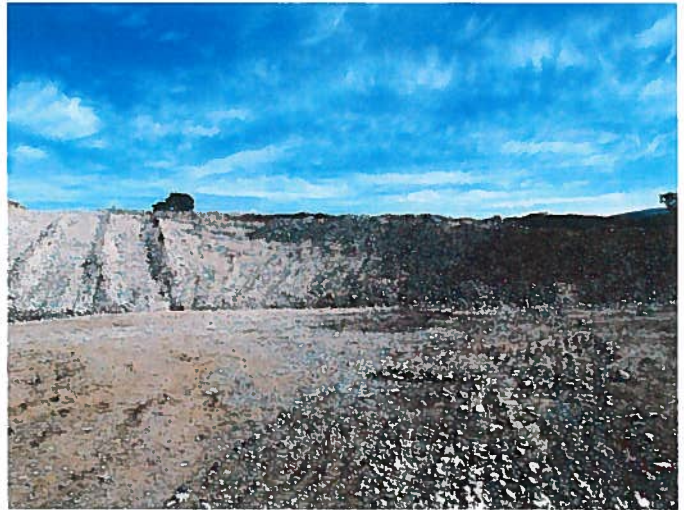
Figure 6: Mined slope in north part of Phase 1a

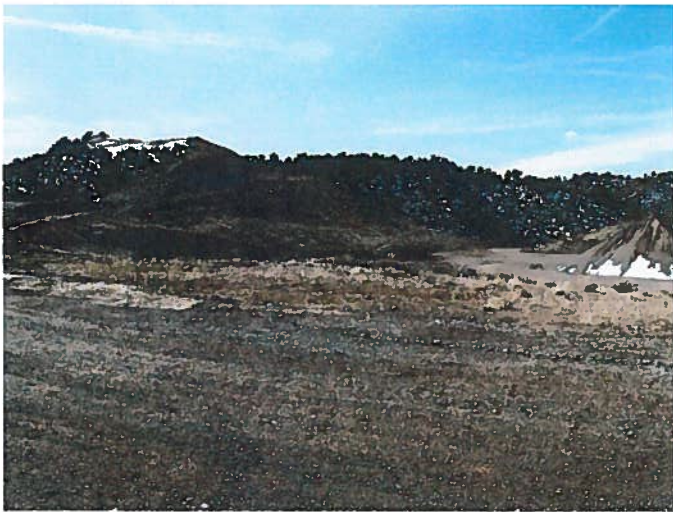
Figure 7: Overburden removal occurred on top of ridge in Phase 1c area.

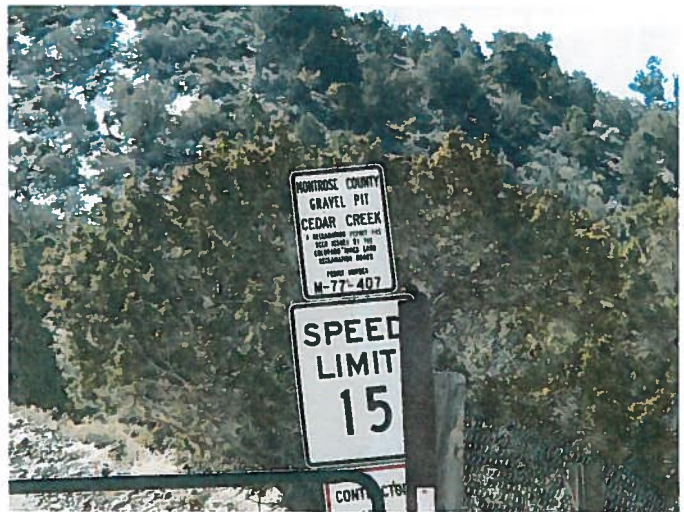
Adequate mine identification signage was noted at the entrance to the site.

Figure 8: Site entrance
