COLORADO DIVISION OF RECLAMATION, MINING AND SAFETY
MINERALS PROGRAM INSPECTION REPORT
PHONE: (303) 866-3567

MINE NAME: Soderquist Pit	MINE/PROSPECTING ID#: M-1987-151	MINERAL: Sand and gravel	COUNTY: Montrose
INSPECTION TYPE: Monitoring	INSPECTOR(S): Dustin M. Czapla	INSP. DATE: April 15, 2014	INSP. TIME: 09:30
OPERATOR: Montrose County	OPERATOR REPRESENTATIVE: Norm David	TYPE OF OPERATION: 110c - Construction Limited Impact

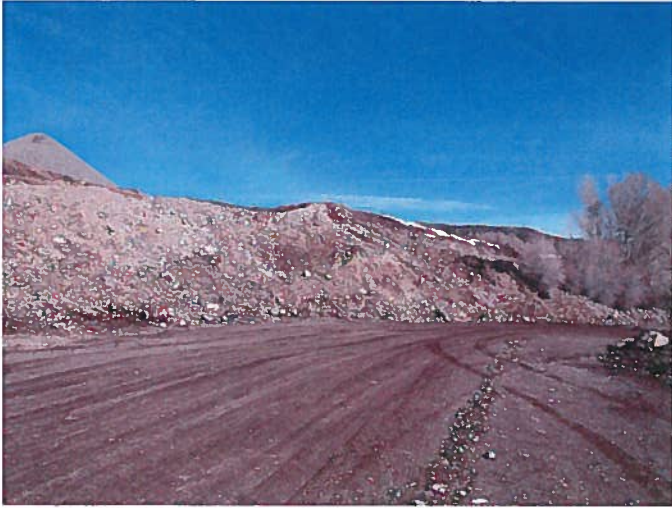
Figure 1: From central mined area, facing north.

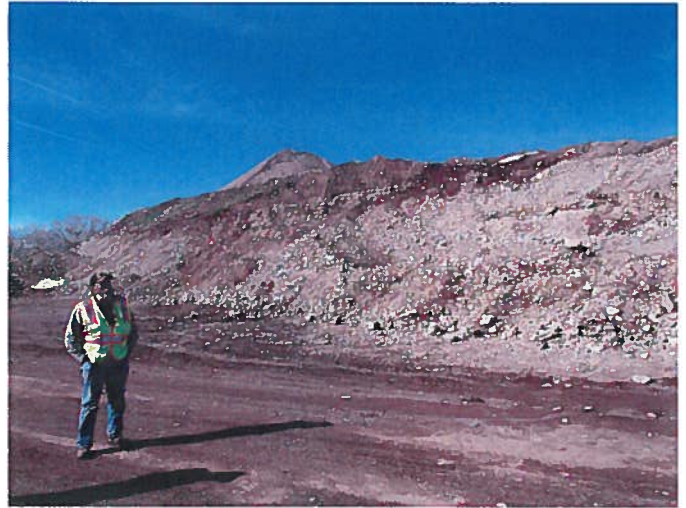
Figure 2: From central mined area, facing south.

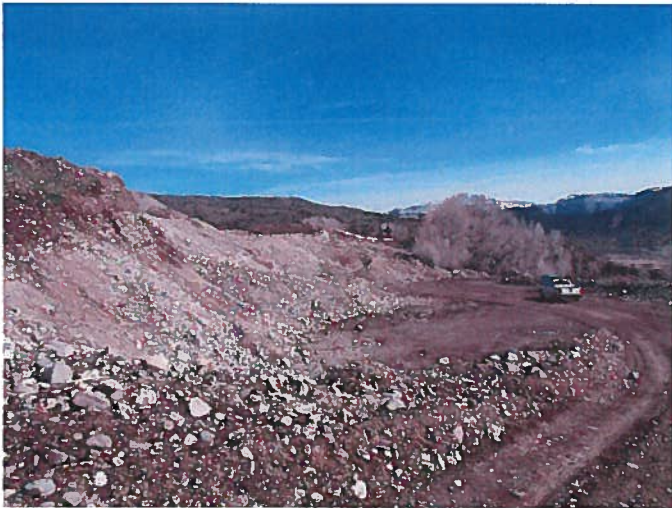
Figure 3: From south side of mined area, facing north.

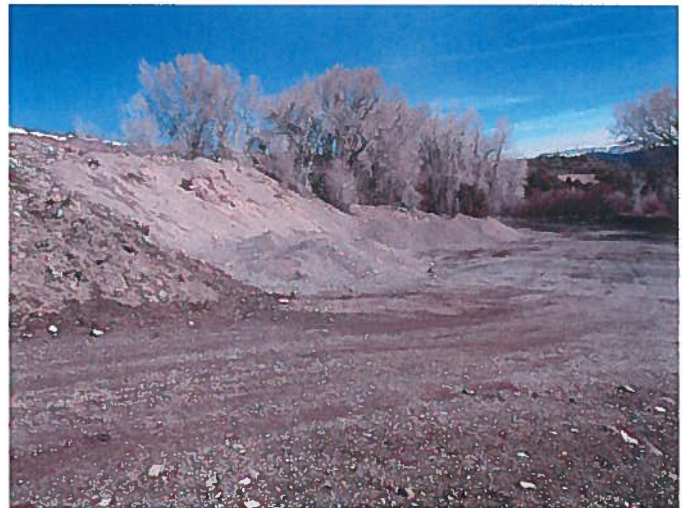
Figure 4: Lower mined/sump area.

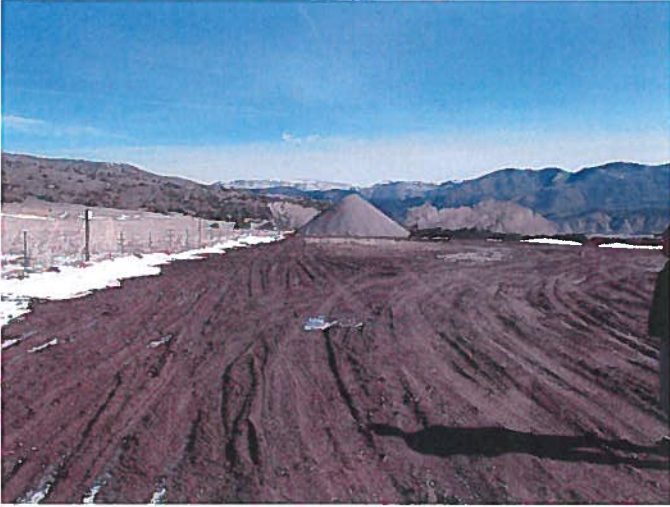
Figure 5: Upper stock pile / "to be mined" area.

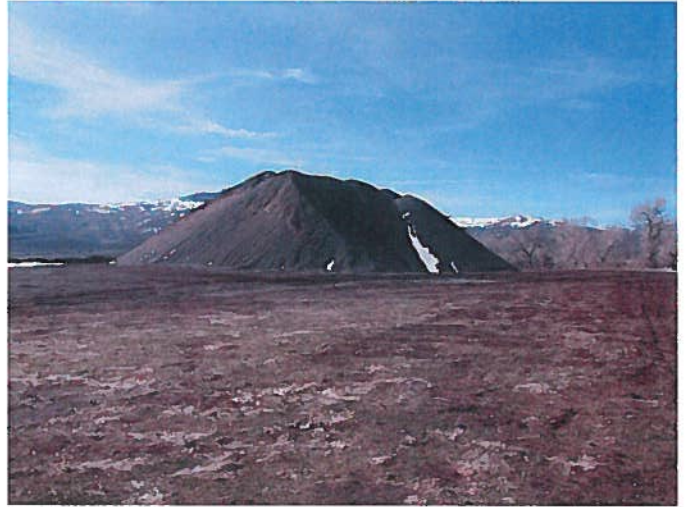
Figure 6: Upper stock pile / "to be mined" area.
