COLORADO DIVISION OF RECLAMATION, MINING AND SAFETY
MINERALS PROGRAM INSPECTION REPORT
PHONE: (303) 866-3567

MINE NAME: Gray Pit #2	MINE/PROSPECTING ID#: M-2005-012	MINERAL: Sand and gravel	COUNTY: Montrose
INSPECTION TYPE: Monitoring	INSPECTOR(S): Dustin M. Czapla	INSP. DATE: April 15, 2014	INSP. TIME: 10:30
OPERATOR: Nick H. Gray	OPERATOR REPRESENTATIVE: Chauncey Luttrell	TYPE OF OPERATION: 112c - Construction Regular Operation

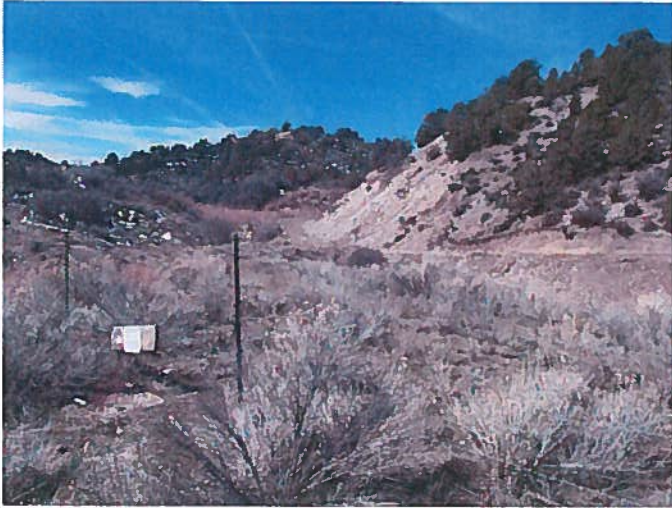
Figure 1: View of the site from Kinikin Road.

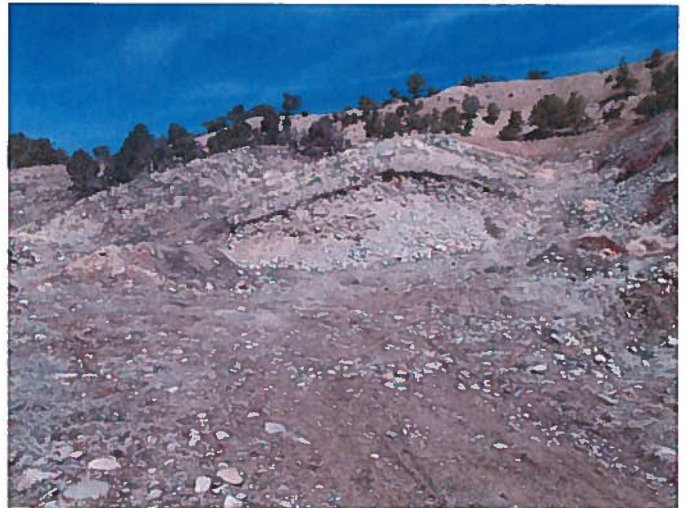
Mining has not yet commenced at this site because of issues concerning CDOT access and a depressed market. Some minor clearing occurred in the Phase 1 area, but disturbance is minimal.

Figure 2: Proposed Phase 1 area.

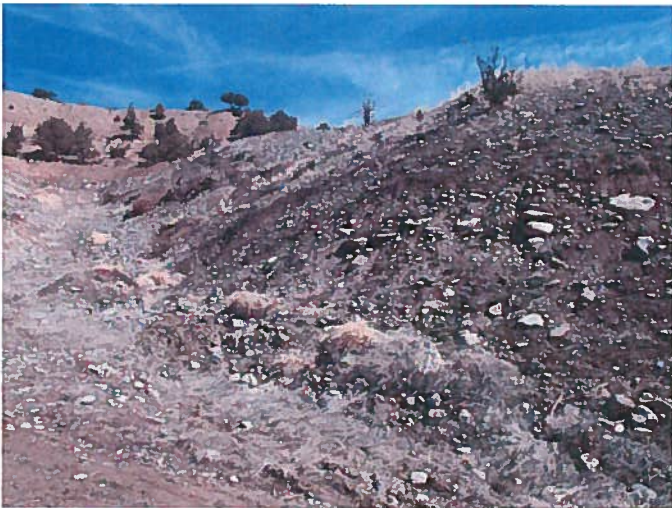
Figure 3: Proposed Phase 1 area.
