# COLORADO DIVISION OF RECLAMATION, MINING AND SAFETY MINERALS PROGRAM INSPECTION REPORT

MINE NAME:	MINE/PROSPECTING ID#:	MINERAL:	COUNTY:
LaSalle Pit	M-2009-042	Gravel and sand	Montrose
INSPECTION TYPE:	INSPECTOR(S):	INSP. DATE:	INSP. TIME:
Monitoring	Dustin M. Czapla	April 17, 2014	13:00
OPERATOR:	OPERATOR REPRESENTATIVE:	TYPE OF OPERATION:	
Montrose County	Norm David	112c - Construction Regular Operation

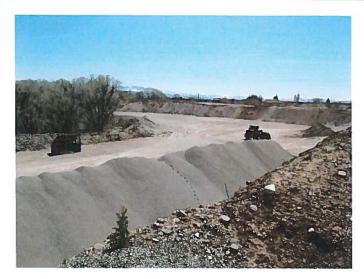
Figure 1: Phase 1 mining area

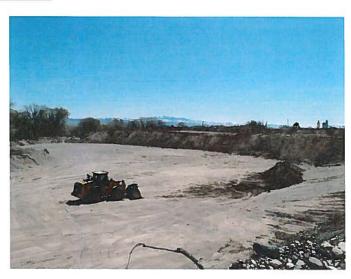
Figure 2: Phase 1 mining area

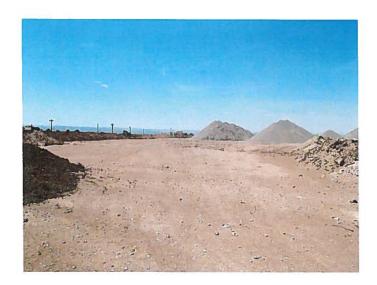
Figure 3: Southern Phase 1 area to be mined

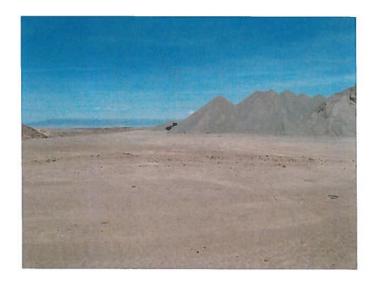
Figure 4: Southern Phase 1 area to be mined

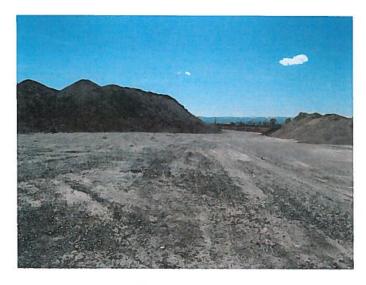
Figure 5: Phase 2 area to be mined

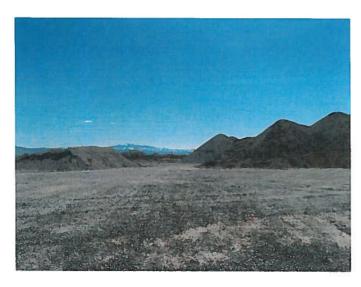
Figure 6: Phase 2 area to be mined
