COLORADO DIVISION OF RECLAMATION, MINING AND SAFETY
MINERALS PROGRAM INSPECTION REPORT
PHONE: (303) 866-3567

MINE NAME: Earl-Hoffman-Reyher Pit #3	MINE/PROSPECTING ID#: M-1991-086	MINERAL: Sand and gravel	COUNTY: Bent
INSPECTION TYPE: Monitoring	INSPECTOR(S): Tyler V. O'Donnell	INSP. DATE: February 27, 2014	INSP. TIME: 14:00
OPERATOR: Bent County	OPERATOR REPRESENTATIVE: Curtis Sniff	TYPE OF OPERATION: 112c - Construction Regular Operation

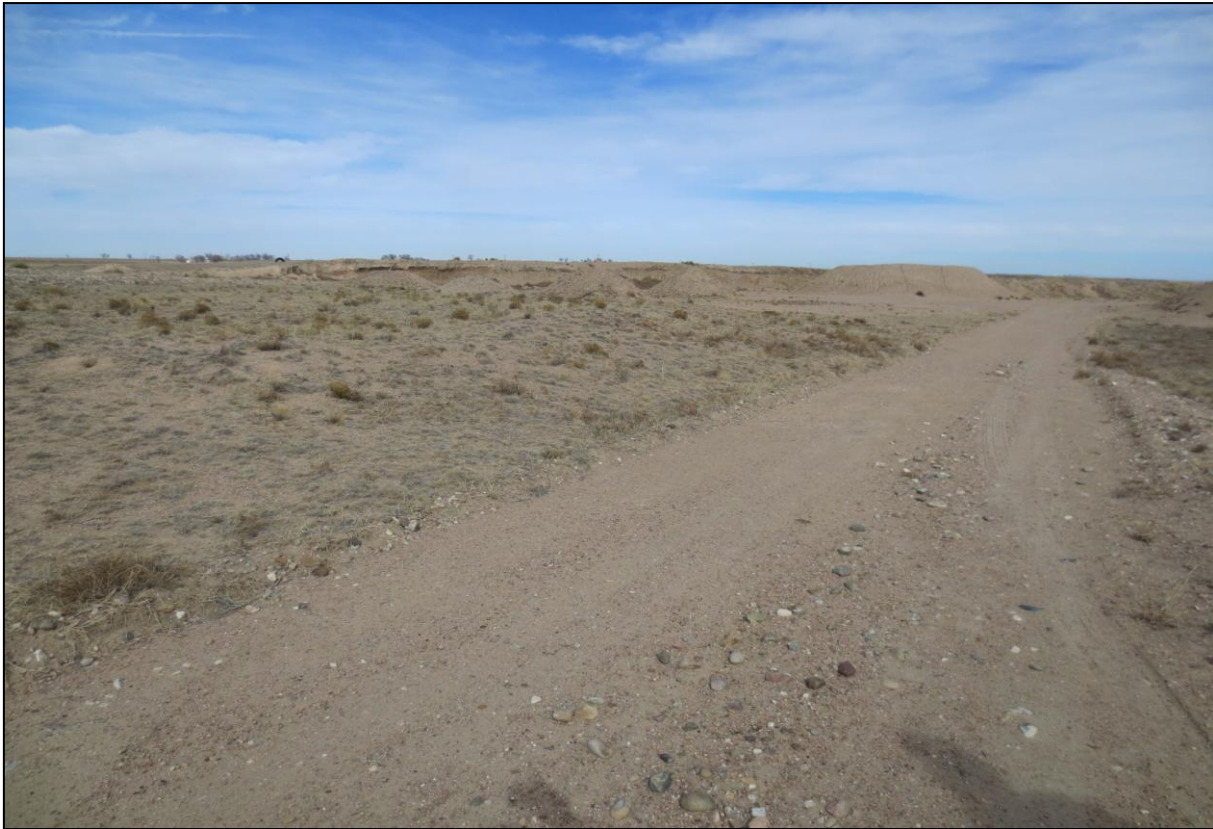
There was a highwall located in the northwestern corner of the permitted area, the highwall was approximately 10 feet high and 350 feet long. There were numerous stockpiles of material scattered all over the pit.

Photo 1: View looking northeast, taken from the access road. Highwall and processed material stockpiles in the background.

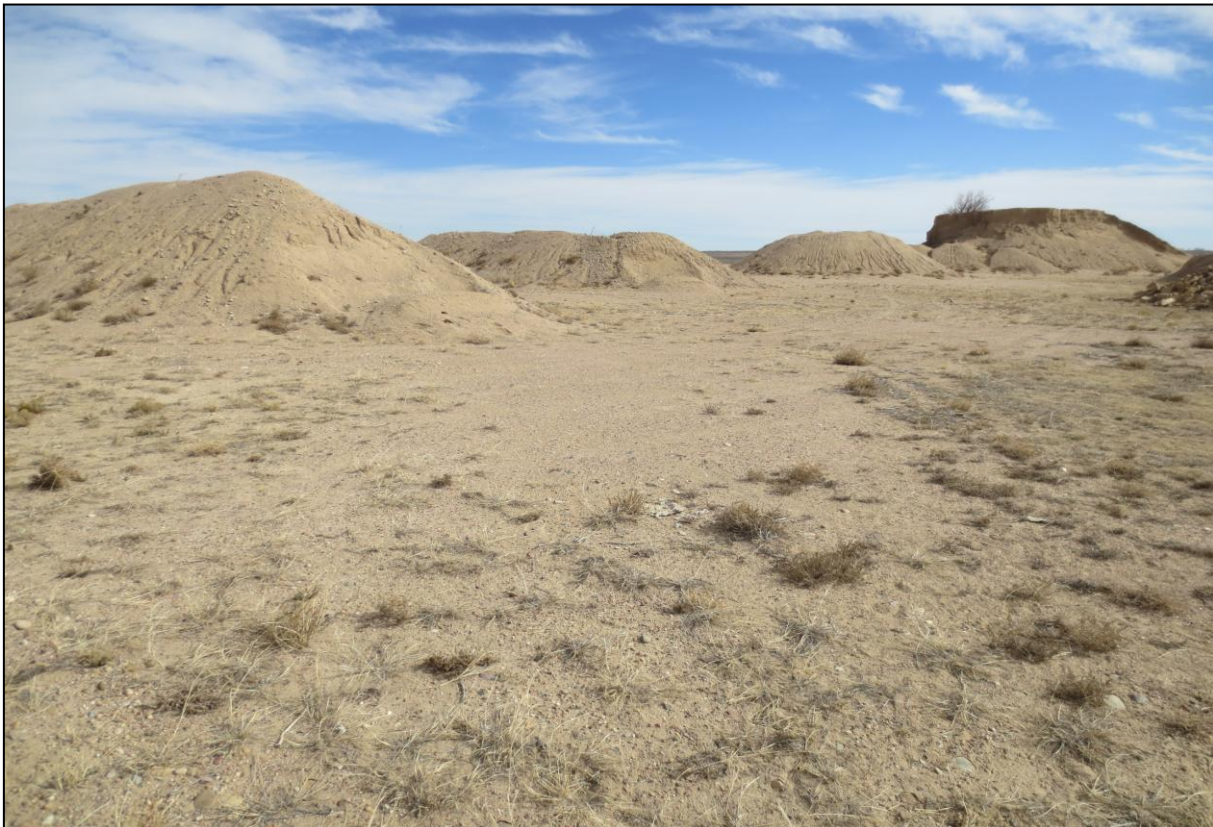
Photo 2: View looking southeast, taken from the access road. Processed material stockpiles in the background.

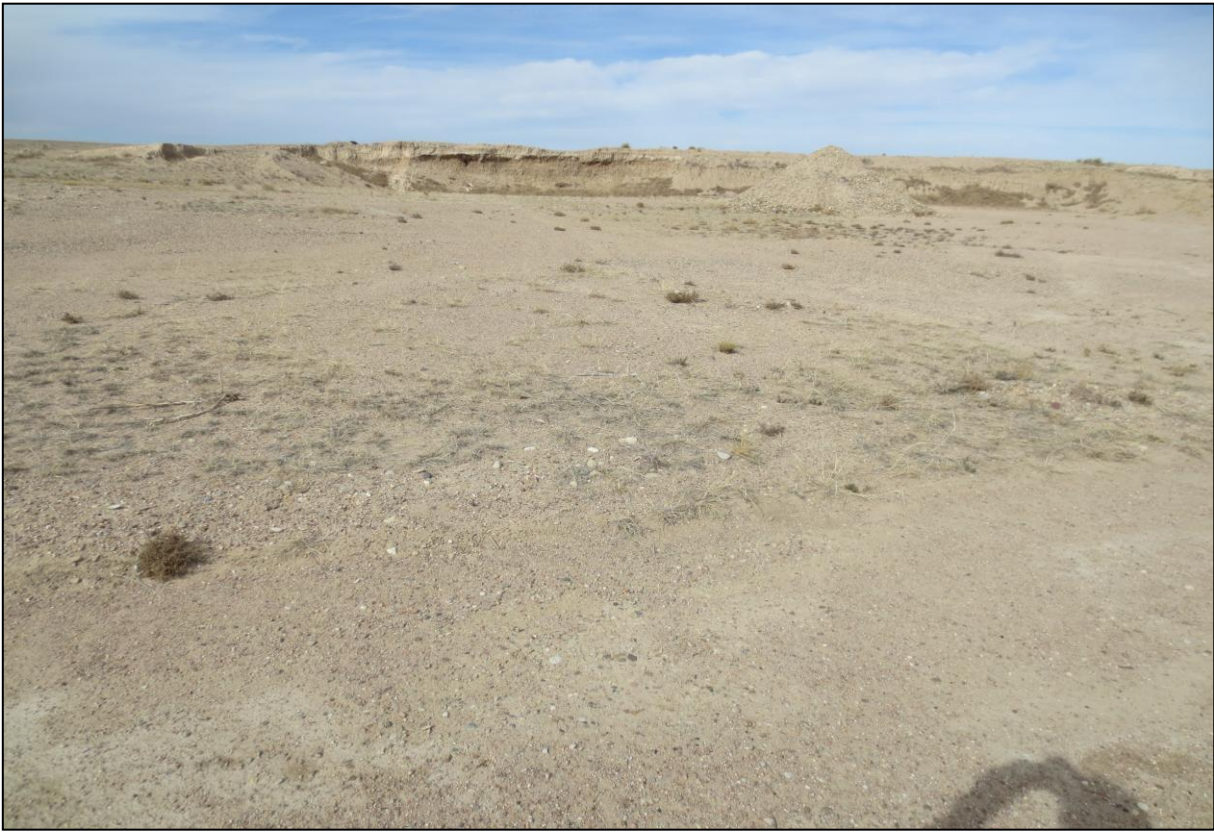
Photo 3: View looking north, taken from the access road. Highwall in the background.

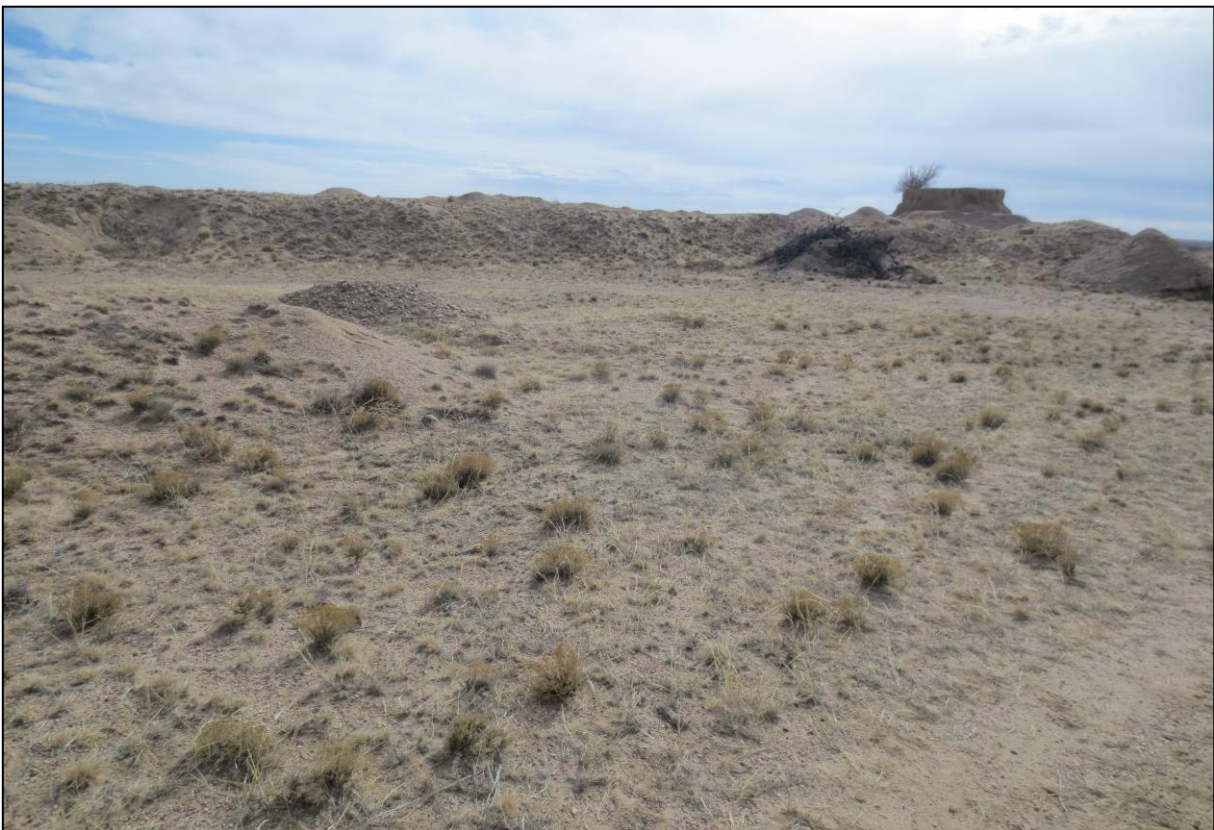
Photo 4: View looking south, taken from the access road. Stockpiles of various types of material in the background.
