COLORADO DIVISION OF RECLAMATION, MINING AND SAFETY
MINERALS PROGRAM INSPECTION REPORT
PHONE: (303) 866-3567

MINE NAME: Cecil 11-34-49	MINE/PROSPECTING ID#: M-1983-001	MINERAL: Sand and gravel	COUNTY: Washington
INSPECTION TYPE: Monitoring	INSPECTOR(S): Elliott R. Russell	INSP. DATE: April 11, 2014	INSP. TIME: 11:25
OPERATOR: Washington County	OPERATOR REPRESENTATIVE: Steve Williams	TYPE OF OPERATION: 110c - Construction Limited Impact

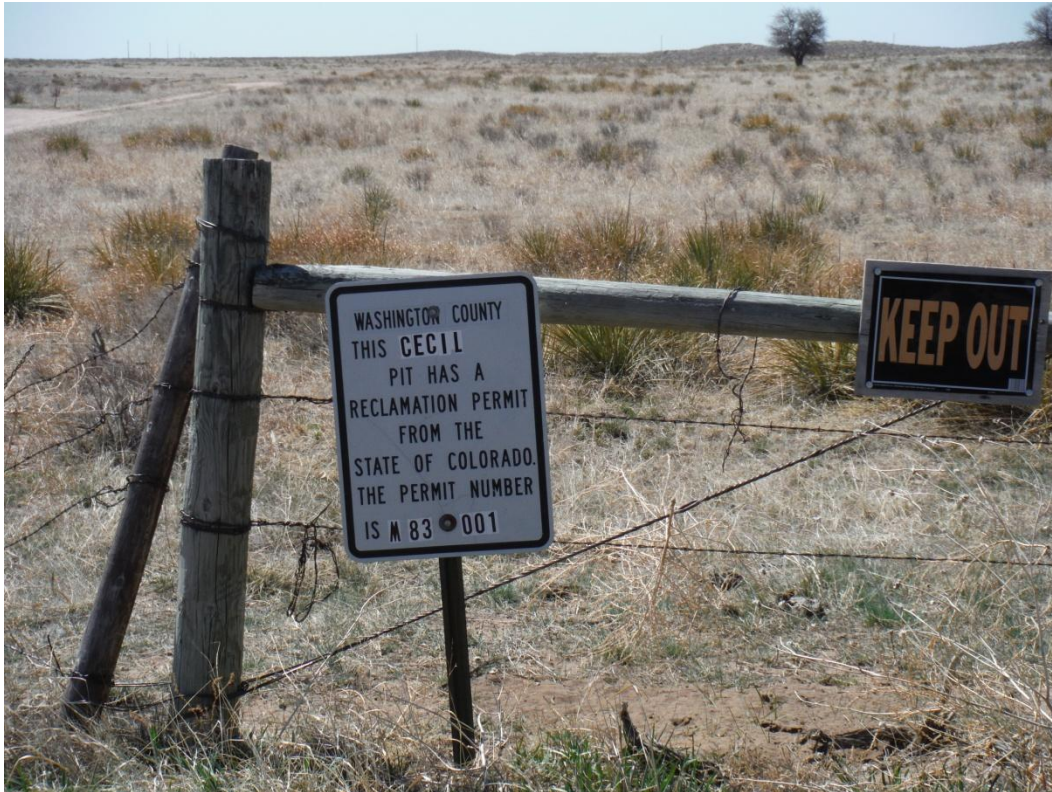
Permit identification sign at the mine entrance; looking south.

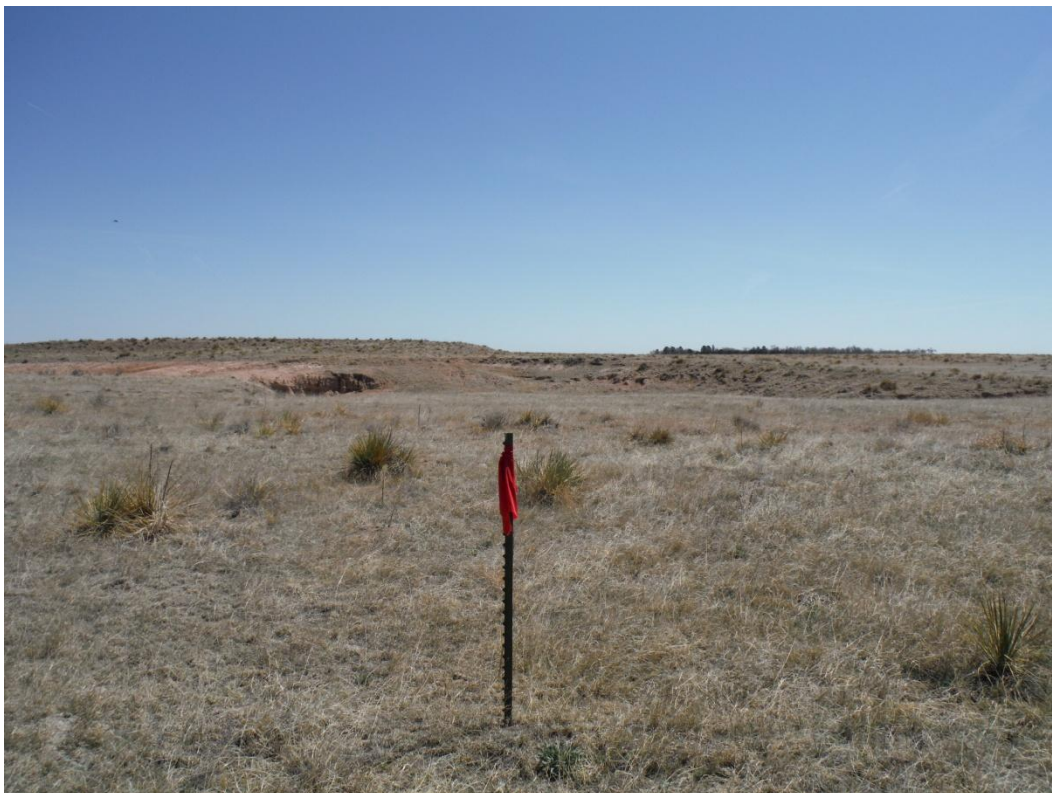
The boundary corners were in place and marked with t-posts. An area, approximately one acre in size, was observed south of the southern permit boundary which appeared to be disturbed, but naturally vegetated. Mr. Williams had stated this area may have been disturbed before the permit was originally issued.

Southwest boundary marker; looking east down the southern boundary line.

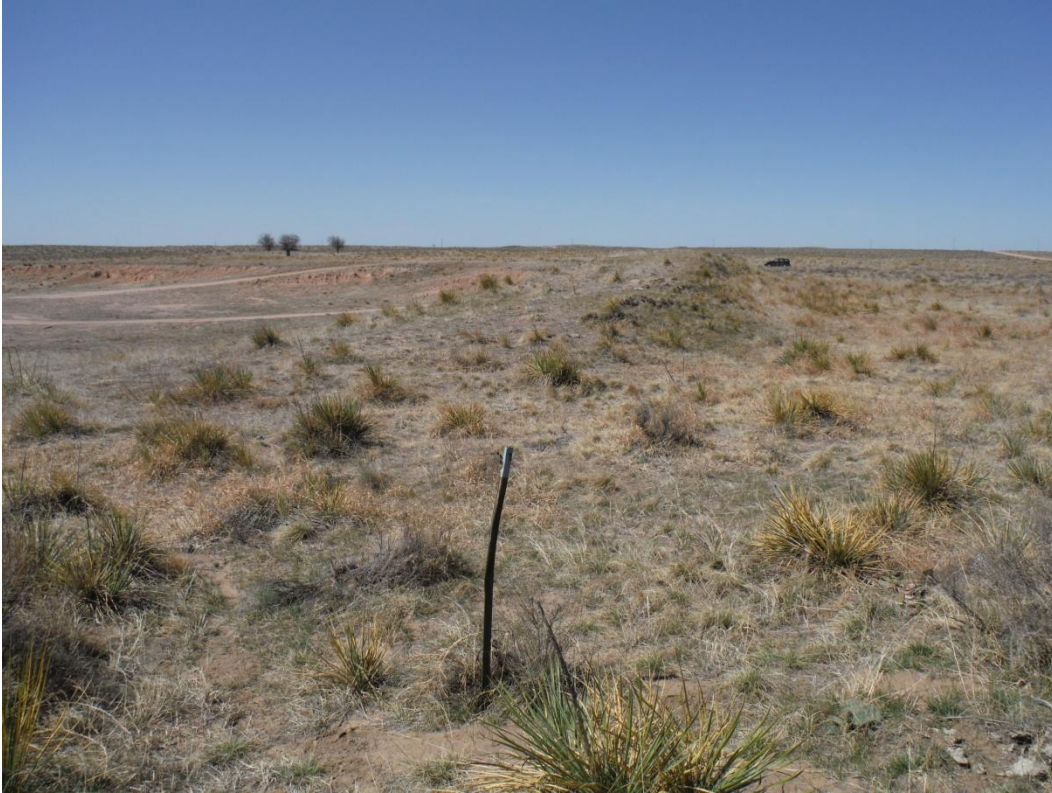
Northeast boundary marker, topsoil pile in background; looking west.

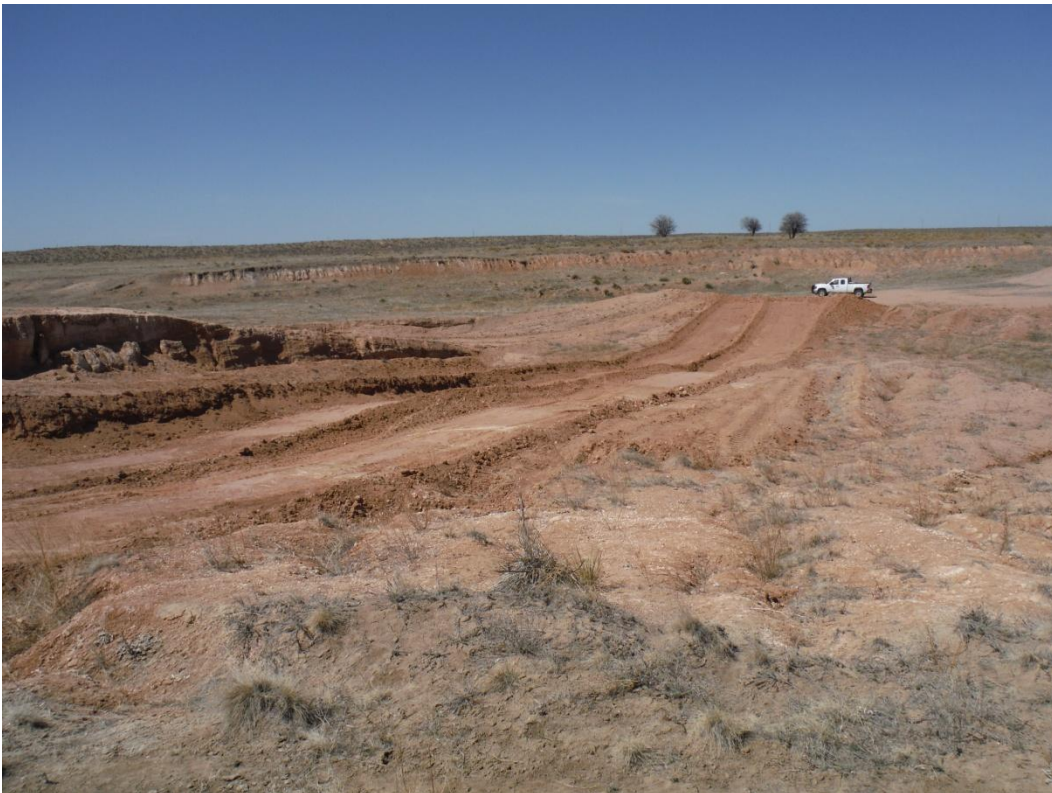
Topsoil had be stripped and piled in two different locations; one pile along the east side of the pit and the other was on the north side. A recent excavation was observed during the inspection. Mr. Williams believes this was caused by someone other than the landowner or Washington County. He stated that the county had not taken any material from the site for a few years. If the Applicant is concerned that more illegal mining may occur once the county grades the slopes for reclamation, the Division recommends either installing a locked gate at the entrance or posting a sign stating reclamation is in progress and not to disturb.

Recent mining activity not conducted by Washington County; looking west.
