COLORADO DIVISION OF RECLAMATION, MINING AND SAFETY
MINERALS PROGRAM INSPECTION REPORT
PHONE: (303) 866-3567

MINE NAME: North R-34 Pit	MINE/PROSPECTING ID#: M-1996-008	MINERAL: Sand and gravel	COUNTY: Montrose
INSPECTION TYPE: Monitoring	INSPECTOR(S): Dustin M. Czapla	INSP. DATE: April 17, 2014	INSP. TIME: 10:00
OPERATOR: Western Gravel, Inc.	OPERATOR REPRESENTATIVE: Judy DeVincentis	TYPE OF OPERATION: 112c - Construction Regular Operation

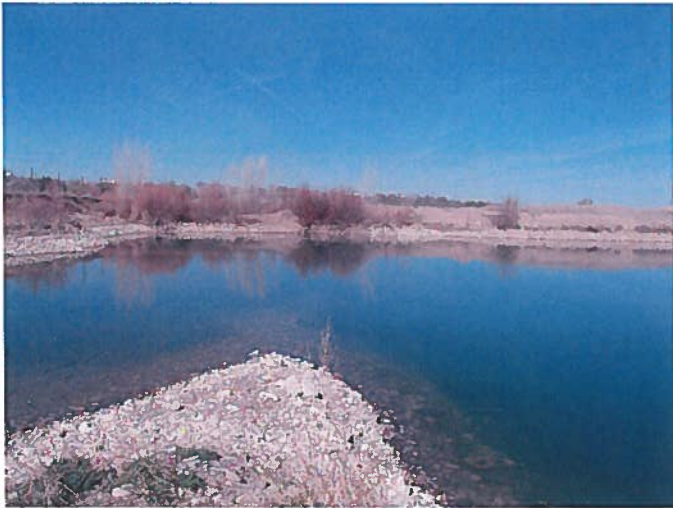
Figure 1: From the southeast side of the Phase 1 pond, facing west.

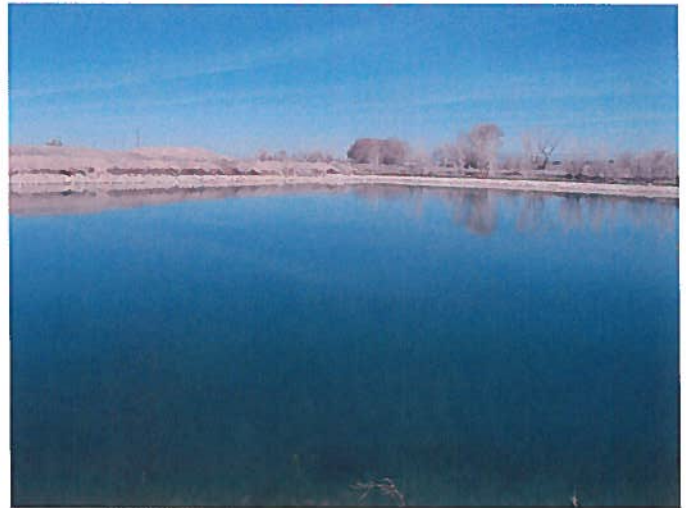
Figure 2: From the southeast side of the Phase 1 pond, facing northwest.

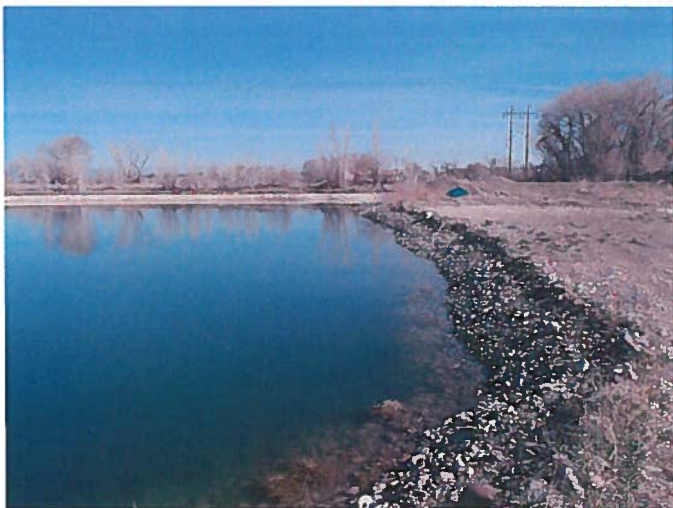
Figure 3: From the southeast side of the Phase 1 pond, facing north.

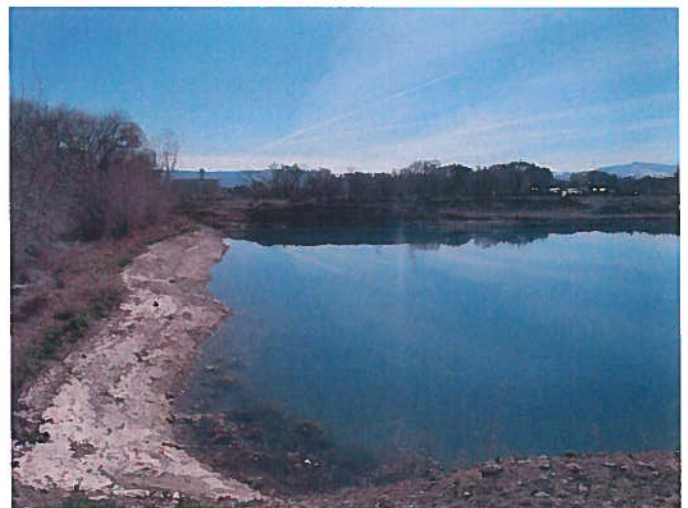
Figure 4: From the northwest side of the Phase 1 pond, facing east.

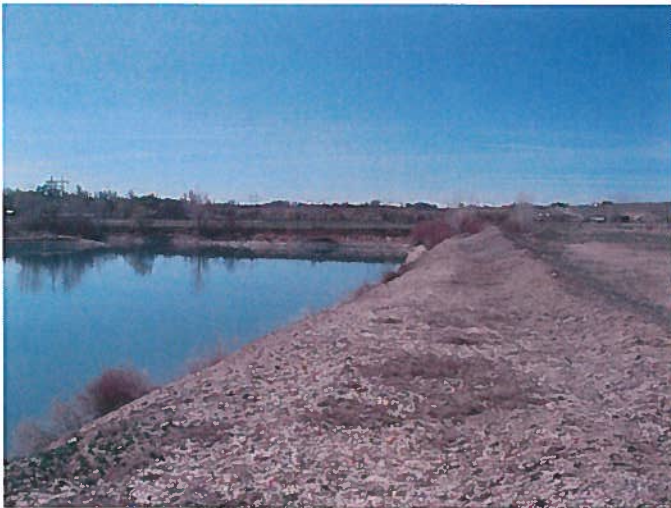
Figure 5: From the northwest side of the Phase 1 pond, facing south.

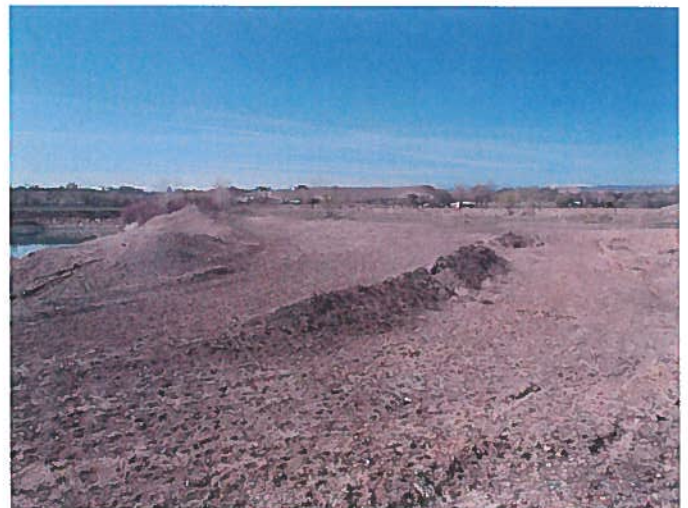
Figure 6: From the northwest side of the Phase 1 pond, facing south.

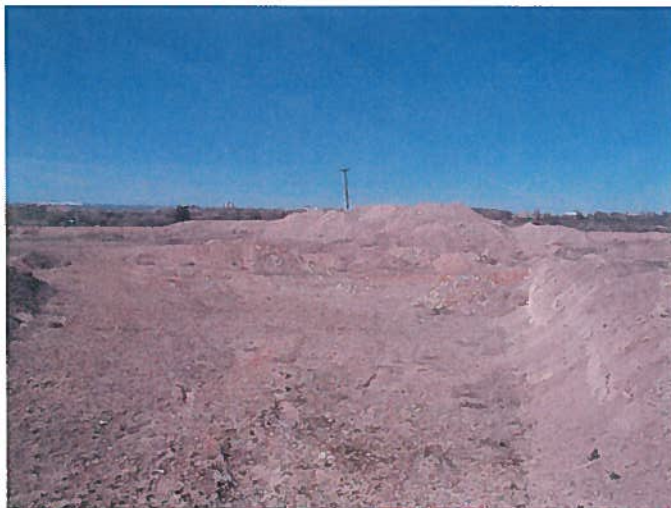
Figure 7: From the northwest side of the Phase 1 pond, facing west.

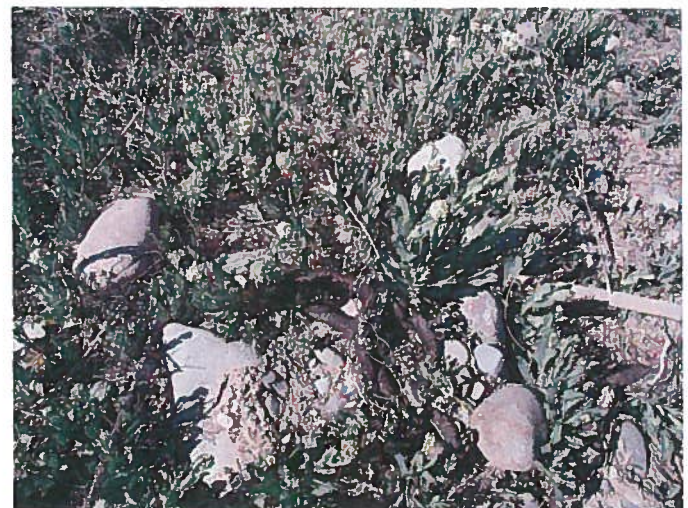
PROBLEM/POSSIBLE VIOLATION: Problem: There are state-listed noxious weeds present on site, specifically hoary cress (white top) and tamarisk. This is a problem for failure to employ weed control methods for state listed noxious weed species within the permitted area, and to reduce the spread of weeds to nearby areas as required by Section 3.1.10 (6) of the rule.

Hoary cress (white top) and tamarisk were observed throughout the disturbed area. A weed control plan was incorporated into this permit through the approval of AM-1, in which the operator committed to conducting a noxious weed survey each spring, and treating any identified infestations as necessary. The operator shall comply with the weed control plan.

Figure 8: Hoary cress observed throughout the disturbed area.

CORRECTIVE ACTIONS: Implement approved weed control plan and provide proof to the Division that this has been done.
