**COLORADO DIVISION OF RECLAMATION, MINING AND SAFETY**  
**MINERALS PROGRAM INSPECTION REPORT**  
**PHONE: (303) 866-3567**

<b>MINE NAME:</b> Pueblo East Pit	<b>MINE/PROSPECTING ID#:</b> M-1986-015	<b>MINERAL:</b> Sand and gravel	<b>COUNTY:</b> Pueblo
<b>INSPECTION TYPE:</b> Monitoring	<b>INSPECTOR(S):</b> Tyler V. O'Donnell	<b>INSP. DATE:</b> April 25, 2014	<b>INSP. TIME:</b> 11:30
<b>OPERATOR:</b> Continental Materials Corporation	<b>OPERATOR REPRESENTATIVE:</b> Mark Klune	<b>TYPE OF OPERATION:</b> 112c - Construction Regular Operation	
<b>REASON FOR INSPECTION:</b> Priority	<b>BOND CALCULATION TYPE:</b> None	<b>BOND AMOUNT:</b> \$2,288,004.00	
<b>DATE OF COMPLAINT:</b> NA	<b>POST INSP. CONTACTS:</b> None	<b>JOINT INSP. AGENCY:</b> None	
<b>WEATHER:</b> Clear	<b>INSPECTOR'S SIGNATURE:</b>

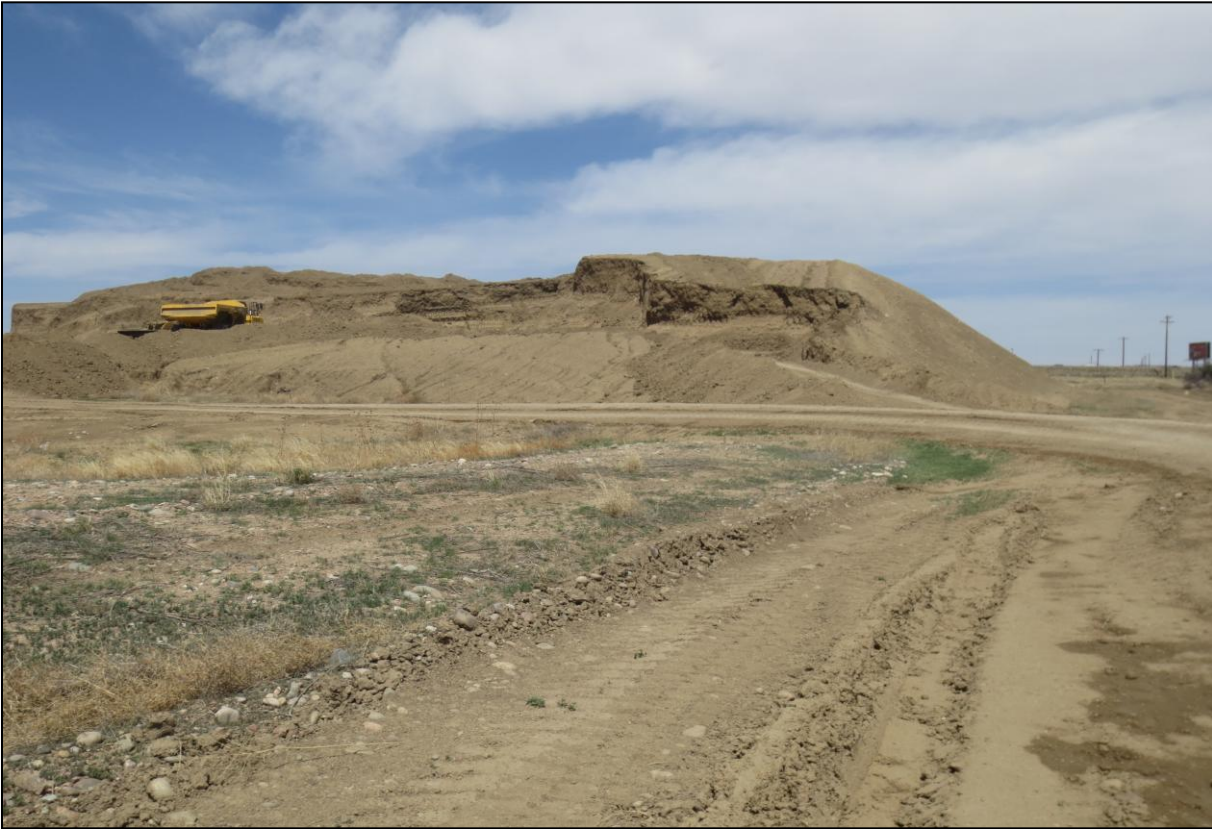
**PROBLEM/POSSIBLE VIOLATION:** Problem: The Phase 2 overburden/topsoil stockpile does not have established vegetation on it and is therefore susceptible to erosion. Rule 3.1.9(1) states if topsoil is not replaced into the backfill area within a time short enough to avoid deterioration of the topsoil, vegetative cover or other means shall be employed so that the stockpile is protected from wind and water erosion.

**Photo 1:** View looking north from the access road, eastern portion of the stockpile.

B) The operator has committed to removing and/or relocating the Phase 2 stockpile beginning in the January-February 2014 time frame. The operator has agreed to completing the removal/relocation by May 30, 2014. The operator shall notify the DRMS it has begun the removal/relocation on or before 2/28/2014 and provide photographic documentation by June 7, 2014 that the process is complete.

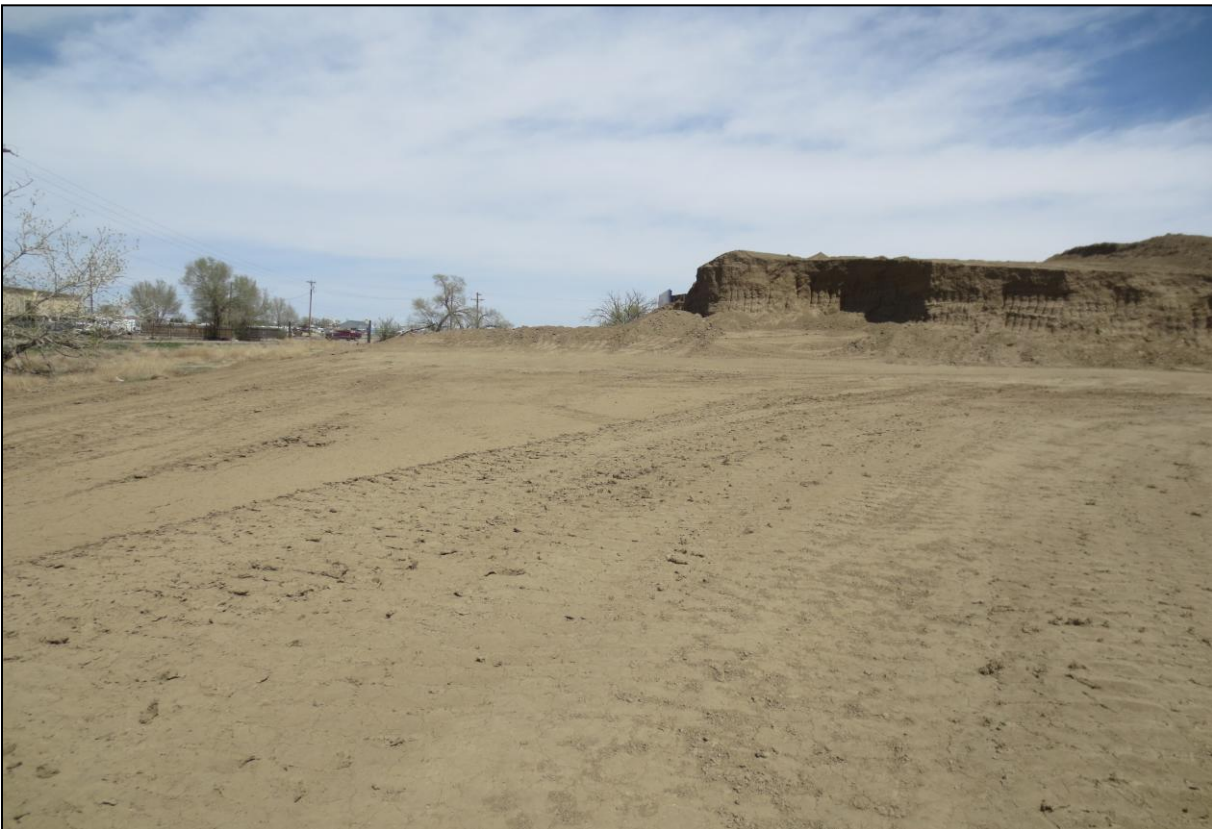
**Photo 2:** View looking north from the access road, western portion of the stockpile.

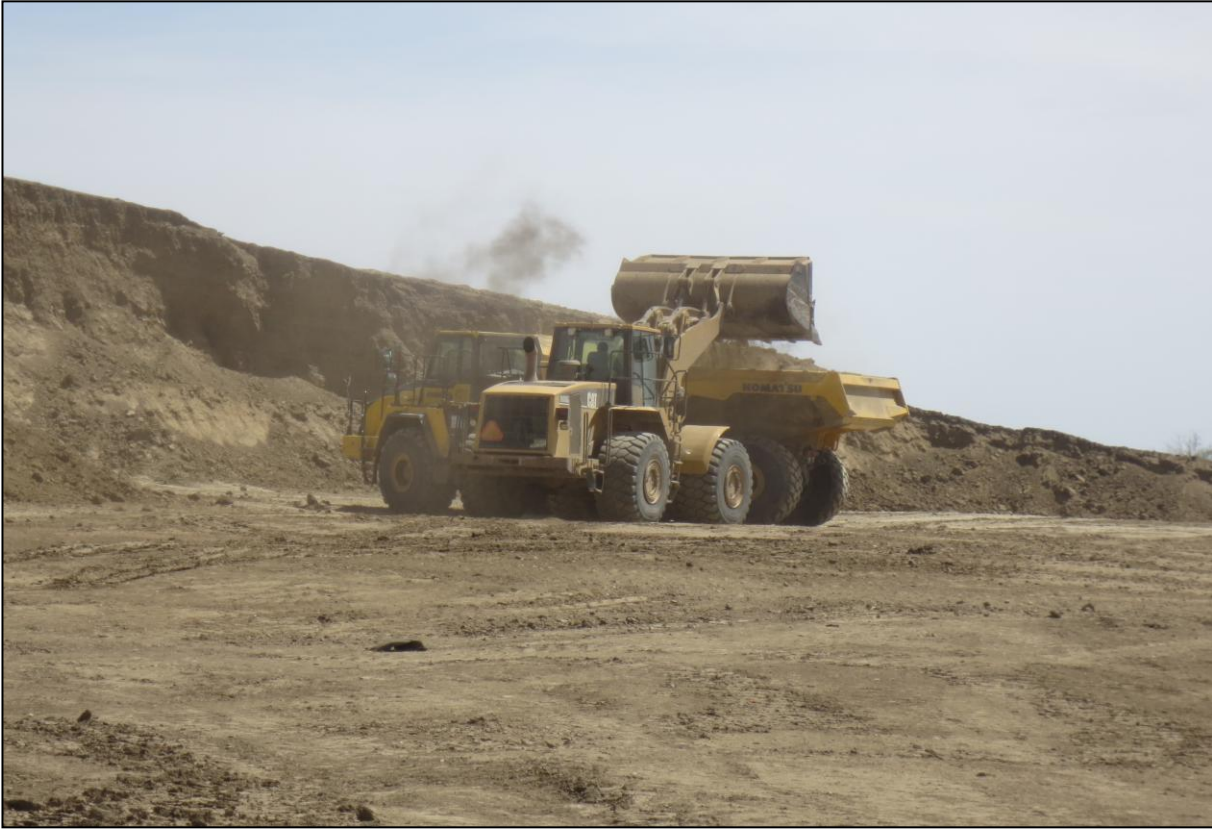
During the inspection the Division observed a Cat 980G front-end loader and a large articulated Komatsu truck. The truck and loader team were moving the stockpile and using the material to backfill and repair slopes around the phase 2 pit. The Operator's representative stated they were working from the southwestern side of the stockpile to mitigate fugitive dust. The Operator's representative indicated that their original estimate of the stockpile suggests that the stockpile was approximately 211,000 cubic yards. The Operator's representative stated that they believe that they have moved roughly half of the stockpile.

**Photo 3:** Truck and loader team, removing material from the stockpile.

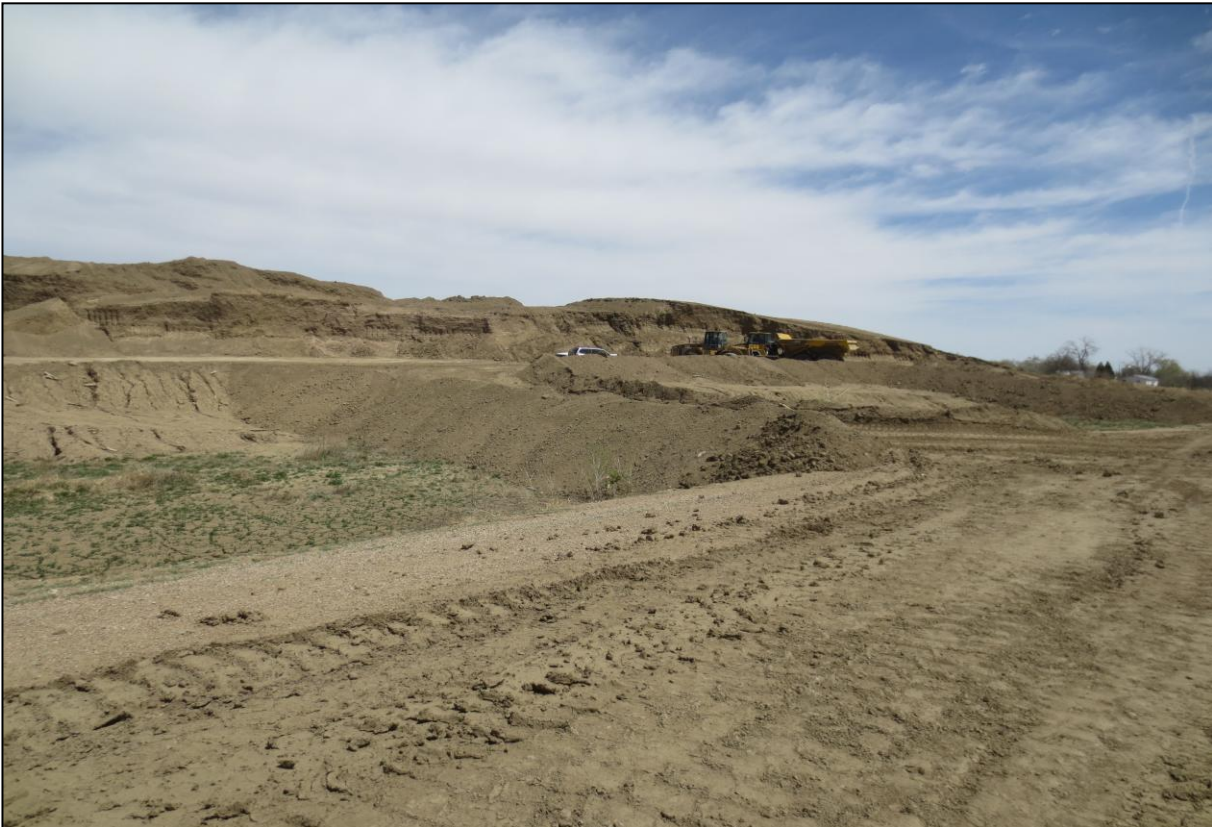
**Photo 4:** View looking northeast from the access road.
