COLORADO DIVISION OF RECLAMATION, MINING AND SAFETY
MINERALS PROGRAM INSPECTION REPORT
PHONE: (303) 866-3567

MINE NAME: Austin Pit	MINE/PROSPECTING ID#: M-1986-047	MINERAL: Sand/gravel/clay	COUNTY: Phillips
INSPECTION TYPE: Monitoring	INSPECTOR(S): Elliott R. Russell	INSP. DATE: April 28, 2014	INSP. TIME: 11:00
OPERATOR: Phillips County	OPERATOR REPRESENTATIVE: Randy Schafer	TYPE OF OPERATION: 110c - Construction Limited Impact

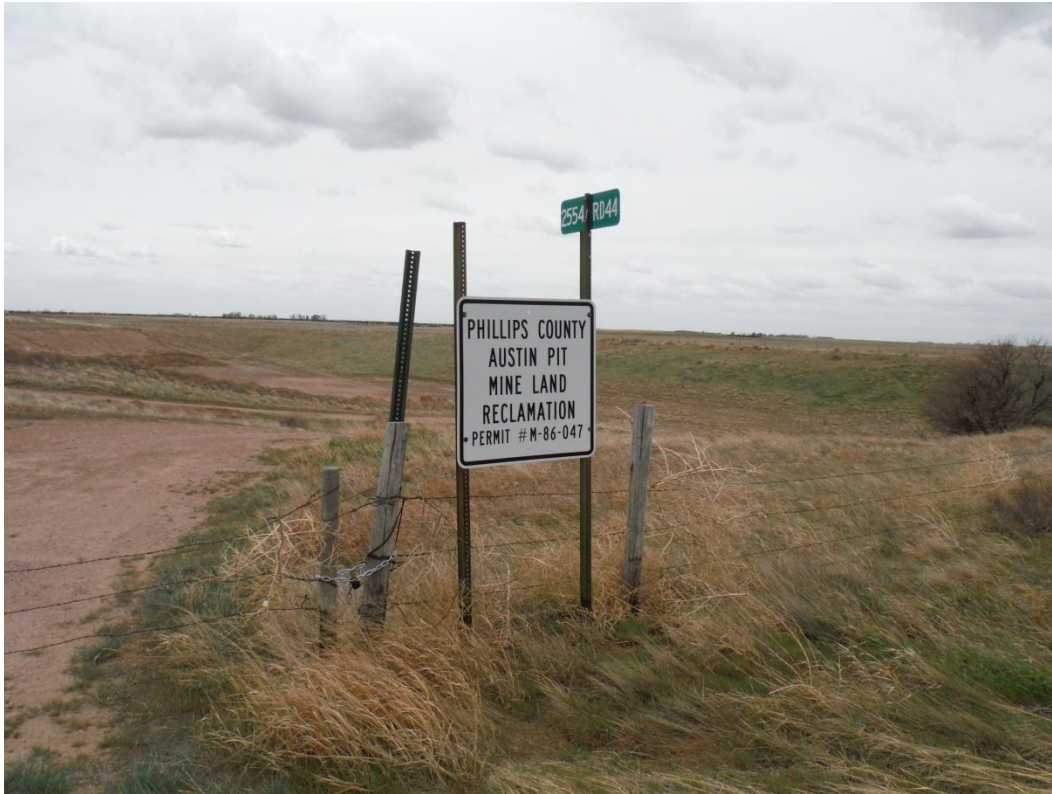
Permit identification sign at the mine entrance along CR44; looking south.

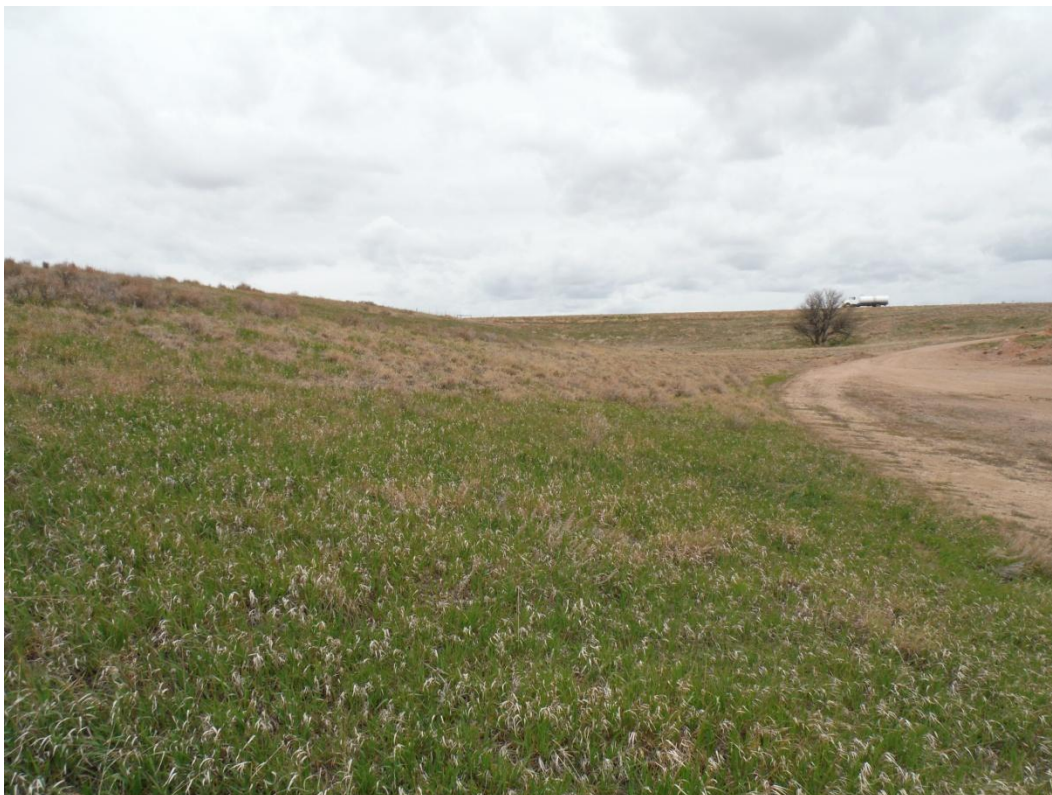
Western portion of site, slope regraded and vegetated; looking north.

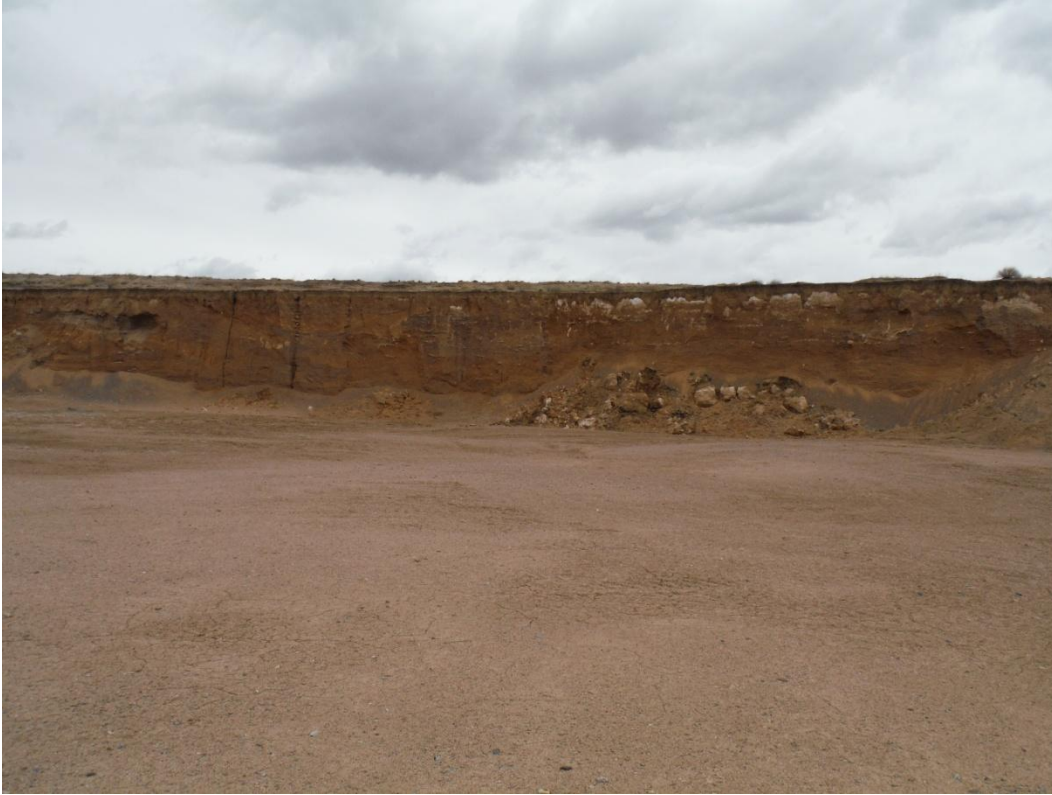
The Austin Pit is a sand and gravel, and clay operation located just south of the county line. The western and north portion of the site had been regraded and vegetated. The eastern portion of the site was where the dig face was located; the highwall was estimated to be 25 feet tall. The southeast portion of the site has yet to be disturbed. A topsoil stockpile was located along the top of the highwall along the eastern boundary of the site. Some rills were noted in the southwest corner of the pit where regrading has occurred; this is not a problem at this time because any erosion is contained within the site and there were no offsite impacts observed.

Active dig face; looking east.

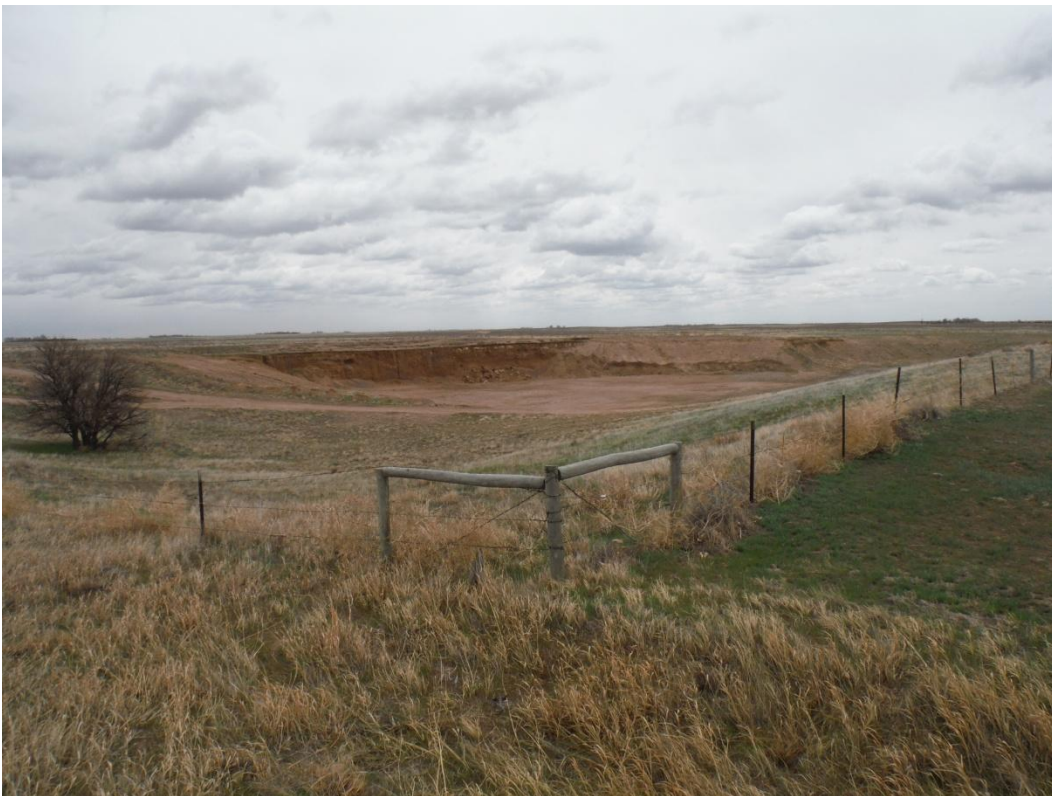
Northwest boundary corner; looking southeast.
