COLORADO DIVISION OF RECLAMATION, MINING AND SAFETY
MINERALS PROGRAM INSPECTION REPORT
PHONE: (303) 866-3567

MINE NAME: Mesita Hill Pit	MINE/PROSPECTING ID#: M-1977-227	MINERAL: Volcanic materials	COUNTY: Costilla
INSPECTION TYPE: Monitoring	INSPECTOR(S): Wallace H. Erickson	INSP. DATE: April 10, 2014	INSP. TIME: 15:30
OPERATOR: MWCA, Inc.	OPERATOR REPRESENTATIVE: None present	TYPE OF OPERATION: 112c - Construction Regular Operation	
REASON FOR INSPECTION: Acreage Reduction (AR-01) Request	BOND CALCULATION TYPE: Partial Bond	BOND AMOUNT: \$67,462.00	
DATE OF COMPLAINT: NA	POST INSP. CONTACTS: None	JOINT INSP. AGENCY: None	
WEATHER: Windy	INSPECTOR'S SIGNATURE:

Mesita Hill Pit
M-1977-227
April 10, 2014

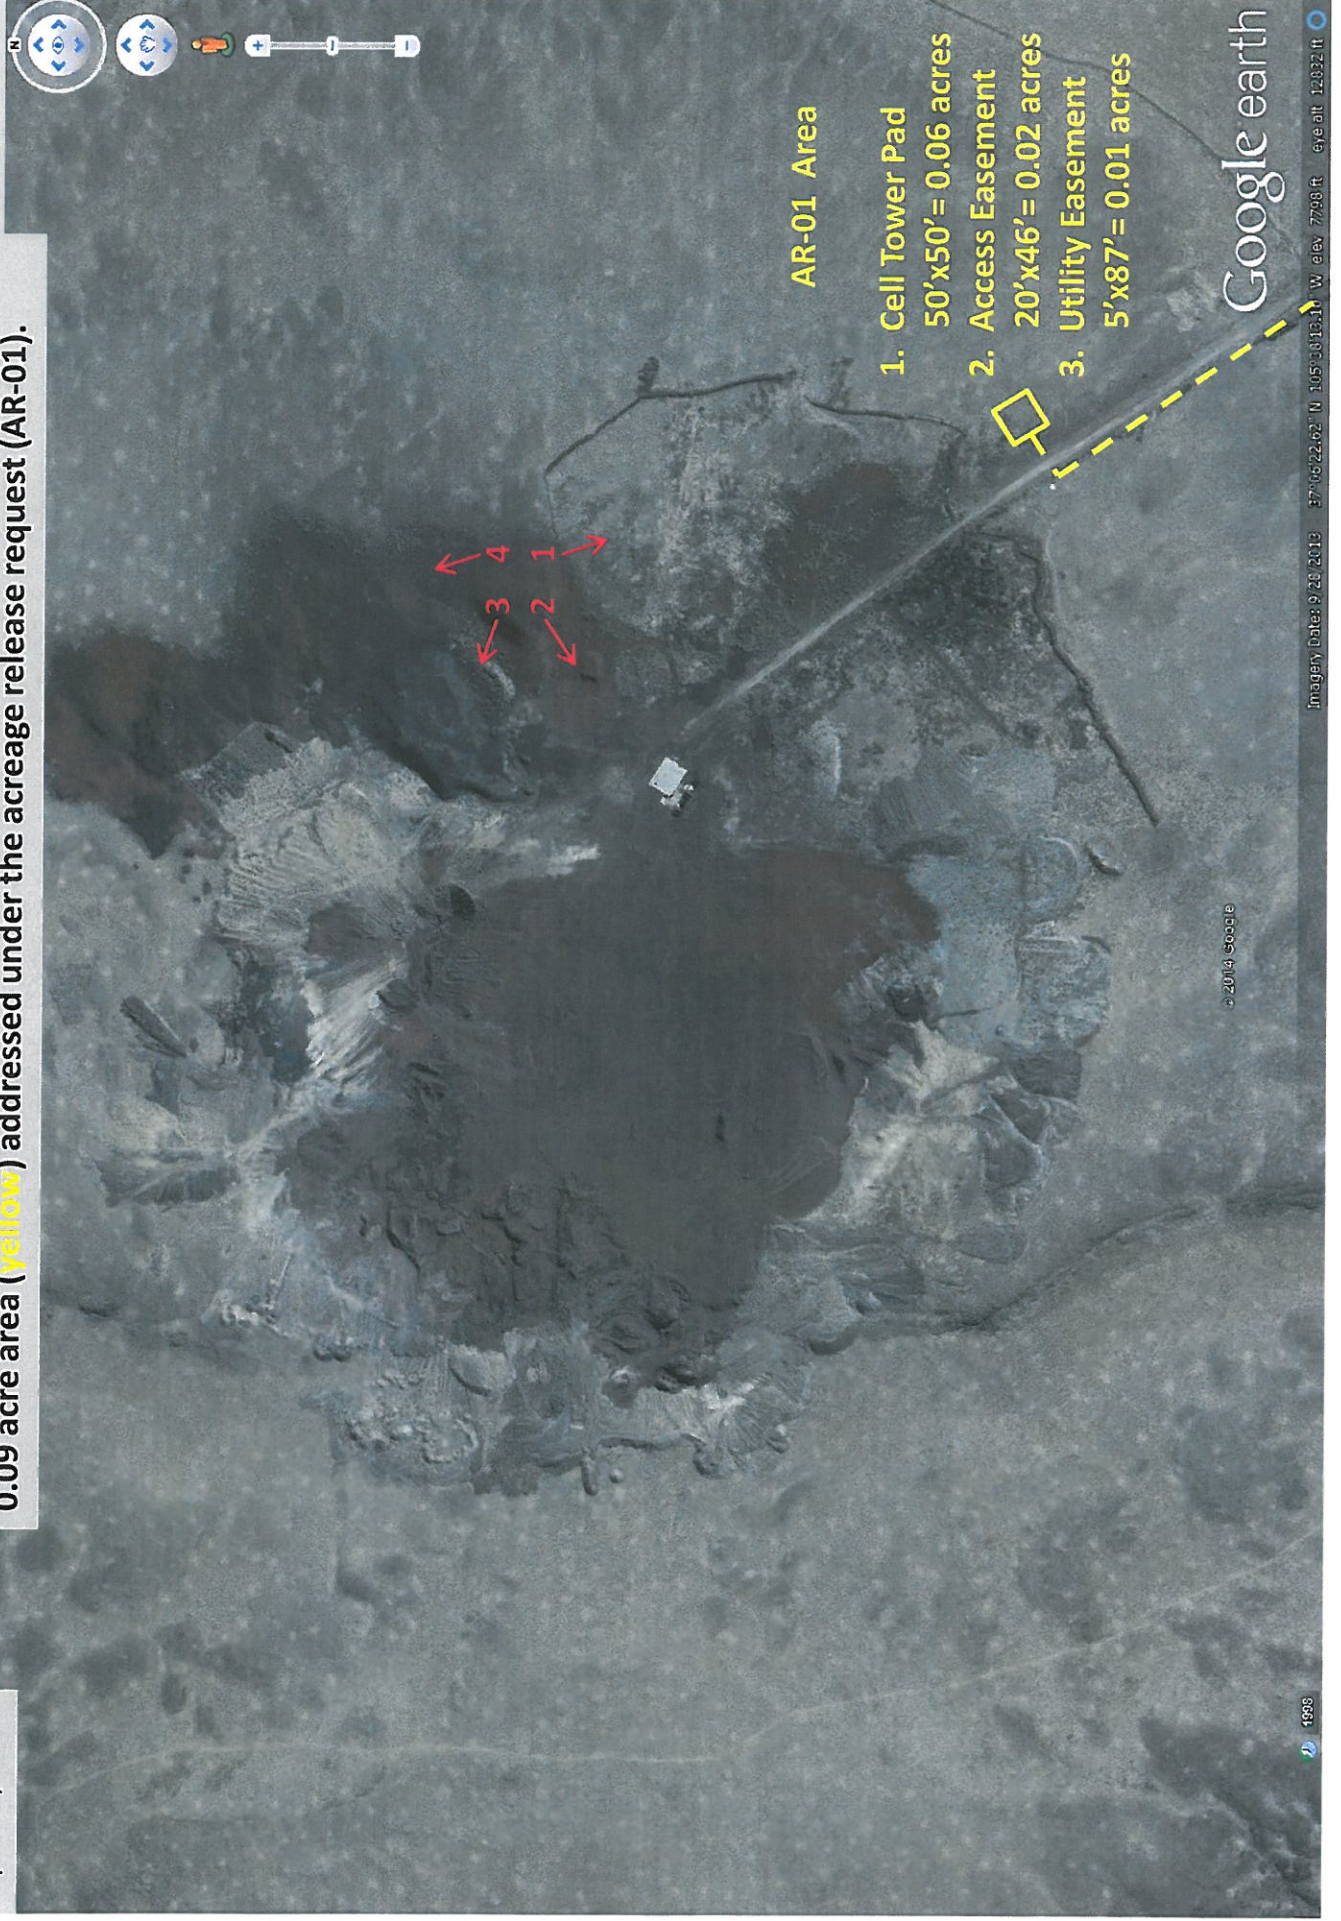
As shown on the enclosed image from Google Earth, the location of the proposed cell tower was immediately adjacent to the access road and south of the disturbance created by the mining activities. The lands addressed under AR-01 include the cell tower pad, approximately 50 feet x 50 feet = 0.06 acres; an access easement to the pad, approximately 20 feet x 46 feet = 0.02 acres; and an easement for utilities, approximately 5 feet x 87 feet = 0.01 acres. For the lands addressed under AR-01, slopes were extremely mild and appeared stable; evidence of settling, slumping or erosion was not observed. Vegetative cover for the lands addressed under AR-01 appeared diverse, effective, capable of self-regeneration, and at least equal in extent of cover to the natural vegetation of the surrounding lands. All mining related equipment and/or debris had been removed. Based on observations made during the inspection and recorded within this report, the Operator has completed reclamation of the 0.09 acres area addressed under AR-01 in accordance with the conditions of the approved reclamation plan and applicable portions of the Act and Rules. The Division recommends approval of AR-01. As part of AR-01 the Operator did not request a reduction in the amount of financial warranty held for the operation. Therefore, the Division's recommendation to approve AR-01 is limited to the release of 0.09 acres and no reduction in the amount of financial warranty.

Google Earth, imagery date September 28, 2013, showing portions of the permit area, locations of photos taken during the inspection (**red**), and the approximate 0.09 acre area (**yellow**) addressed under the acreage release request (AR-01).

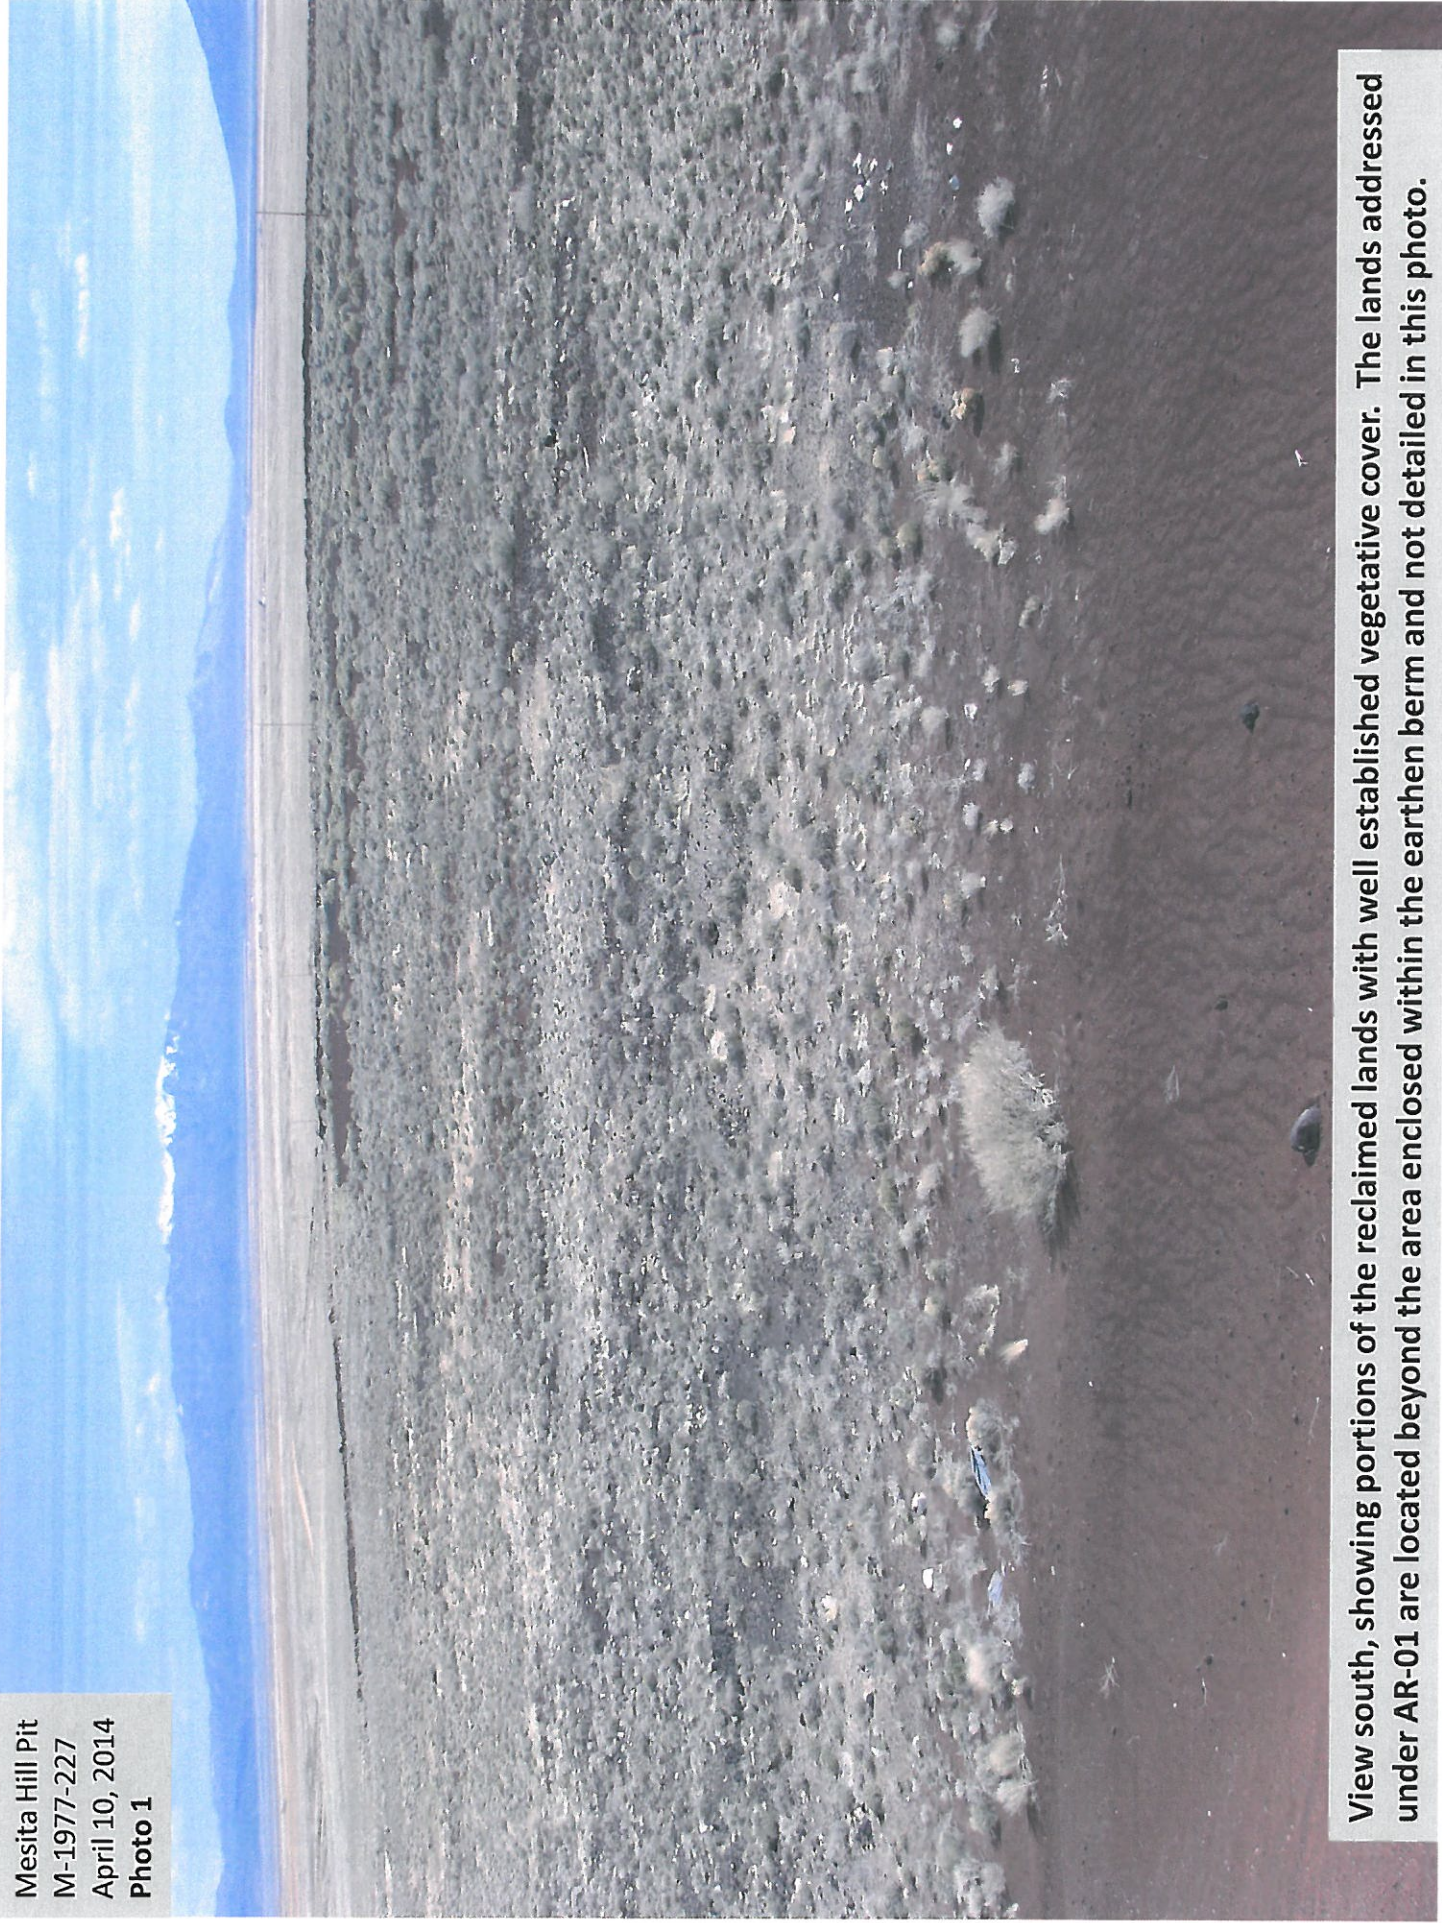
Mesita Hill Pit
M-1977-227
April 10, 2014
Photo 1

View south, showing portions of the reclaimed lands with well established vegetative cover. The lands addressed under AR-01 are located beyond the area enclosed within the earthen berm and not detailed in this photo.

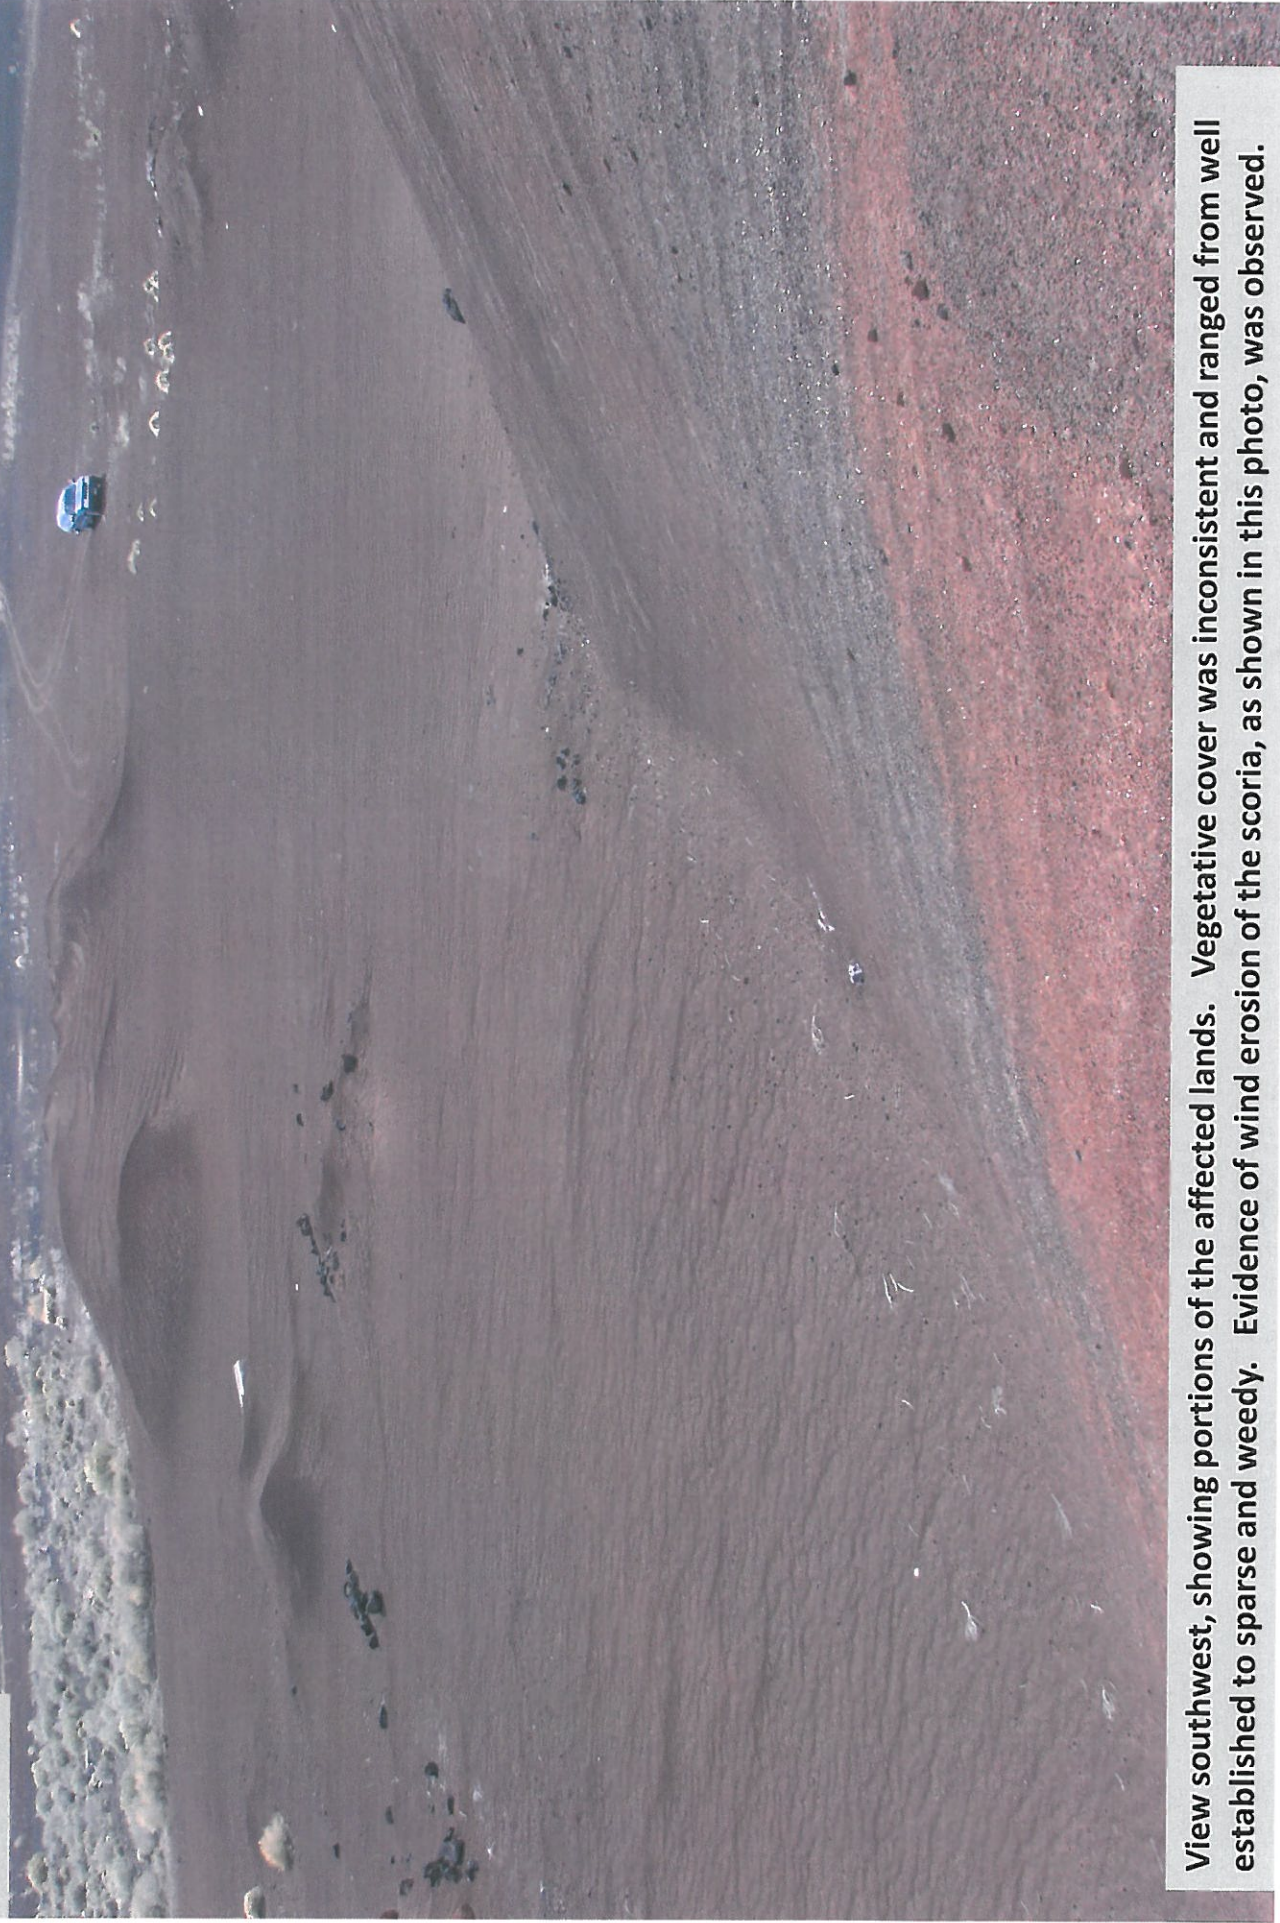
Mesita Hill Pit
M-1977-227
April 10, 2014
Photo 2

View southwest, showing portions of the affected lands. Vegetative cover was inconsistent and ranged from well established to sparse and weedy. Evidence of wind erosion of the scoria, as shown in this photo, was observed.

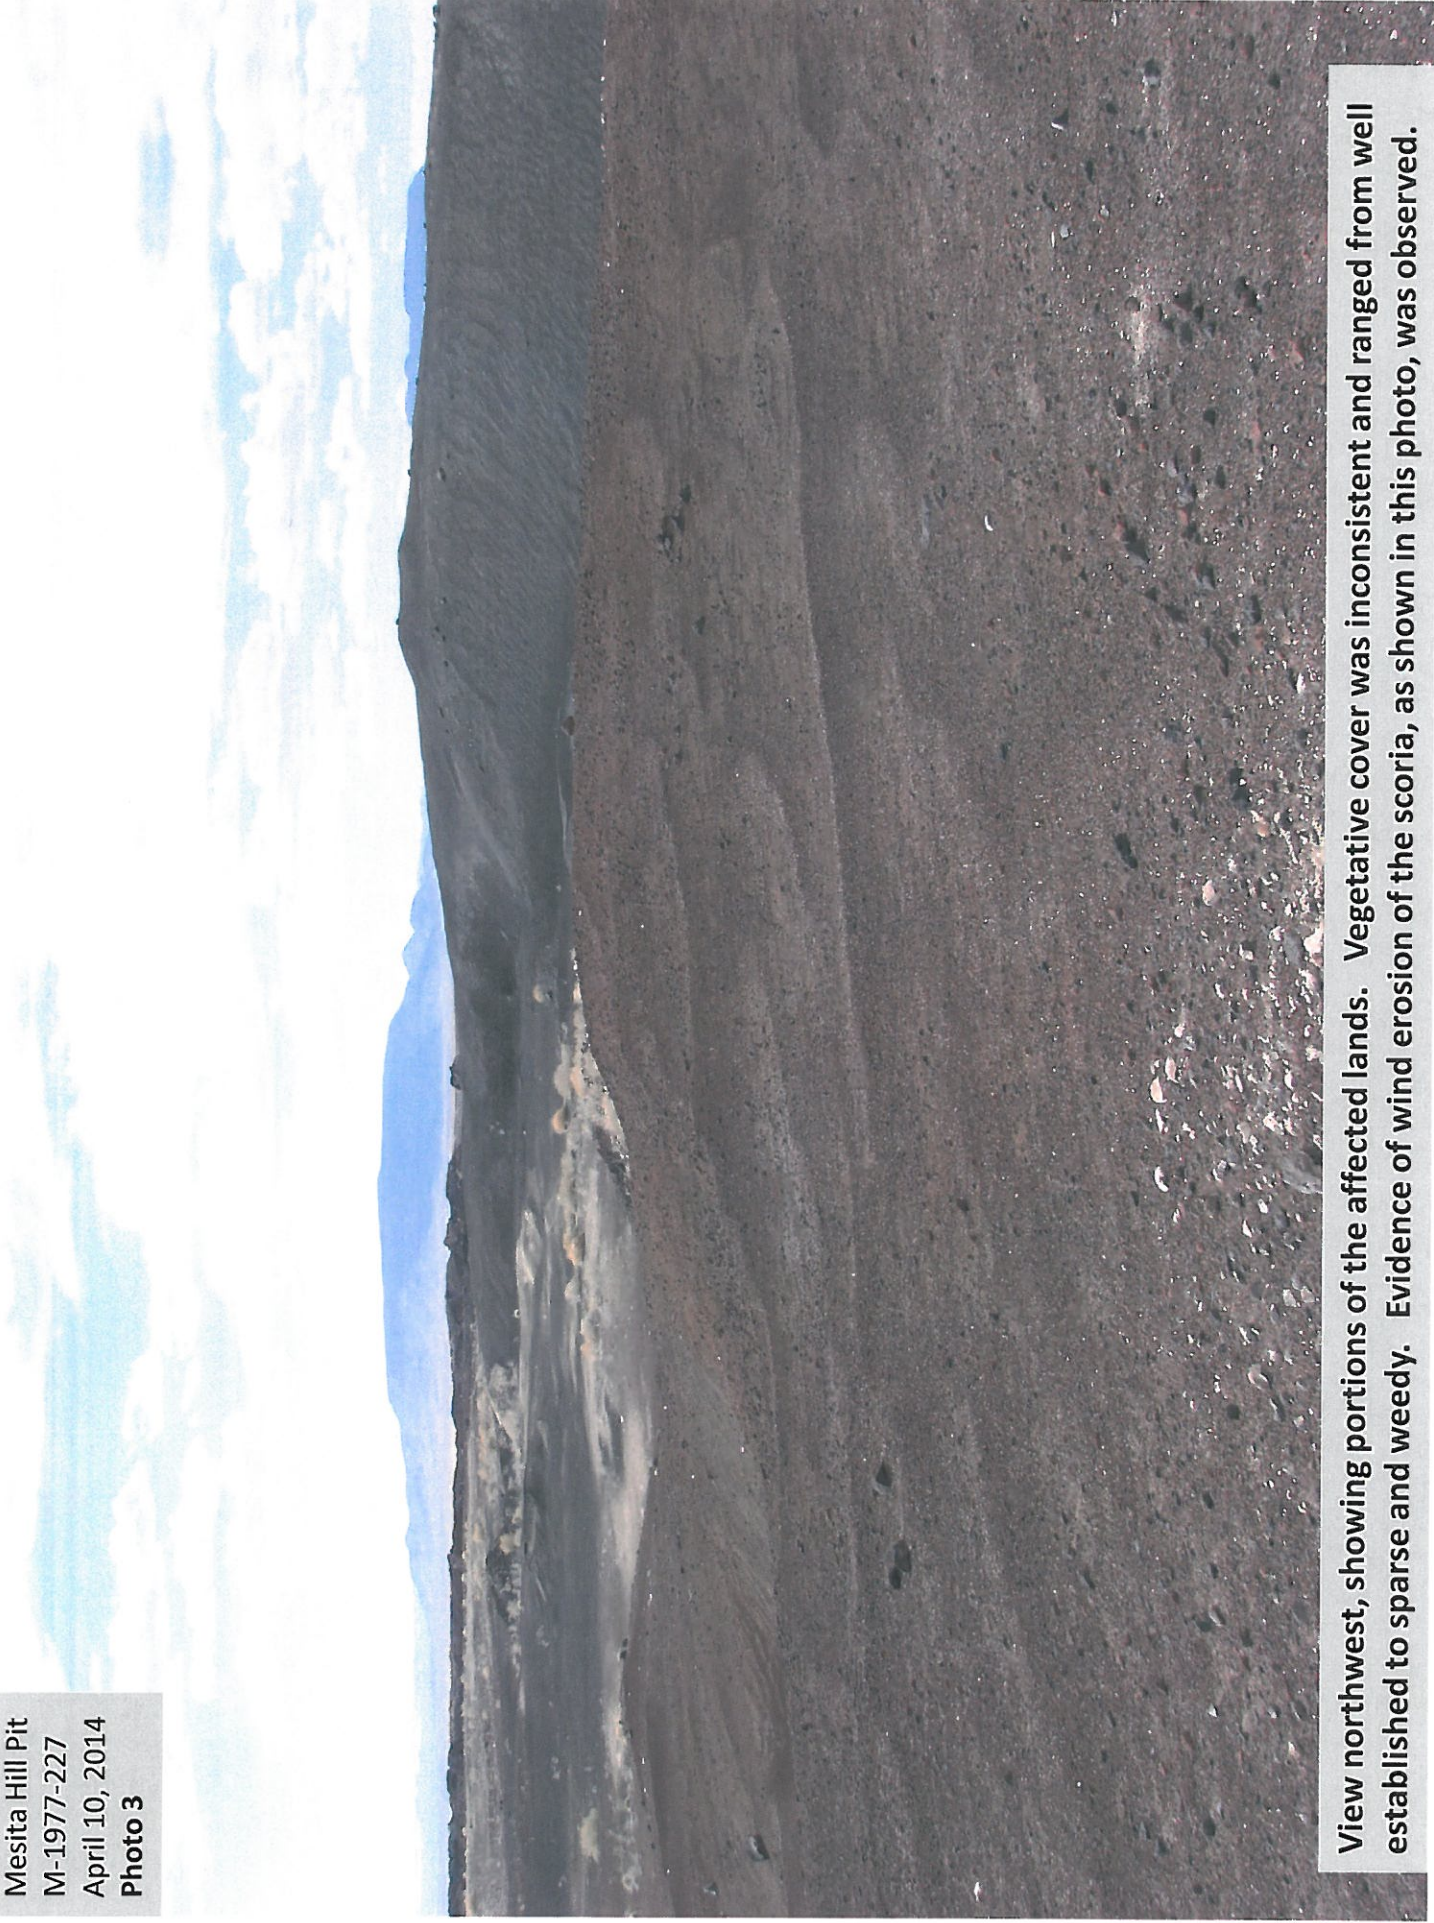
Mesita Hill Pit
M-1977-227
April 10, 2014
Photo 3

View northwest, showing portions of the affected lands. Vegetative cover was inconsistent and ranged from well established to sparse and weedy. Evidence of wind erosion of the scoria, as shown in this photo, was observed.

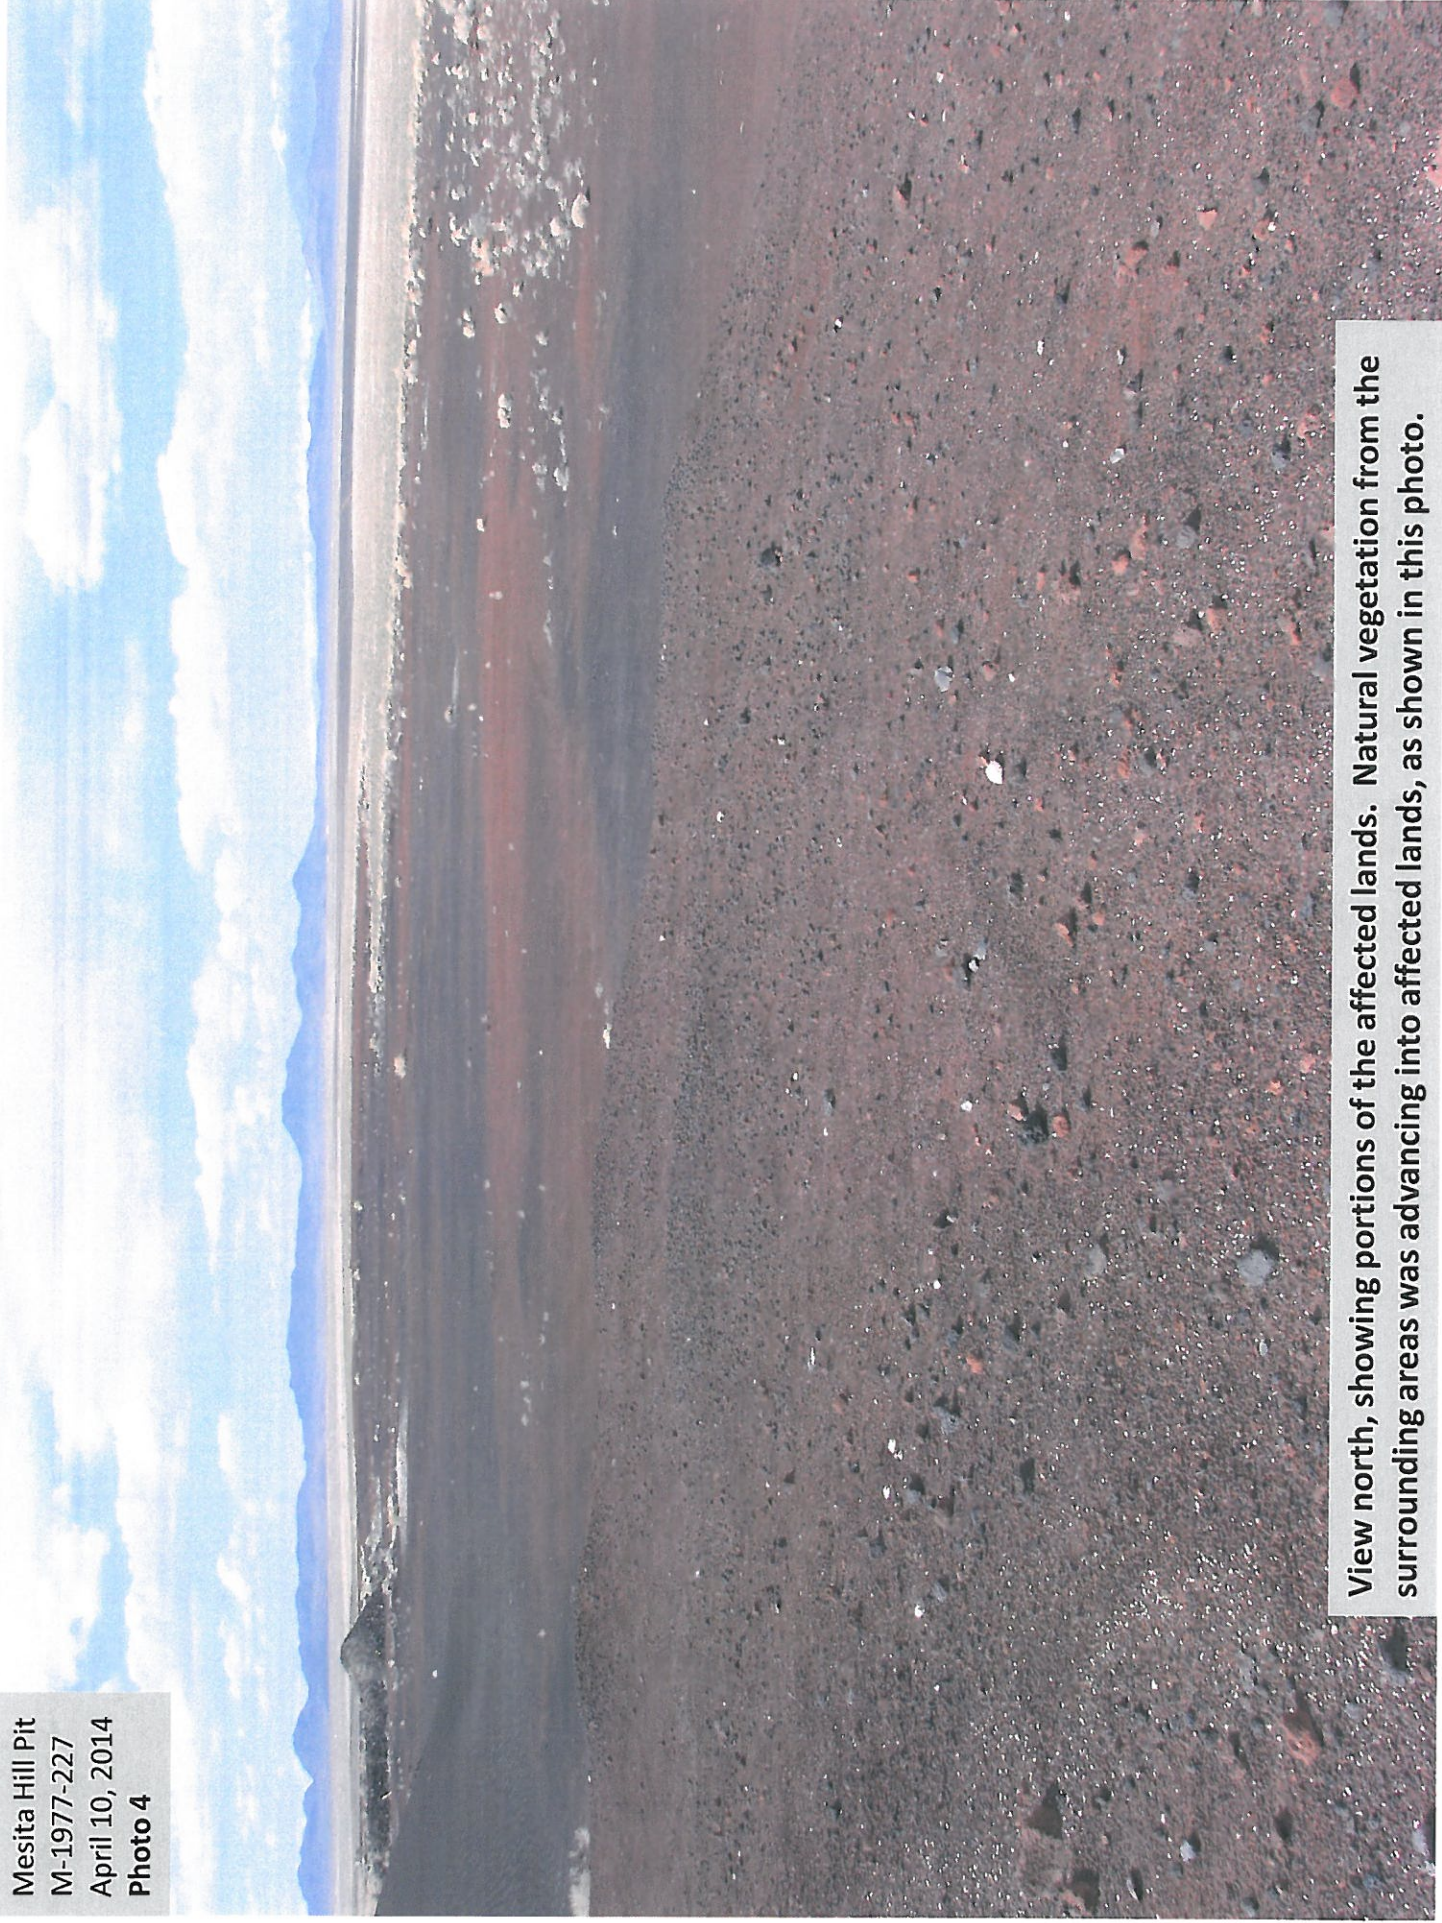
Mesita Hill Pit
M-1977-227
April 10, 2014
Photo 4

View north, showing portions of the affected lands. Natural vegetation from the surrounding areas was advancing into affected lands, as shown in this photo.
