**COLORADO DIVISION OF RECLAMATION, MINING AND SAFETY**  
**MINERALS PROGRAM INSPECTION REPORT**  
**PHONE: (303) 866-3567**

<b>MINE NAME:</b> Riverside Pit	<b>MINE/PROSPECTING ID#:</b> M-1976-056	<b>MINERAL:</b> Sand and gravel	<b>COUNTY:</b> Logan
<b>INSPECTION TYPE:</b> Surety Release Inspection	<b>INSPECTOR(S):</b> Elliott R. Russell	<b>INSP. DATE:</b> March 24, 2014	<b>INSP. TIME:</b> 14:00
<b>OPERATOR:</b> McAtee Construction Company	<b>OPERATOR REPRESENTATIVE:</b> Darren Gebhart	<b>TYPE OF OPERATION:</b> 112c - Construction Regular Operation

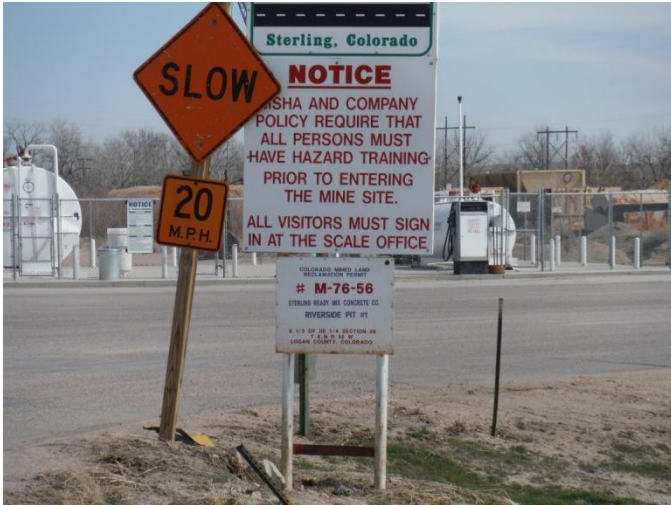
Permit sign at site entrance; looking east

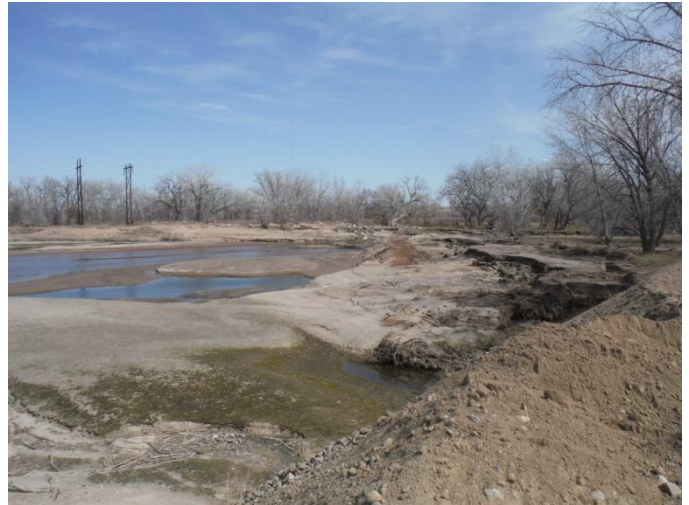
The area proposed for release is located on the eastern side of the permit and includes Lake Robert. After a flooding event, it appeared that two channels were cut into Lake Robert's southern shoreline and had destroyed the road that was used to access the east portion of the lake. One channel on the southwest side had been backfilled by the Operator but the larger of the two, near the southeast corner of the lake, still had water running through it. This remaining channel was approximately 80 feet wide and 10 feet deep. After further investigation, the water that was flowing into Lake Robert was traced back to a breach in the Low-line Ditch (approximately 800 feet upstream). At the time of the inspection, none of the water was continuing down the ditch and all of it was flowing through the breach; this breach was located adjacent to a concrete-armored spillway structure that appears to be designed to allow for high flows from the ditch to release water in a natural channel which originally flowed around the east side of Lake Robert and returned to the South Platte River.

Damaged shoreline and access road; looking east

Prior to approval of a release, all equipment and stockpiled material would need to be removed from the release area and the access roads, as well as the equipment parking area, would need to be adequately revegetated; in addition the southern and eastern shoreline would need to be resloped and revegetated. The Division would allow the use recycled concrete (similar to that already in place) along this shoreline to protect it from future undercutting. If the landowner requests the access roads and parking area to remain after final release of the area, the Operator should include this in the Technical Revision mentioned above and a signed letter from the landowner. In addition, the bridge that spans the Low-line Ditch should be included as well or it will need to be removed prior to final release.

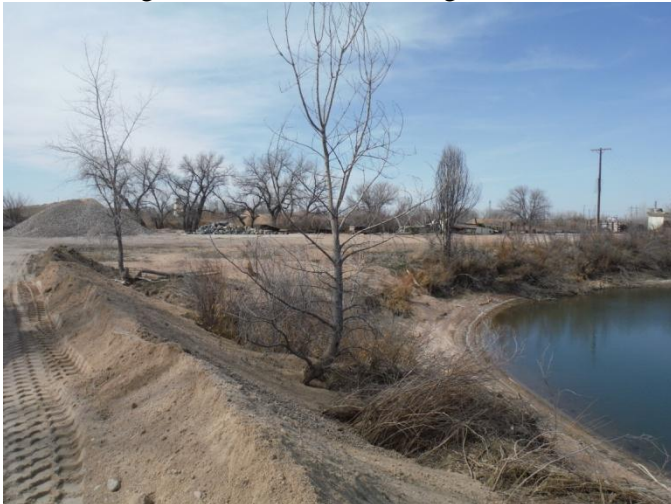
- On the west side of the lake is a large equipment storage area and parking lot.
- The southwest portion of the lake area has two stockpiles of material.
- Also in the southwest portion of the lake area, remains a bridge which spans the Low-line Ditch.

Stockpiles and equipment storage area; looking west

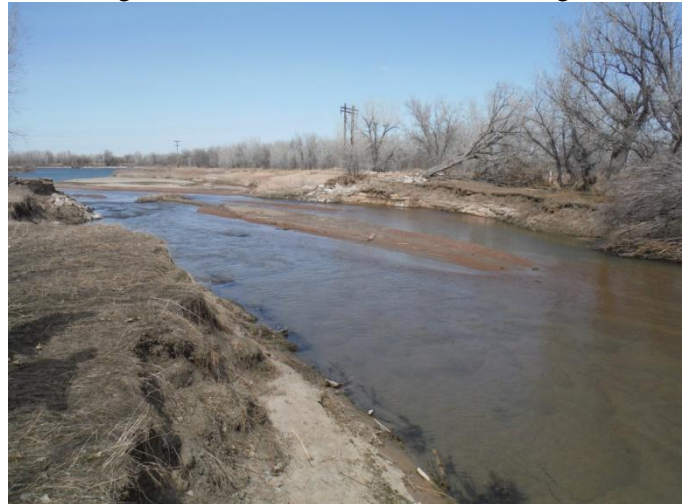
New channel on southeast corner of Lake Robert; looking north (downstream)

Although the vegetation in the release area may have been close to satisfying the requirements for final release prior to the flood, the area does not qualify for release now because, as a result of the flood, conditions in the release area no longer meet the requirements of the reclamation plan. The largest change caused by the flood in the release area is that much of the flow of the Low-line Ditch now flows through Lake Robert in the release area. The Operator may apply for a Technical Revision that modifies the reclamation plan to include significant flow of the Low-line Ditch/South Platte River through Lake Robert. The Revision would need to include designs for the inlet and outlet of Lake Robert that will accommodate river flows and protect the channel. If the Revision is approved, the operator could re-apply for release of the Lake Robert area.

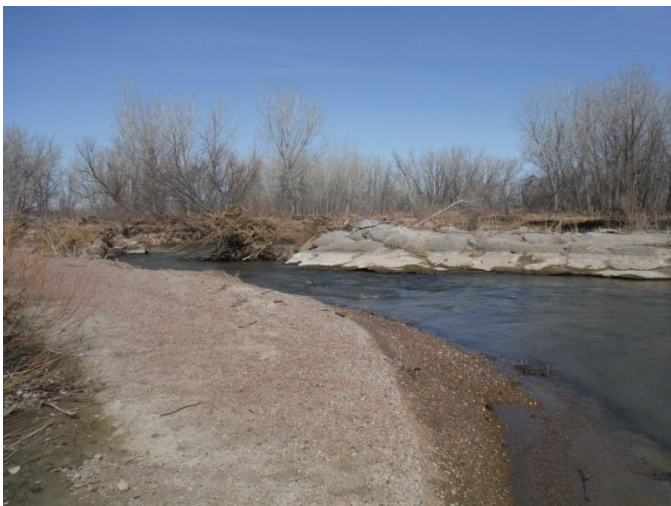
- On October 27, 2013 the Division received a letter from the operator explaining the status of the Lake Robert area after the South Platte River had flooded the Sterling area on September 16, 2013. The letter discussed that the flooding had damaged the Low-line Ditch and had caused the river to enter Lake Robert and had yet to return to the natural channel. They requested information on how to proceed.

Breach in the Lowline-Ditch; looking northeast

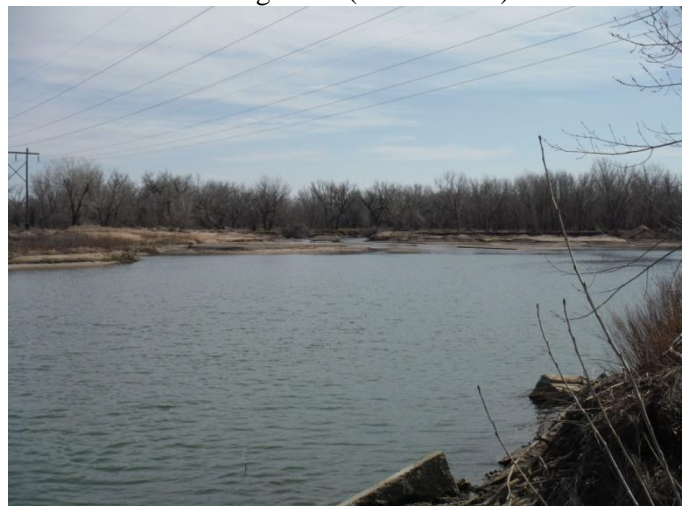
A large sand bar is now developing in the southeast portion of the lake as a result of the new inflow of water. The entire middle half of the east shoreline has been damaged and undercut from the flood waters. This shoreline appears to be unstable and the slope of the shoreline does not meet the requirements of Rule 3.1.5(7). During the inspection the Division observed several stretches of Lake Robert's shoreline having recycled concrete armoring.

Sandbars in southeast corner of Lake Robert; looking southeast

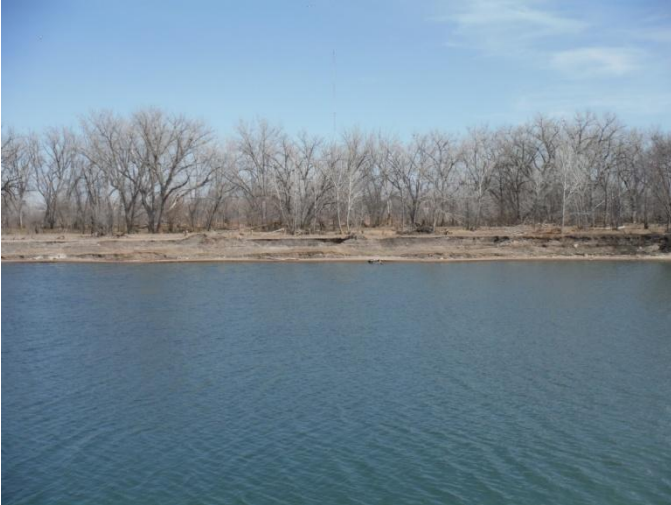
Damaged mid-lake shoreline; looking east

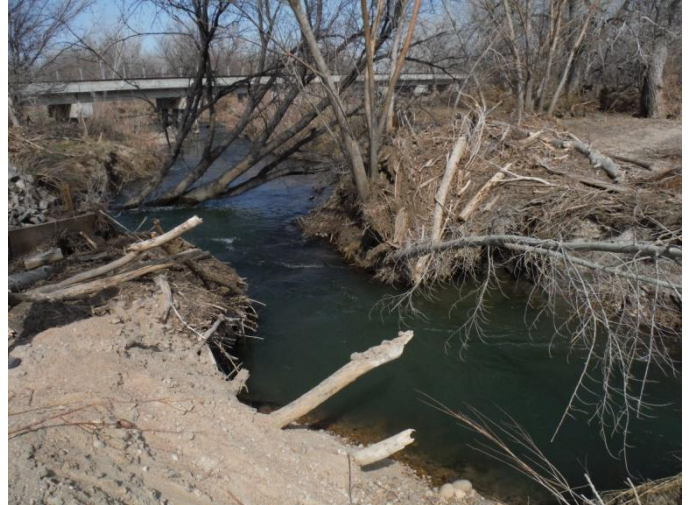
On the north shoreline of Lake Robert, the flood waters had cut a channel approximately 15 feet wide and 8 feet deep which allows water to leave the lake and return back to the South Platte River. The operator had stated that this area was where the original spillway/outlet was located for the lake prior to the flooding and was approximately 1-2 feet deep.

New channel on northern shoreline of Lake Robert;  
looking north (downstream)

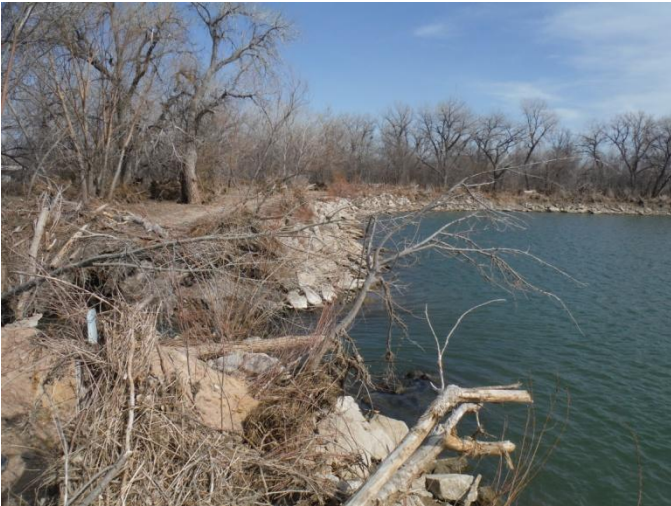
Northern shoreline; looking east
