COLORADO DIVISION OF RECLAMATION, MINING AND SAFETY
MINERALS PROGRAM INSPECTION REPORT
PHONE: (303) 866-3567

MINE NAME: Bettger Gravel Pit	MINE/PROSPECTING ID#: M-1976-051	MINERAL: Sand and gravel	COUNTY: Routt
INSPECTION TYPE: Monitoring	INSPECTOR(S): Dustin M. Czapla	INSP. DATE: May 6, 2014	INSP. TIME: 15:00
OPERATOR: Duckels Construction, Inc.	OPERATOR REPRESENTATIVE: Fred Duckels	TYPE OF OPERATION: 112c - Construction Regular Operation

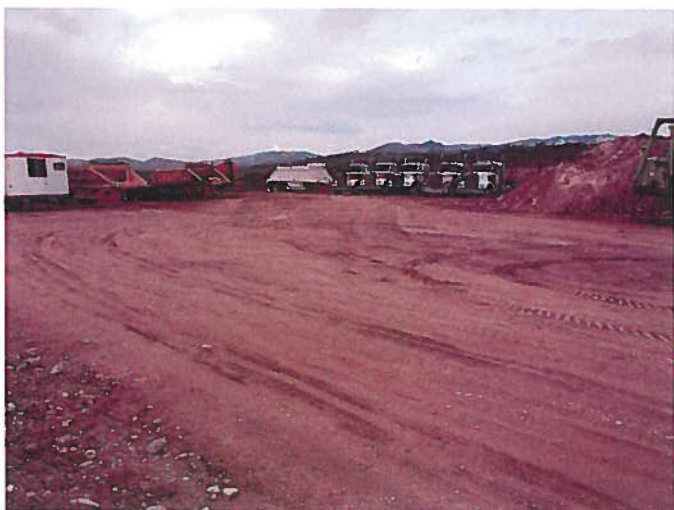
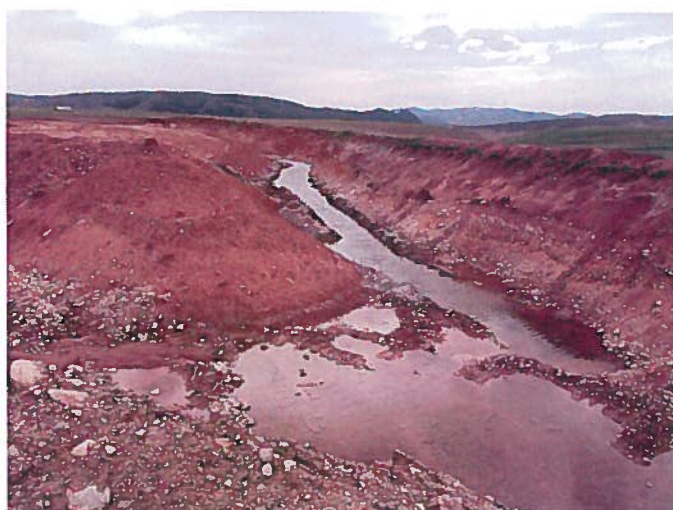
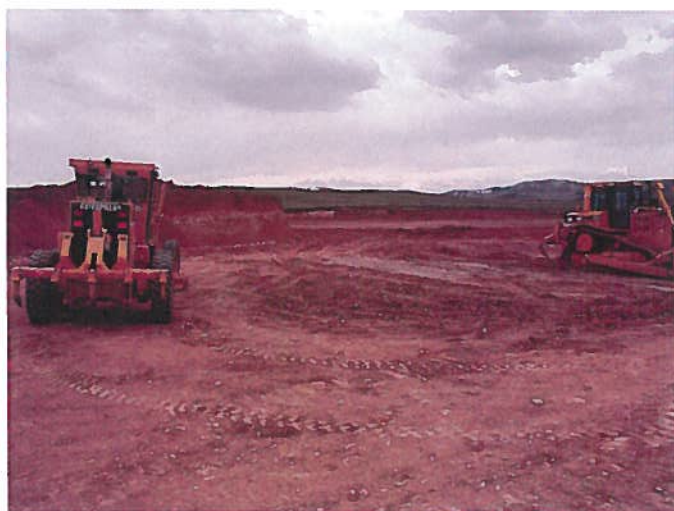
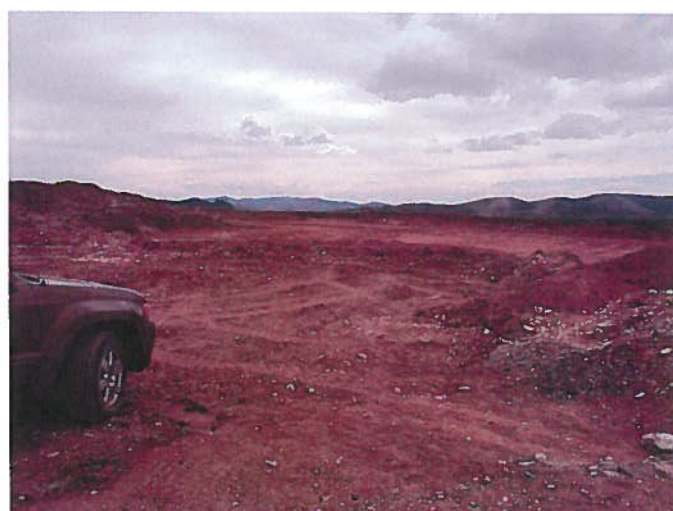
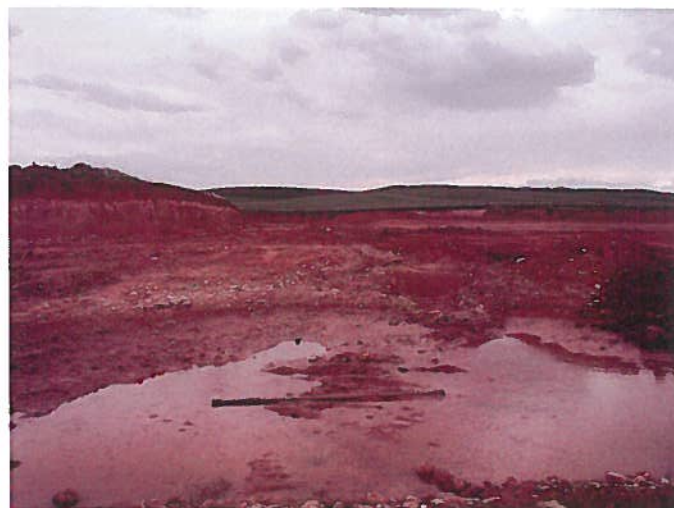
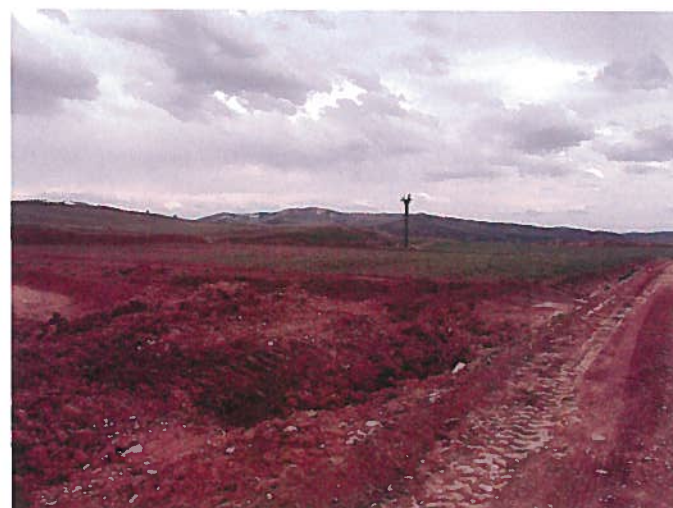
PHOTOGRAPHS

Adequate mine identification signage was noted at the entrance to the site.

The affected area was marked by posts that were clearly visible and adequate to delineate the affected area boundary.

Reclamation closely follows the mining at this site. Topsoil and overburden are removed from the active cut and placed on the previously mined area. This method keeps the overall disturbance minimized. Mining has commenced in the first phase of the AM-5 area.
