**COLORADO DIVISION OF RECLAMATION, MINING AND SAFETY**  
**MINERALS PROGRAM INSPECTION REPORT**  
**PHONE: (303) 866-3567**

<b>MINE NAME:</b> Hogue/River Pit	<b>MINE/PROSPECTING ID#:</b> M-1992-066	<b>MINERAL:</b> Gravel	<b>COUNTY:</b> Routt
<b>INSPECTION TYPE:</b> Monitoring	<b>INSPECTOR(S):</b> Dustin M. Czaplá	<b>INSP. DATE:</b> May 6, 2014	<b>INSP. TIME:</b> 15:30
<b>OPERATOR:</b> Duckels Construction, Inc. dba Yampa Aggregates	<b>OPERATOR REPRESENTATIVE:</b> Fred Duckels	<b>TYPE OF OPERATION:</b> 112c - Construction Regular Operation

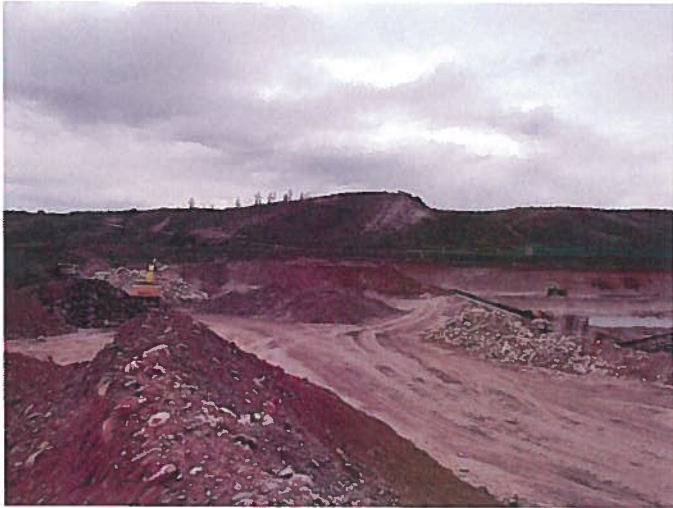
Active mining area.

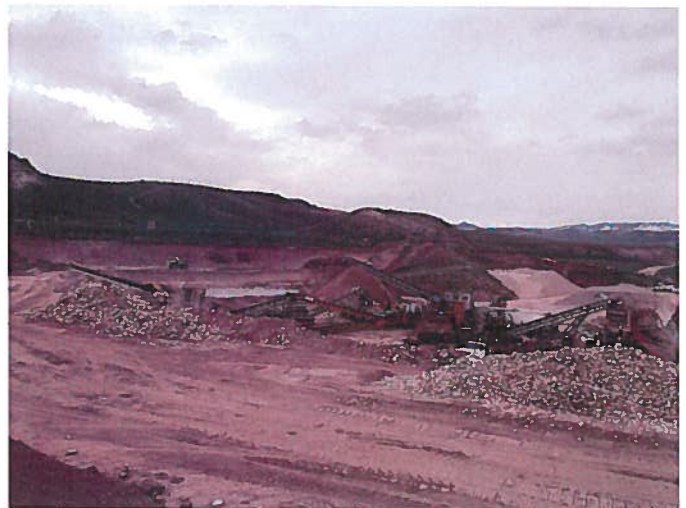
Active mining area.

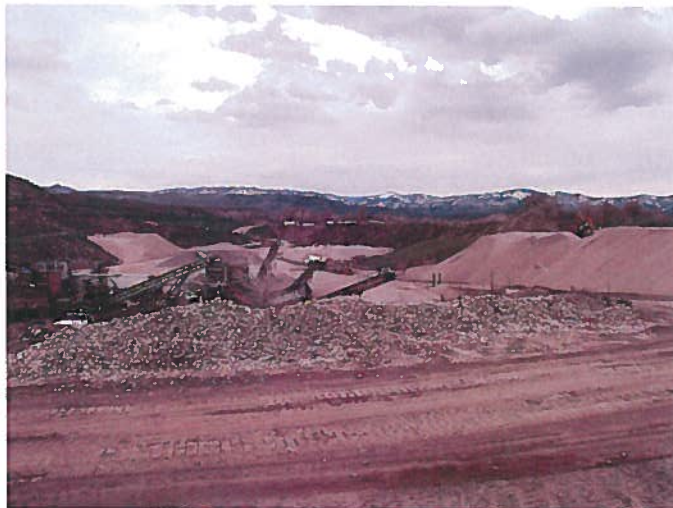
Active mining area.

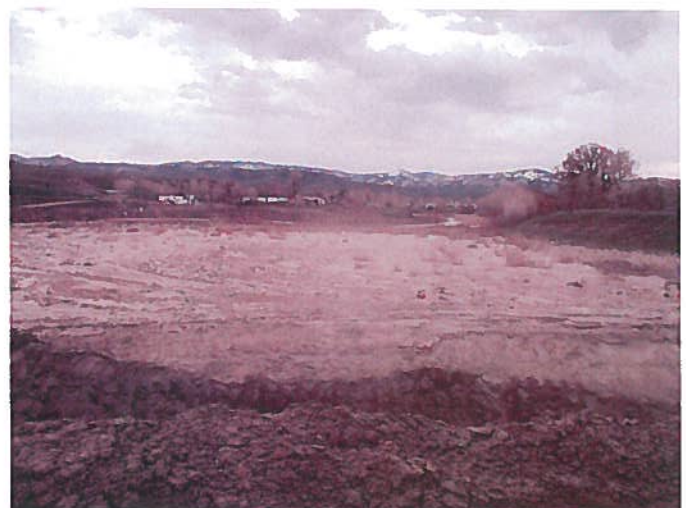
Process water cleaning pond.

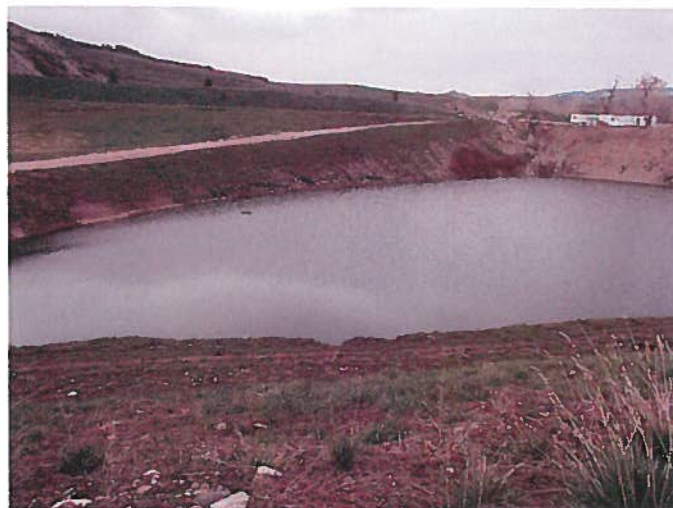
This site is active. The active pit area is located in the west portion of the permit area. Mining has not yet commenced in the AM-2 area. Various materials stockpiles are located throughout the pit floor. Crushing equipment is located in the active pit area. Topsoil is stockpiled in a visual berm along Hwy 40. The stockpile is stable and well vegetated. Process water is pumped into a pond in the east side of the pit, which drains to a discharge pond after settling, then discharges to the Yampa River. The process water pond was being cleaned out during the inspection. Slopes surrounding the discharge pond appeared stable.

Discharge pond.

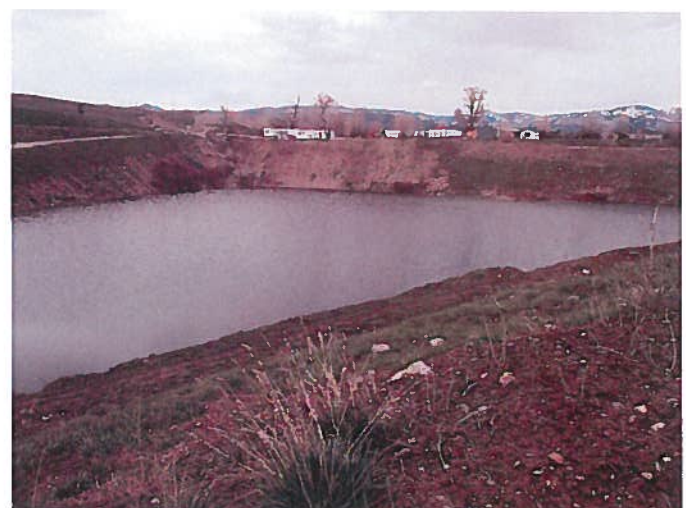
Discharge pond.
