Nyholt Mann Pit M-1982-147

MODIFIED 30-DAY LEAK TEST RESULTS

MANN LAKES, LAKE #2

ADAMS COUNTY, COLORADO

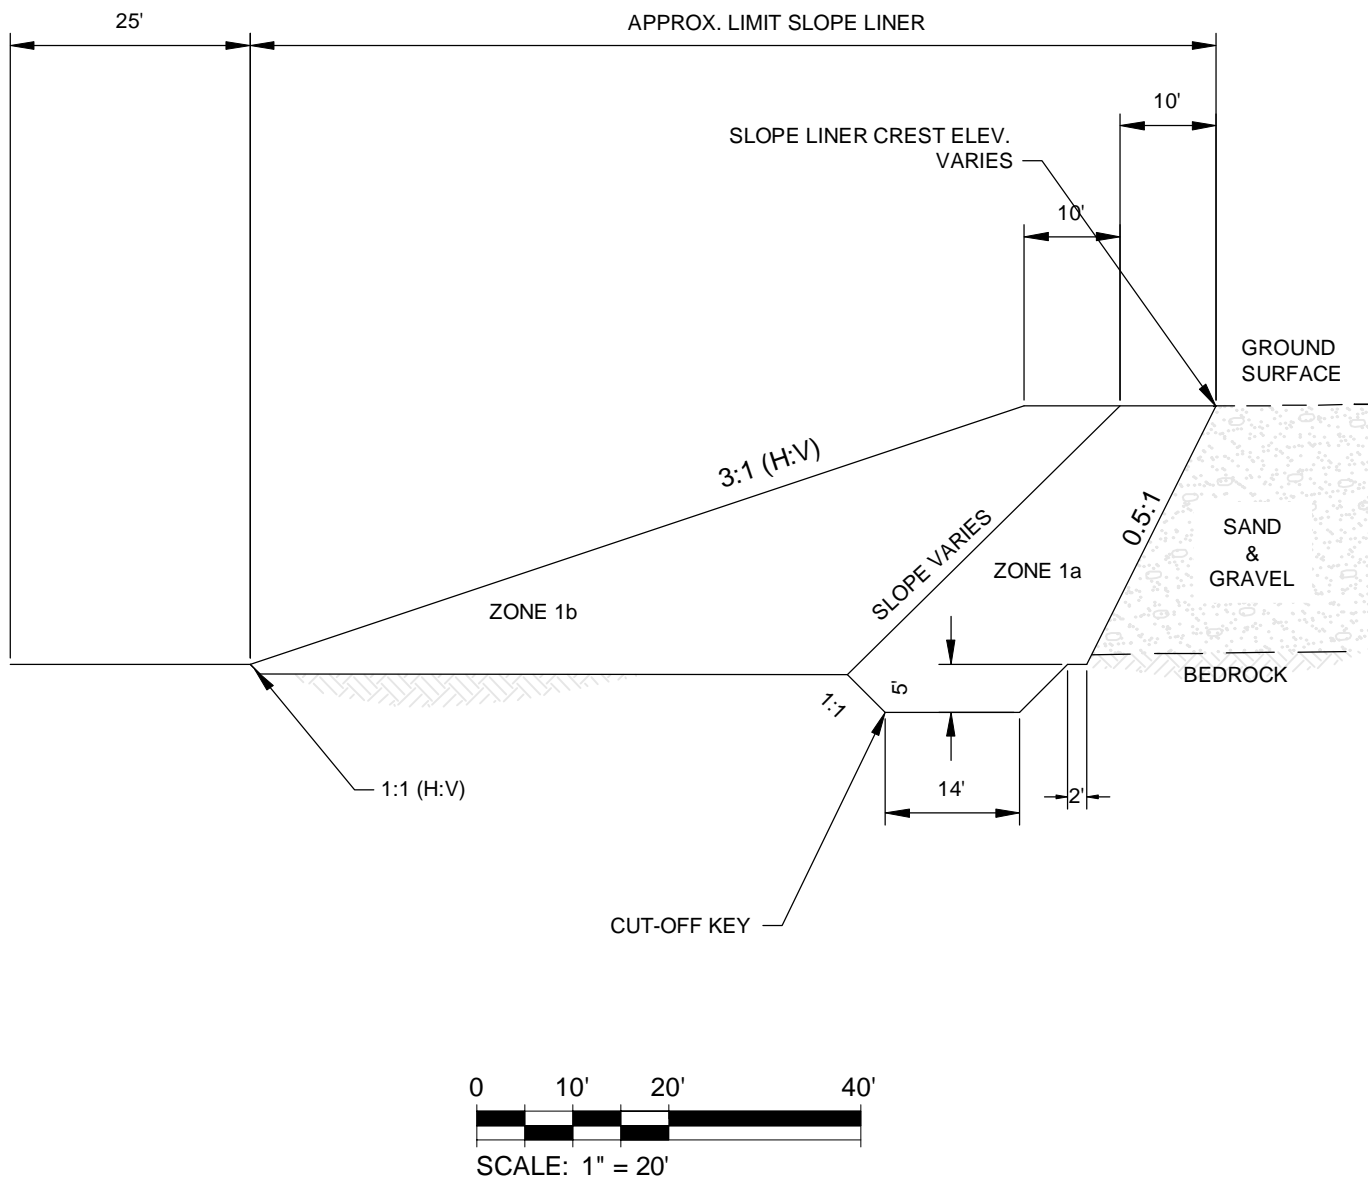
FIG 2

Mann Lakes is lined with compacted clay embankment seal zone (Zone 1a) adjacent to and protected by gravelly clay zone (Zone 1b). A typical liner section is provided on Figure 2. A plan view of the lined pit is provided on Figure 1. The slope liner typically slopes 3:1 horizontal to vertical (H:V) into the pit.

The liner was designed by others and constructed by Lafarge and Kelley Trucking between 1998 and 2007. Materials used in liner construction consisted of a mixture of clay overburden, clay mud lens and claystone bedrock. Tetra Tech observed construction of parts of the liner and concurs that the liner is constructed to the design standards.

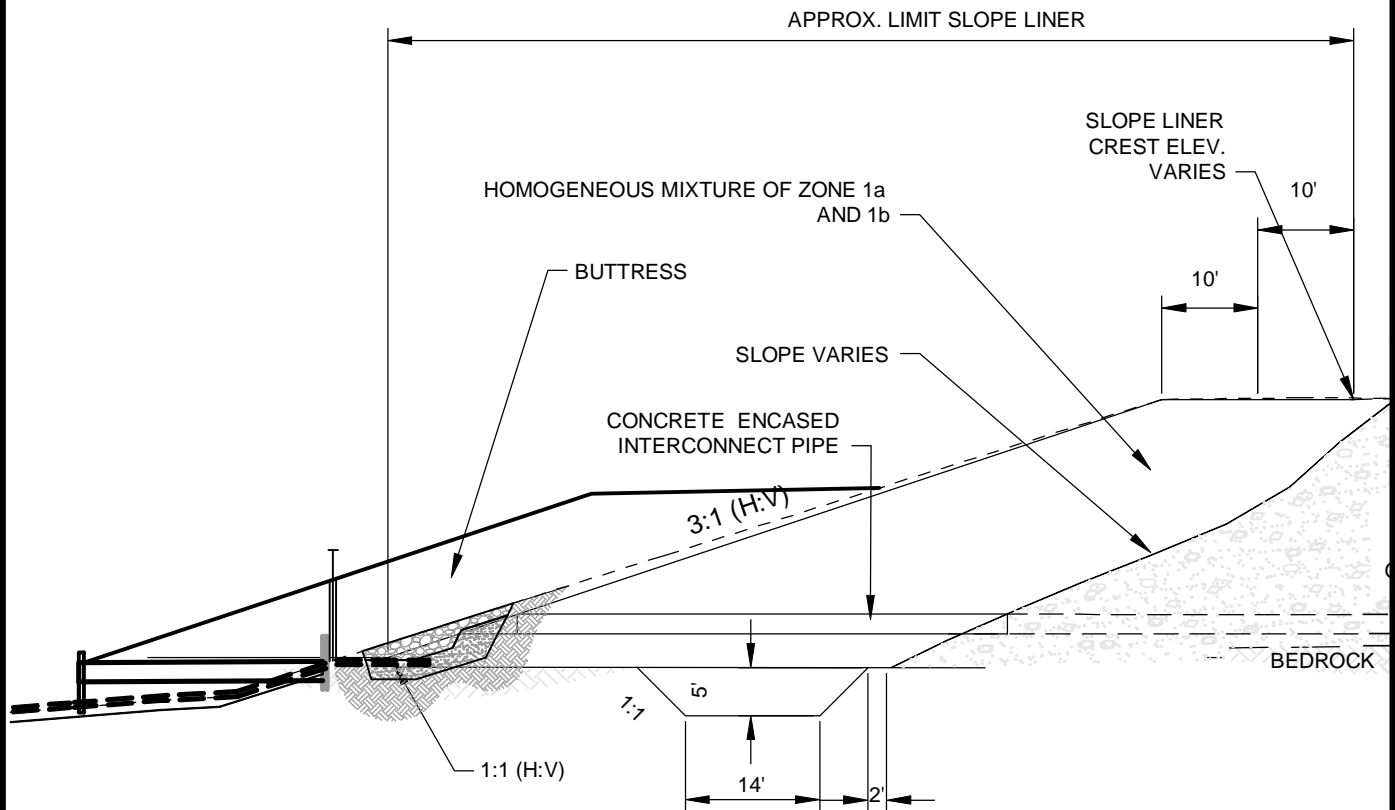
FIG 3

On or about August 15, 2011, a breach in the Lake #2 slope liner within the Lake #2 to Lake #3 interconnect excavation footprint was discovered. Groundwater flow emanating from the breach into Lake #2 was measured multiple times with a cutthroat flume. The flow was consistently measured to be approximately 85 gpm, approximately 33 gpm more than the allowable design standard of 52 gpm.

Between March and April 2011, L&M Enterprises constructed interconnects between Lakes #1 and #2 as well as between Lakes #2 and #3. The breach plan, designed by Tetra Tech, included breaching the liners with side slope excavations of 1:1 (H:V), installation of 24-inch pvc interconnect pipes encased in lean concrete, and the backfilling of the breached areas with a homogenous mixture of the material removed from the existing liners. The liner configuration encountered during the excavation differed from the anticipated configuration. A typical liner section encountered during the breach is provided in Figure 3.

Early in 2012, Tetra Tech designed a buttress to stabilize the breach and mitigate the flow into Lake #2. The buttress extends a length of approximately 90 feet (45-feet either side of the interconnect centerline). The buttress has a maximum height of approximately 22 feet. The downstream side of the buttress slopes 3:1 from the top of the buttress to the reservoir floor. The bench at the top of the buttress slopes 2% towards the reservoir allowing for drainage. A dewatering drain consisting of ¾" to 1½" washed rock and a 6" diameter perforated Advanced Drainage Systems (ADS) pipe with a 3' (horizontal) by a 1' (vertical) cross sectional dimension is located at the existing seep. The dewatering drain extends 10-feet horizontal into the existing slope liner. The drain extends via 6-inch PVC from the edge of the existing slope liner, under the buttress to the toe, daylighting on the reservoir floor. A ball valve is located at the interface between the existing slope liner and stability buttress with valve access directly above the valve via an 8-inch diameter PVC riser and removable valve stem. The drain is enclosed in a geotextile fabric to minimize the migration of fines into the drainage layer.

In June 2012, L&M Enterprises constructed the buttress designed by Tetra Tech. The buttress has effectively stabilized the breach area and mitigated flow into the reservoir. A typical stabilization buttress section is provided in Figure 3.

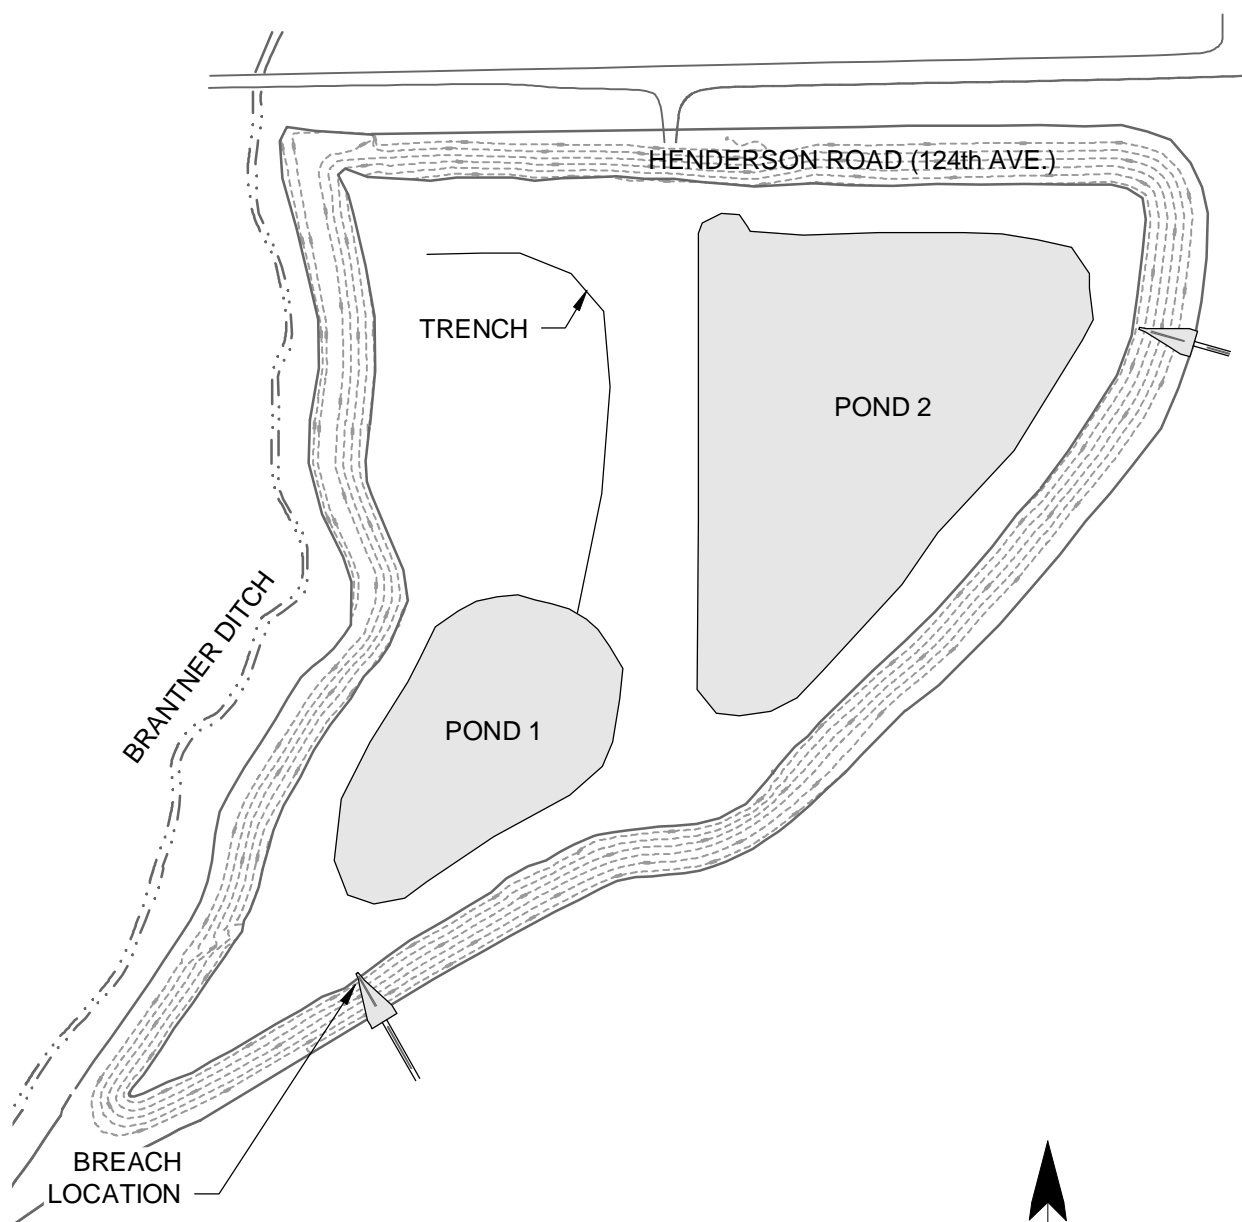
FIG 4

Site reconnaissance was performed in early June, 2012. Two pond locations and one trench location in Lake #2 were identified for monitoring. The ponds and trench were numbered sequentially, beginning with number 1. The initial pond and trench locations are shown on Figure 4.

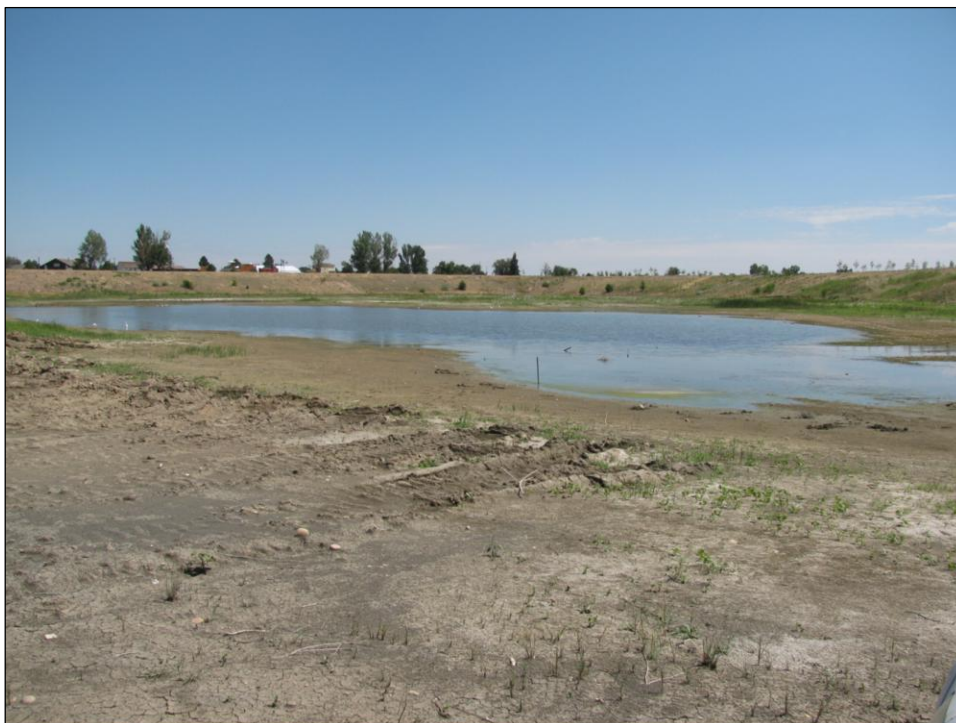
POND 2, LAKE 2

Measurements were performed on a weekly basis, as well as after major precipitation events by Tetra Tech personnel. Photos of Pond #2 and the trench are provided on Figure 5. The last measurements were made July 17, 2012.

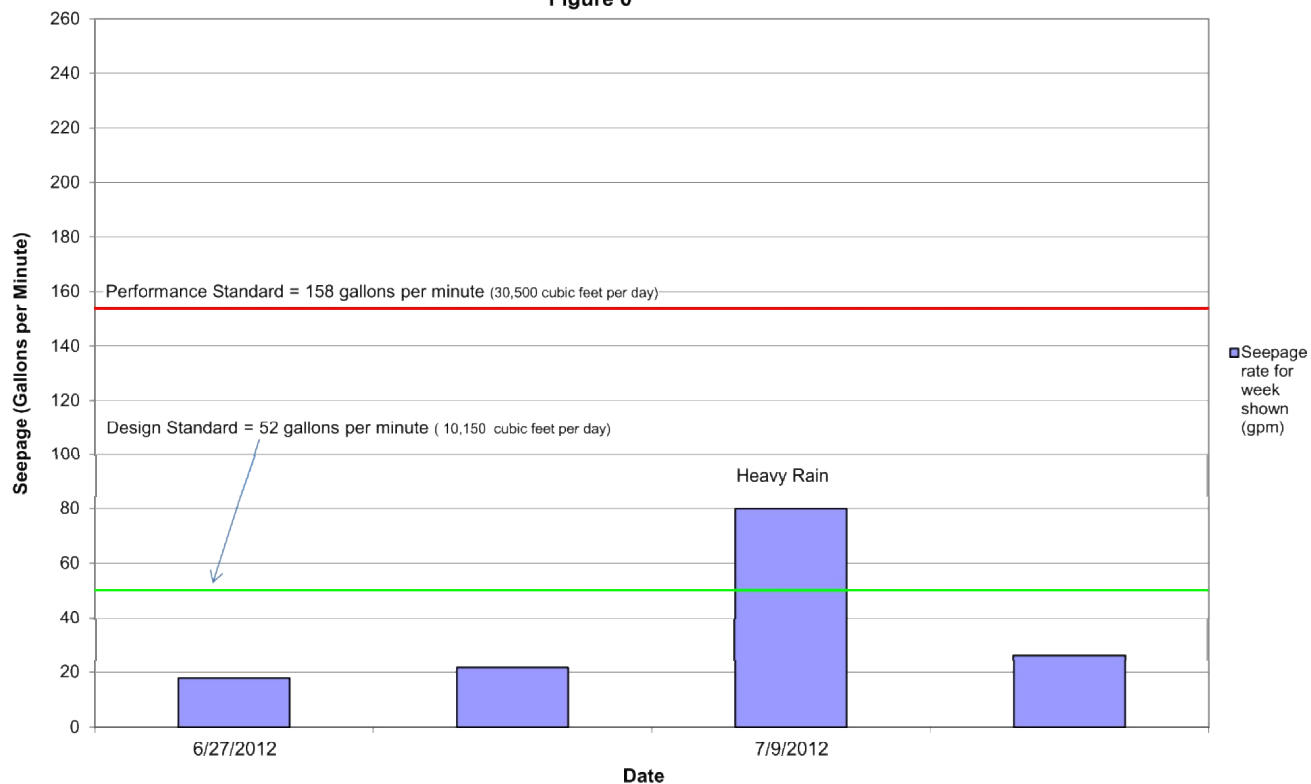
FIG 6

Calculated seepage into the pits typically ranged from approximately 3,438 to 15,386 cubic feet per day (17.9 to 79.9 gpm) for Lake #2. The high value is skewed due to heavy rainfall. Table one lists the total calculated seepage for each measurement and Figure 6 graphically illustrates the total calculated seepage compared to the maximum allowable seepage for the design and performance standards. Appendix B contains the weather data and the calculations for each pond. Electronic versions in spread sheet format are provided in the pocket.

Calculated seepage into Mann Lakes, Lake #2 ranged from approximately 3,438 cubic feet per day (17.9 gpm) to 15,386 cubic feet per day (79.9 gpm). Based on observation of the slope liner breach repair and measurements from the leak tests, it is our opinion that the slope liner for Mann Lakes, Lake #2 continue to meet the design seepage standards of the State Engineer.
