COLORADO DIVISION OF RECLAMATION, MINING AND SAFETY
MINERALS PROGRAM INSPECTION REPORT
PHONE: (303) 866-3567

MINE NAME: Speer Mining Resource	MINE/PROSPECTING ID#: M-1983-176	MINERAL: Gravel	COUNTY: Adams
INSPECTION TYPE: Monitoring	INSPECTOR(S): Tom Kaldenbach	INSP. DATE: November 20, 2013	INSP. TIME: 10:00
OPERATOR: Asphalt Specialties Co., Inc.	OPERATOR REPRESENTATIVE: Rob Laird	TYPE OF OPERATION: 112c - Construction Regular Operation

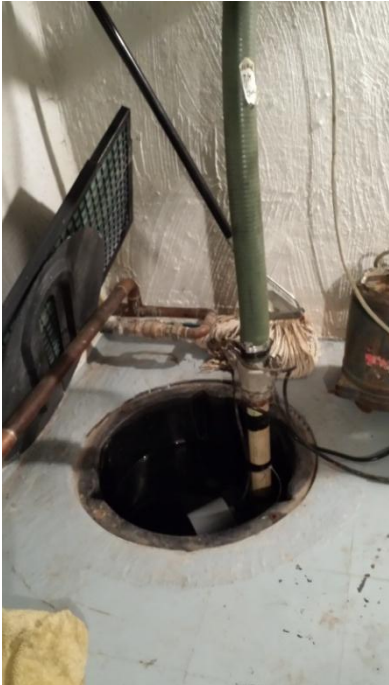
Mr. Kirby was present during the portion of the inspection at his home. He explained that he has had to continuously pump water from a sump in his basement since September 2013 in order to prevent flooding of the basement (pumping had also been necessary at various times in past years, and the Board found the Speer Mining operator in violation in 2009 for failure to prevent flooding of the basement). The homeowner's pumping rate appeared during this inspection to be roughly 10 gallons per minute, based on a visual estimate of the pumped water being discharged onto the ground in the yard of the house. The pump was approximately 5 feet lower in elevation than the land surface outside the basement, as seen through a window in the basement. There was no other evidence of flooding seen at the home.

Photo 1 – Sump pump in the basement of Mr. Kirby's house.

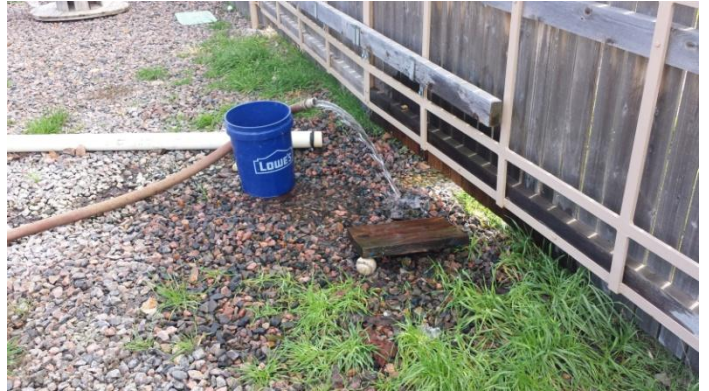
Photo 2 – Sump pump discharge in the yard of Mr. Kirby's house.

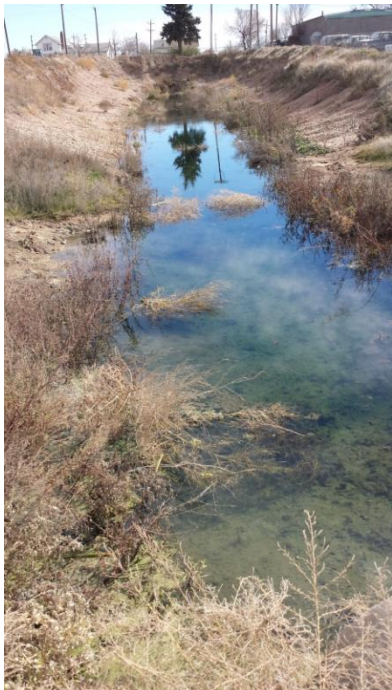
During the inspection, water movement was barely detectable throughout the length of the trench. The operator's representative explained that inflows of groundwater into the pits and the lake on the mine site significantly increased in mid-September, following the extensive rains that caused flooding in much of the South Platte basin. He explained that the mine would take whatever action is necessary (for example pumping or work on the trench and the lake) to significantly increase flow through the trench and out of the lake so that groundwater does not mound upgradient from the site. He also explained that he would step-up cooperative efforts with the homeowner to prevent flooding impacts at the home. DRMS will follow-up with the operator to verify positive drainage through the Speer Resource site has been adequately restored.

Photo 3 – Trench on Speer Mining Resource site.

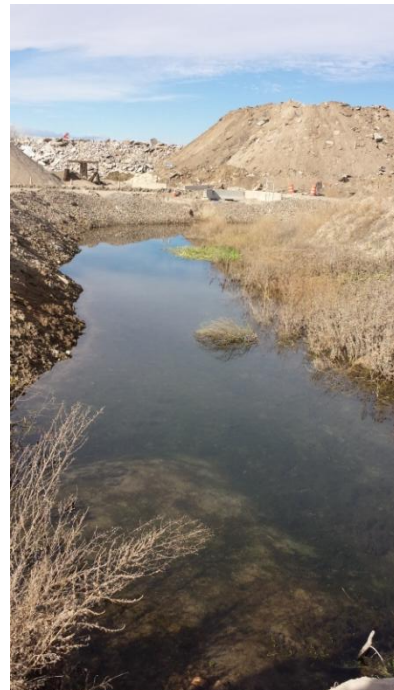
Photo 4 – Trench downstream from location of Photo 3.

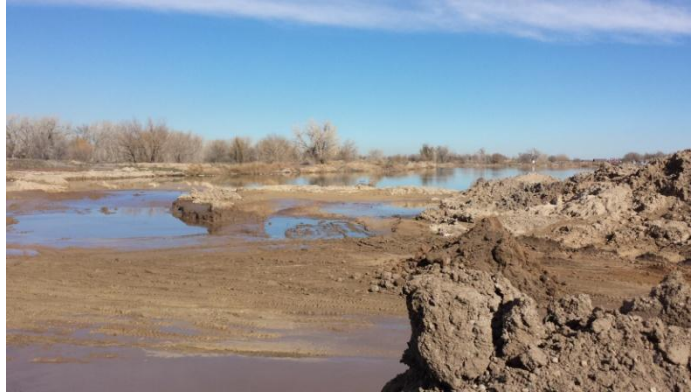
Photo 5 – Area where trench (in foreground) flows into pit lake (in background). Water from lake is pumped into South Platte River at location in distance in right-center of photo.
