**COLORADO DIVISION OF RECLAMATION, MINING AND SAFETY**  
**MINERALS PROGRAM INSPECTION REPORT**  
**PHONE: (303) 866-3567**

<b>MINE NAME:</b> Debetz Pit	<b>MINE/PROSPECTING ID#:</b> M-1977-283	<b>MINERAL:</b> Sand and gravel	<b>COUNTY:</b> Adams
<b>INSPECTION TYPE:</b> Monitoring	<b>INSPECTOR(S):</b> Tyler V. O'Donnell	<b>INSP. DATE:</b> April 23, 2014	<b>INSP. TIME:</b> 09:00
<b>OPERATOR:</b> Adams County	<b>OPERATOR REPRESENTATIVE:</b> Craig Tessmer, Kurt Carlson, and Marc Pedrucci	<b>TYPE OF OPERATION:</b> 112c - Construction Regular Operation

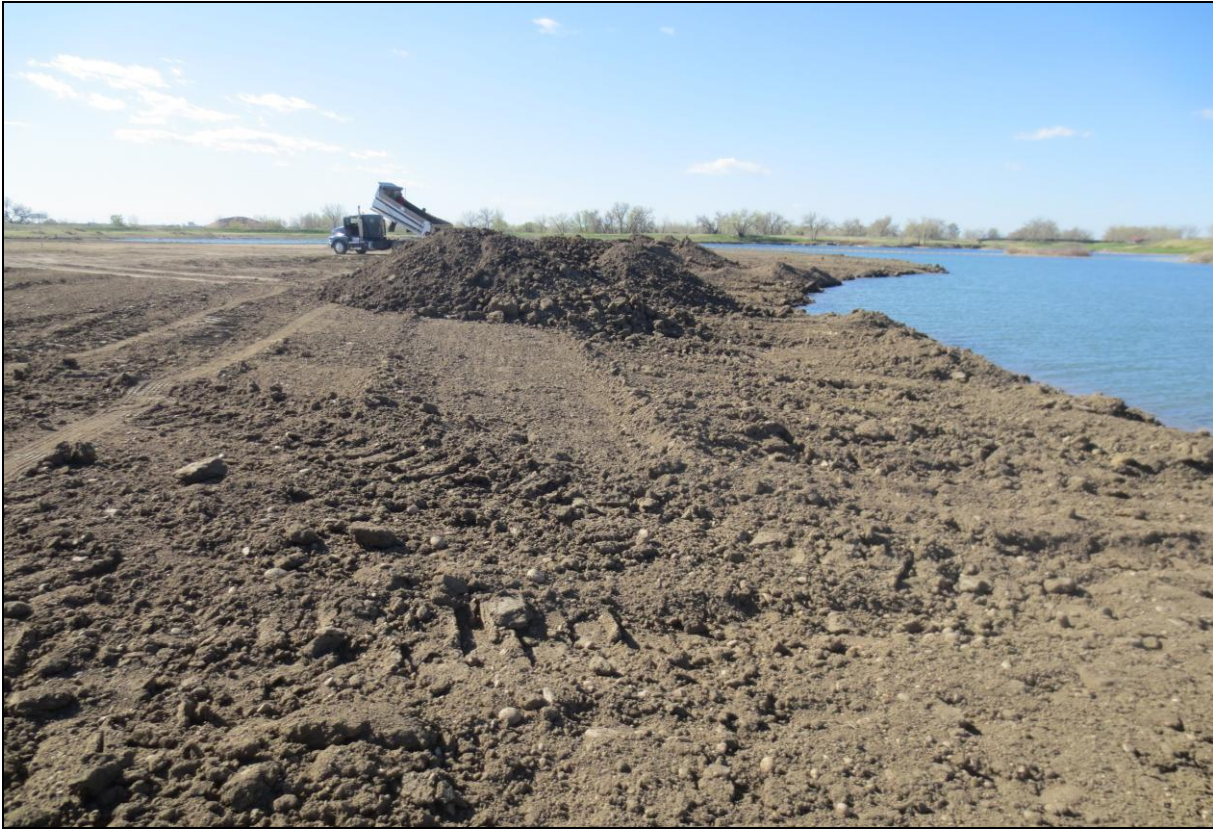
The sky was clear during the inspection. During the inspection dumb trucks were observed importing fill material and stockpiling material near the shoreline. The Operator also had a medium size bull dozer on site, however the dozer was not operational during the inspection. The Operator's representative stated the dozer is used to push the imported fill into the pond. The Operator's representative stated that roughly 35,000 cubic yards had been backfilled into the pond. The 35,000 cubic yards covered approximately 3 acres of exposed groundwater. The Operator intends to backfill 6 acres or more of exposed groundwater. The Operator intends to complete reclamation by winter of 2015. No problems or violations were noted during the inspection.

**Photo 1:** Dump truck placing inert fill in the northern portion of the site.

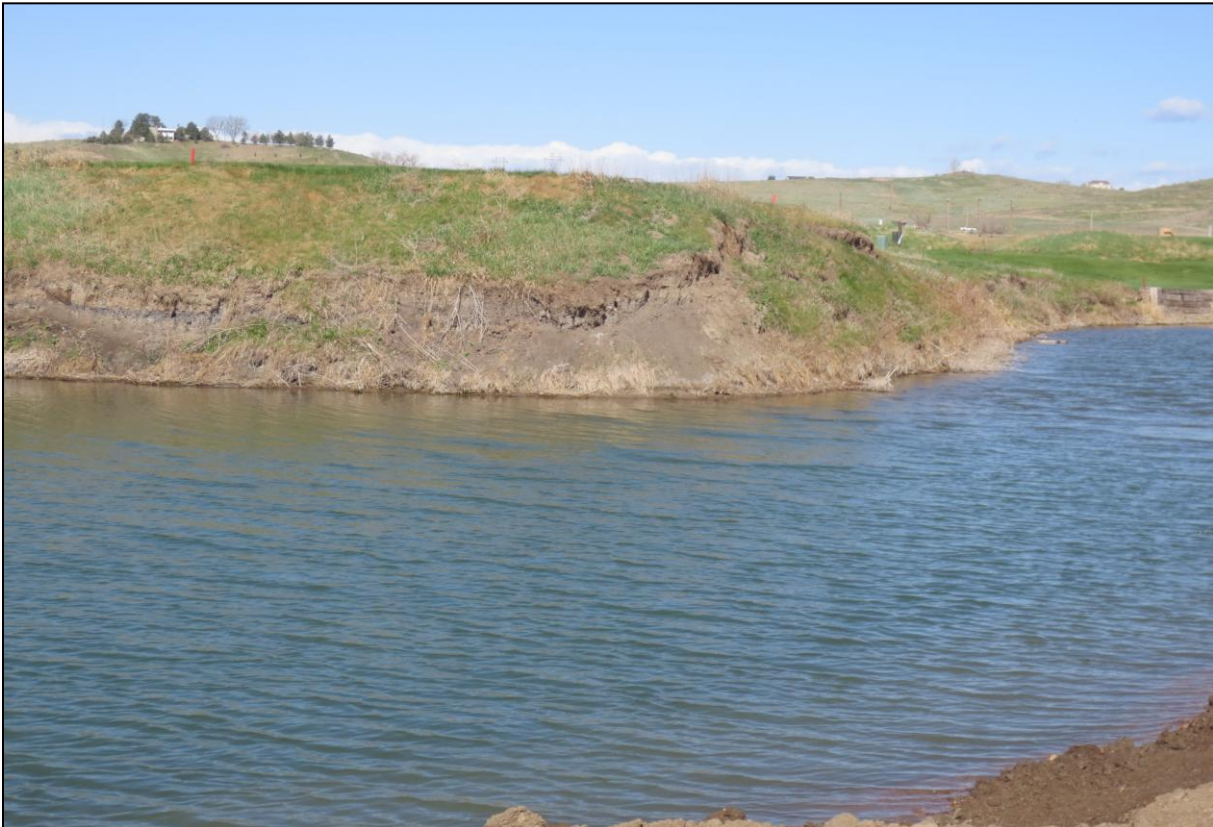
There were areas where the Operator had backfilled and graded slopes to 3H:1V or flatter. There were areas along the western permit boundary where a retaining wall had been constructed along the golf course. The retaining wall was near vertical. Portions of the southern lake shore had slopes that were near vertical 1H:1V. Slopes along the southern edge of the pond will need to be re-graded to 3H:1V. The Operator is advised to submit a technical revision and provide an updated reclamation plan and reclamation plan map describing how the slopes of the pond will be re-graded/stabilized along edge of the golf course.

**Photo 2:** Unstable slope along the shoreline of the golf course. The Operator will need to stabilize and establish vegetation on the slope.

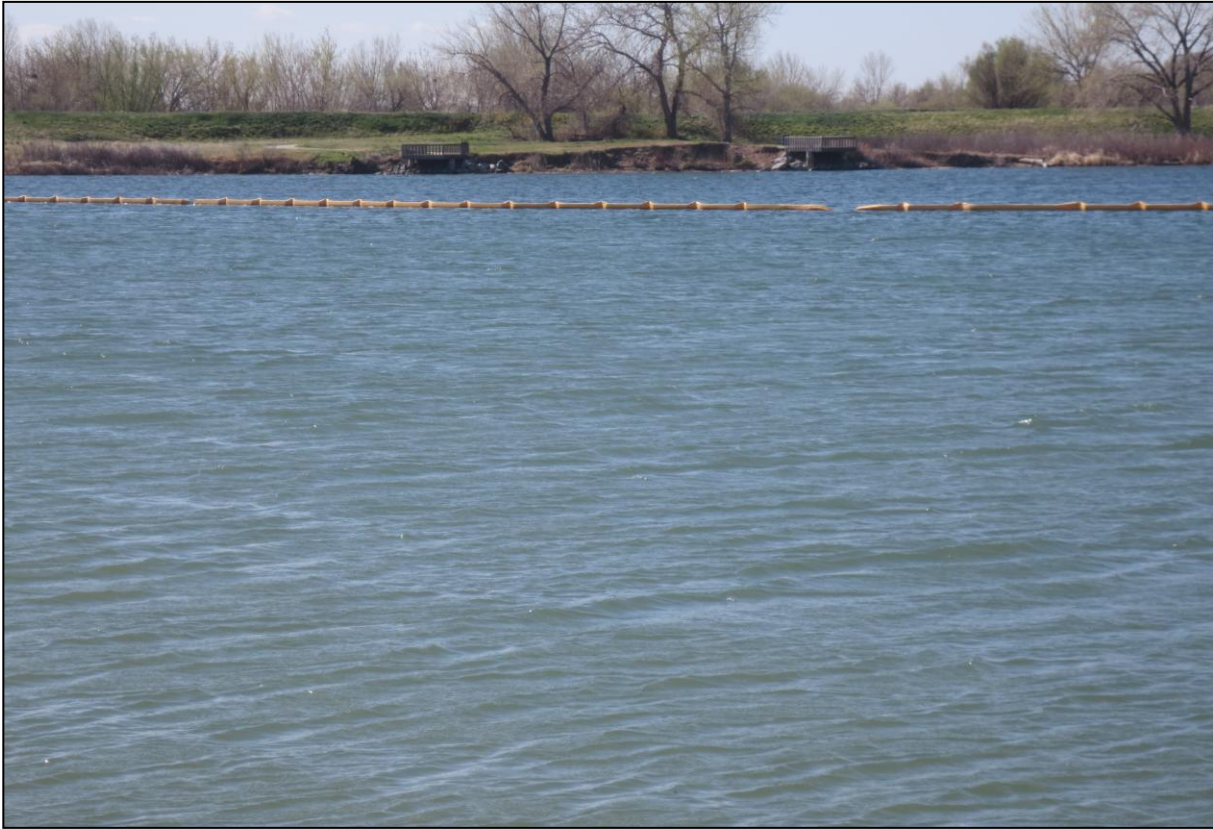
There was no evidence of excessive erosion (rills, gullies, or sediment fans). The Operator had installed a turbidity curtain to prevent damaging to the fish population and ecosystem in the parts of the lake that are not being backfilled. The Operator's installation of the turbidity curtain is commendable.

**Photo 3:** Turbidity curtain in the foreground. Slopes in the background that will need to be re-graded to 3H:1V.

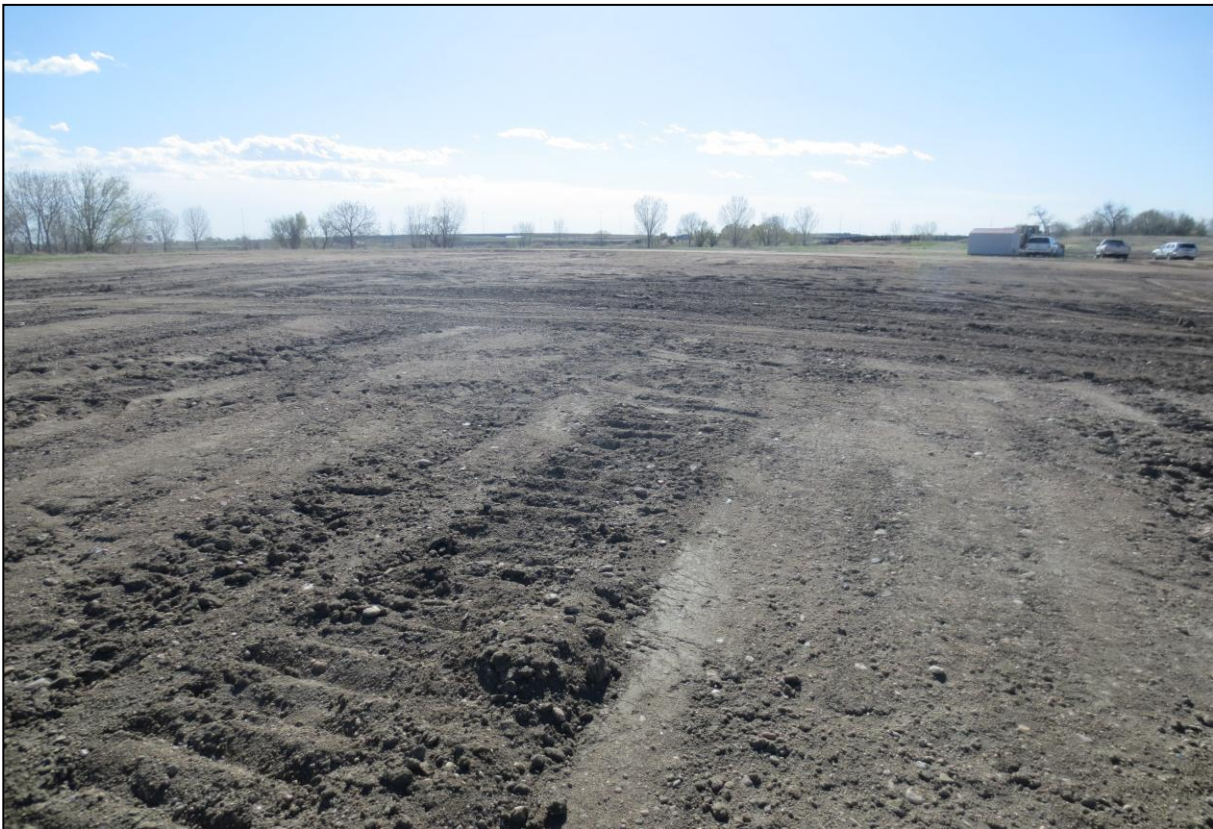
All activity appeared to be within the approved permit boundary. The Operator is conducting backfilling operations as approved in TR-01.

**Photo 4:** Northern portion of the pit that has been re-graded after inter fill has been placed.

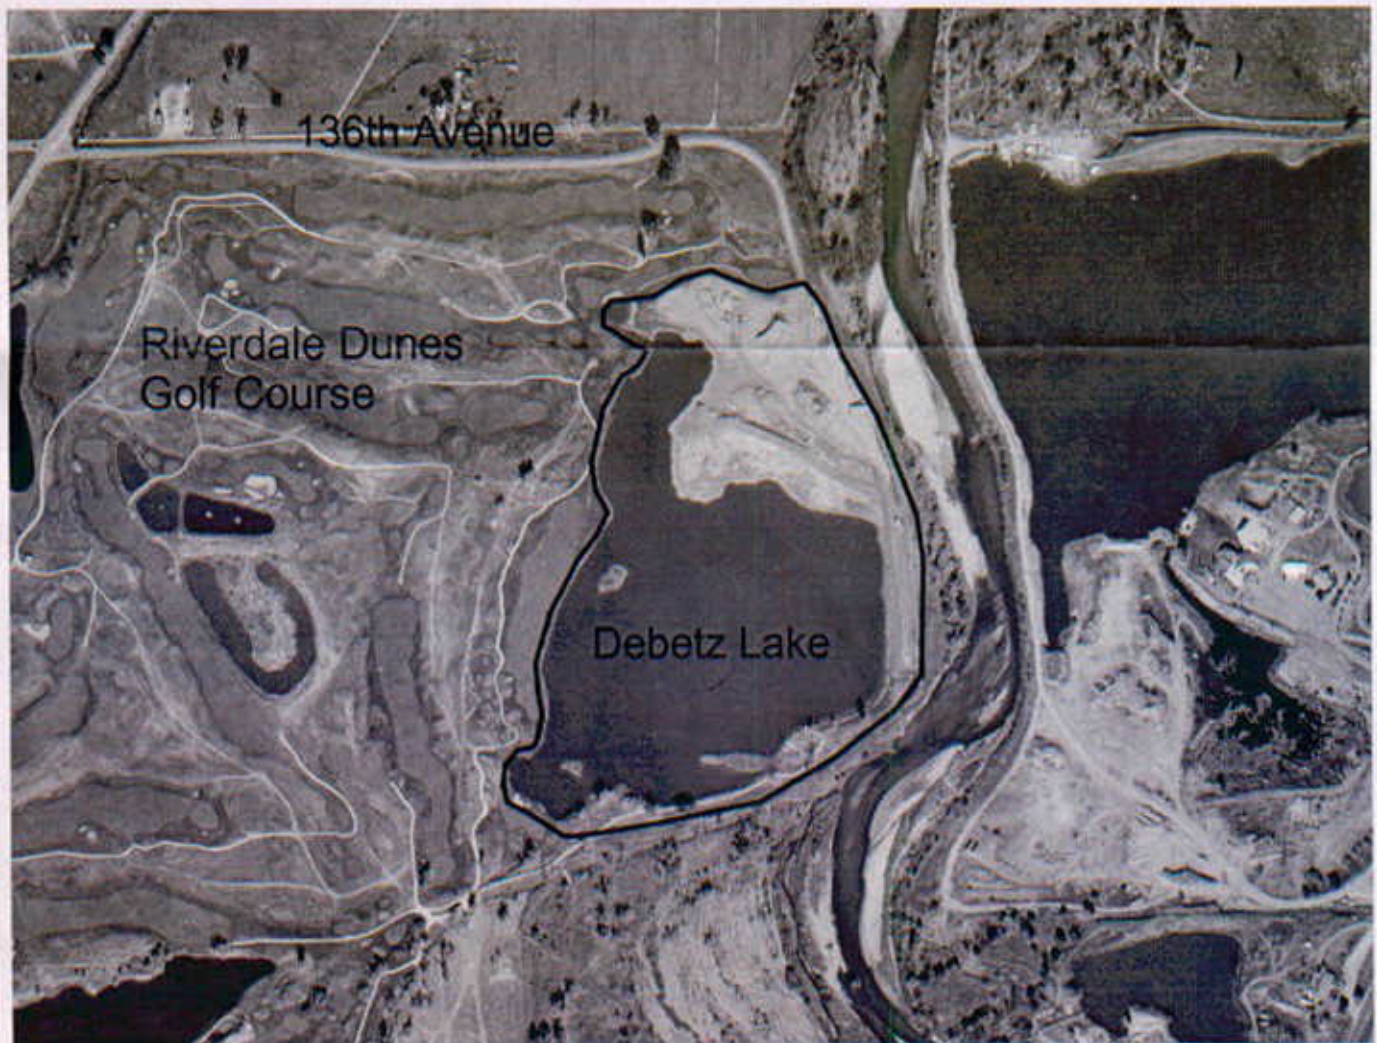
## Current Mining Permit Boundary

During the inspection there was some confusion about where the Approved permit boundary was located; the Division has attached a copy of the last reclamation plan map with the approved permit boundary.

This map is being submitted to clearly delineate the current mining permit boundary for Debetz Pit. This includes the disturbed area northeast of the lake, as well as all of the shoreline of the lake.
