COLORADO DIVISION OF RECLAMATION, MINING AND SAFETY
MINERALS PROGRAM INSPECTION REPORT
PHONE: (303) 866-3567

MINE NAME: Nyholt Pit (aka Mann)	MINE/PROSPECTING ID#: M-1982-147	MINERAL: Sand and gravel	COUNTY: Adams
INSPECTION TYPE: Monitoring	INSPECTOR(S): Tyler V. O'Donnell	INSP. DATE: April 23, 2014	INSP. TIME: 10:00
OPERATOR: Adams County	OPERATOR REPRESENTATIVE: Craig Tessmer, Kurt Carlson, and Marc Pedrucci	TYPE OF OPERATION: 112c - Construction Regular Operation

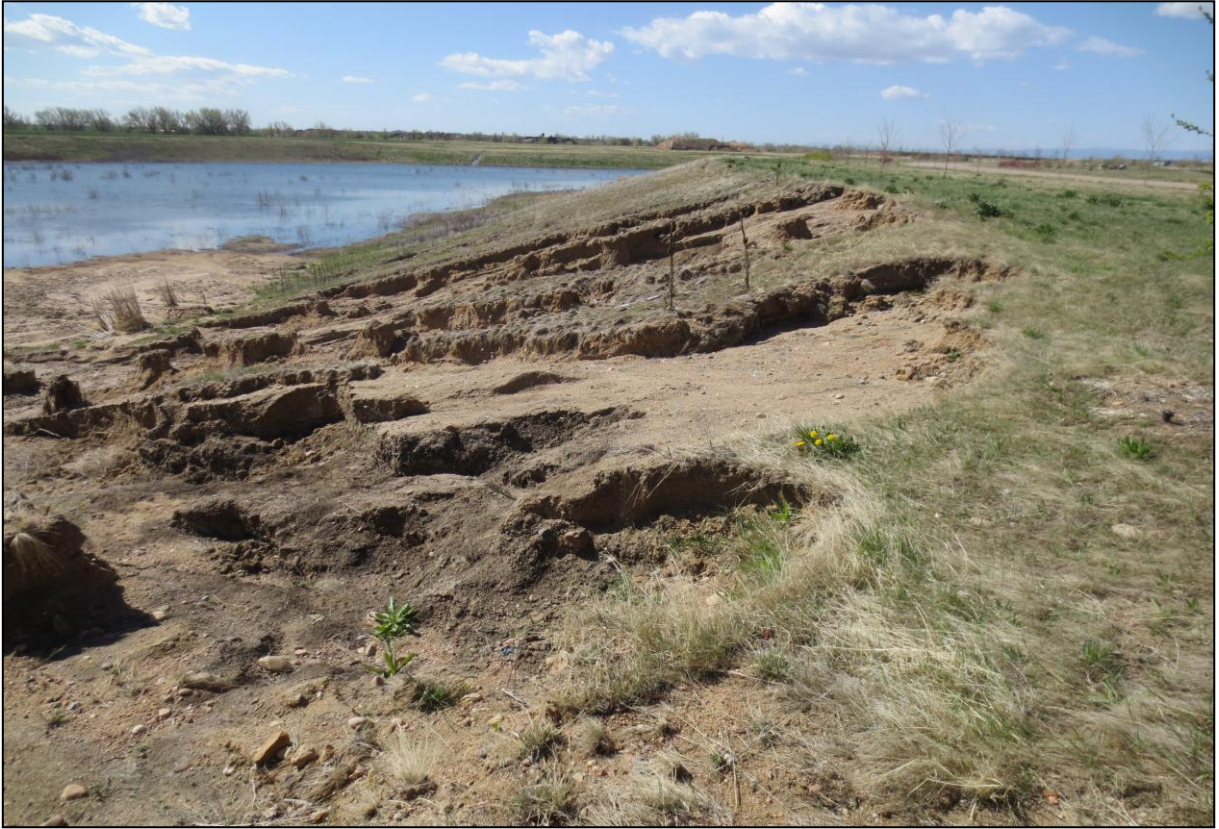
Portions of Lake 1 slopes have been damaged by erosion. The northwest corner of Lake 1 was damaged by water that over topped the dewatering trench and ran down the pit slope. The water that flowed from the dewatering trench created large gullies in the pit slope (see photo 1 and 2). The segment of damaged pit slope is approximately 150 feet long. It appears that the compacted clay liner could have been damaged in the northwest corner of the pit. The northeast corner of Lake 1 was also damaged by water flowing either from the dewatering trench or from the South Platte River. A gully formed near the spillway in the northeast corner of Lake 1. The riprap structure failed which allowed the gully to down cut further into Lake 1. In the northwest and northeast corners of Lake 1 portions of the compacted clay liner were visible at the surface. No seeps or damp spots were observed, however it is unclear if the gullies compressed the compacted clay liner in either location. The Division would request that the Operator provide an engineering analysis demonstrating that the liners have not been comprised and don't require a SEO's leak test. The Operator's representative explained that there is potential that the northwest and northeast slopes will be reconstructed and armored. The Operator will need to submit a technical revision to revise the reclamation plan and the reclamation plan map if the Operator chooses to add armoring to the northwest corner and/or additional armoring in the northeast corner.

Photo 1: Northwest corner of Lake 1 was damaged by water that over topped the dewatering trench.

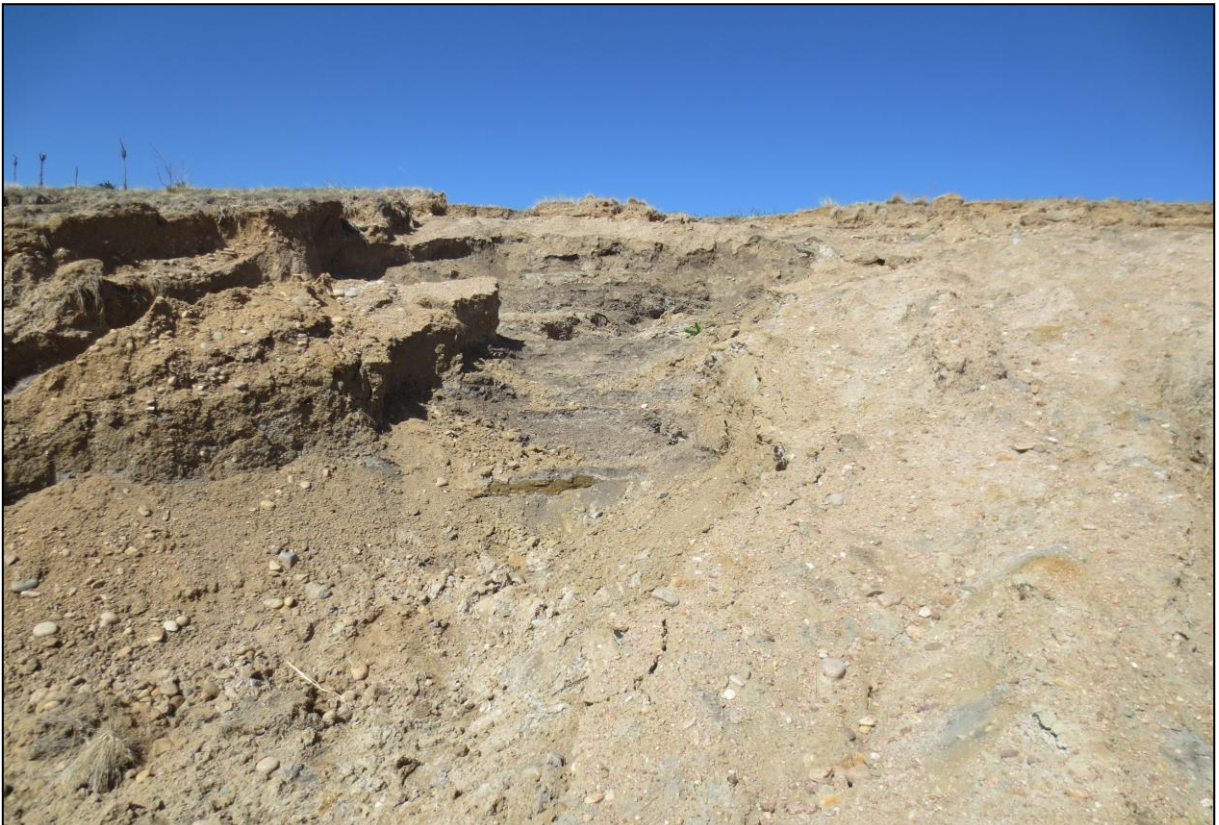
Photo 2: Gully in the northwest corner of Lake 1.

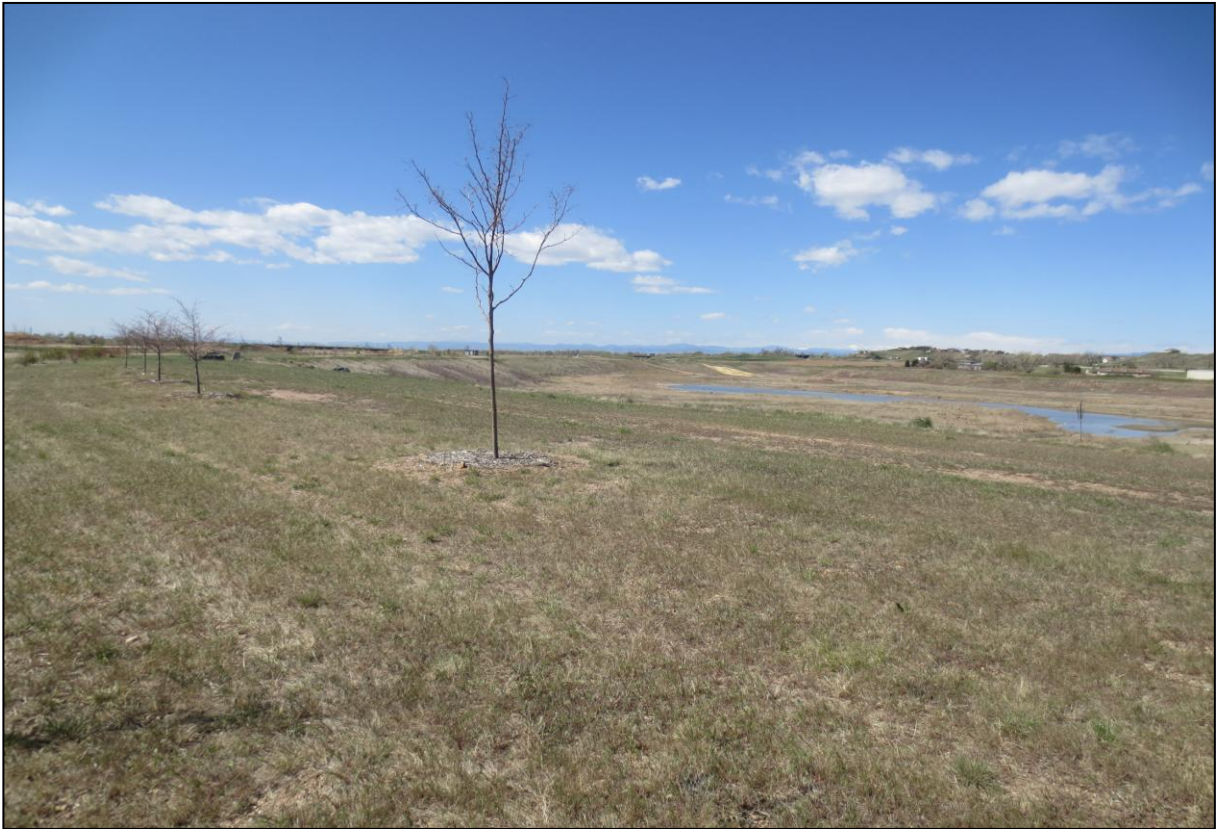
Based on visual estimate of the amount of standing vegetation observed around the majority of the permitted site, lives vegetative cover within the permitted area can be expected to be more than 40% excluding the location of the stockpiles between lakes 1 and 3. The cover included a variety of life forms and species. Herbaceous species included: Switchgrass, Blue Grama, Neddle and Thread, Sandreed, Slender Wheatgrass and Side Oats Grama. Sunflowers, and various forbs, are scattered on the site. The Operator had planted trees along the access road and around the lakes. The mix of vegetation on the site can be expected to provide self-generating forage for wildlife. Vegetation within the permit area was at least as well established as that on the surrounding area.

Photo 3: Revegetated area near the northeast corner of lake #2.

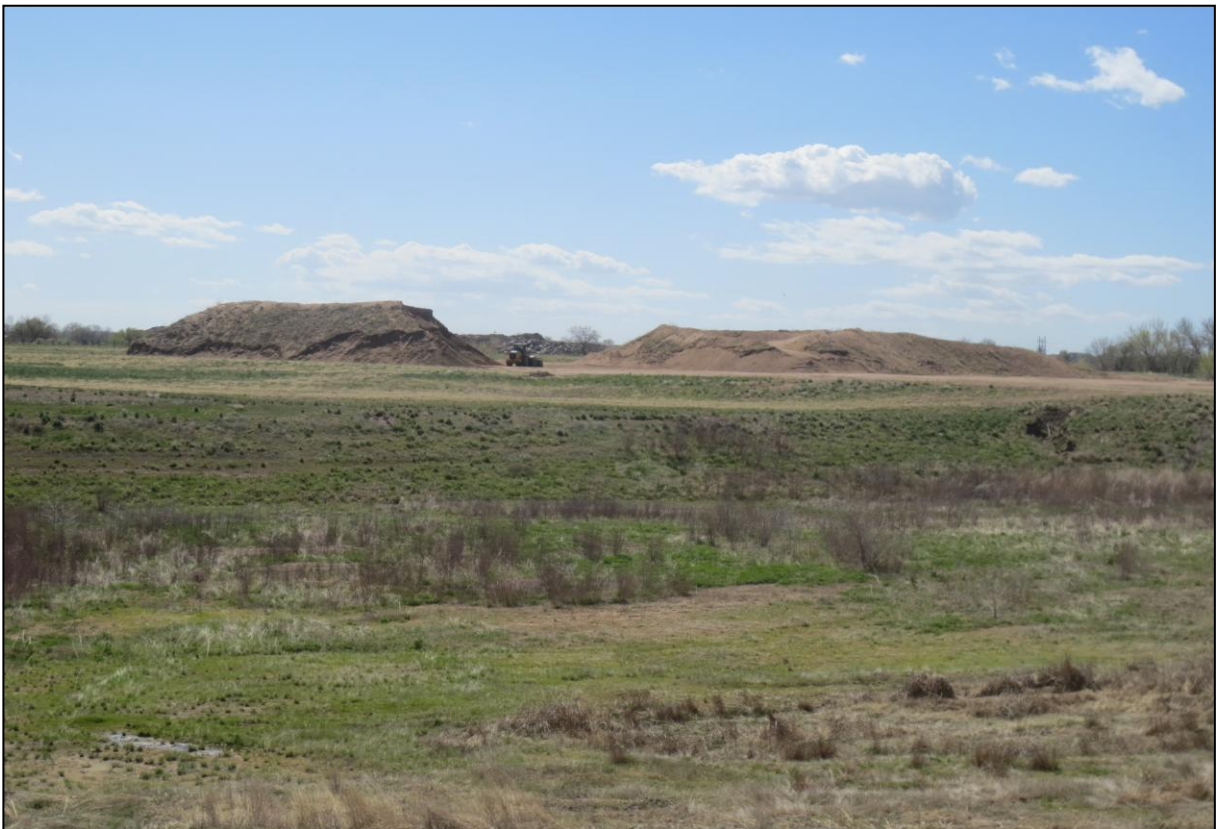
Photo 4: Product stockpiles between lakes 1 and 3.

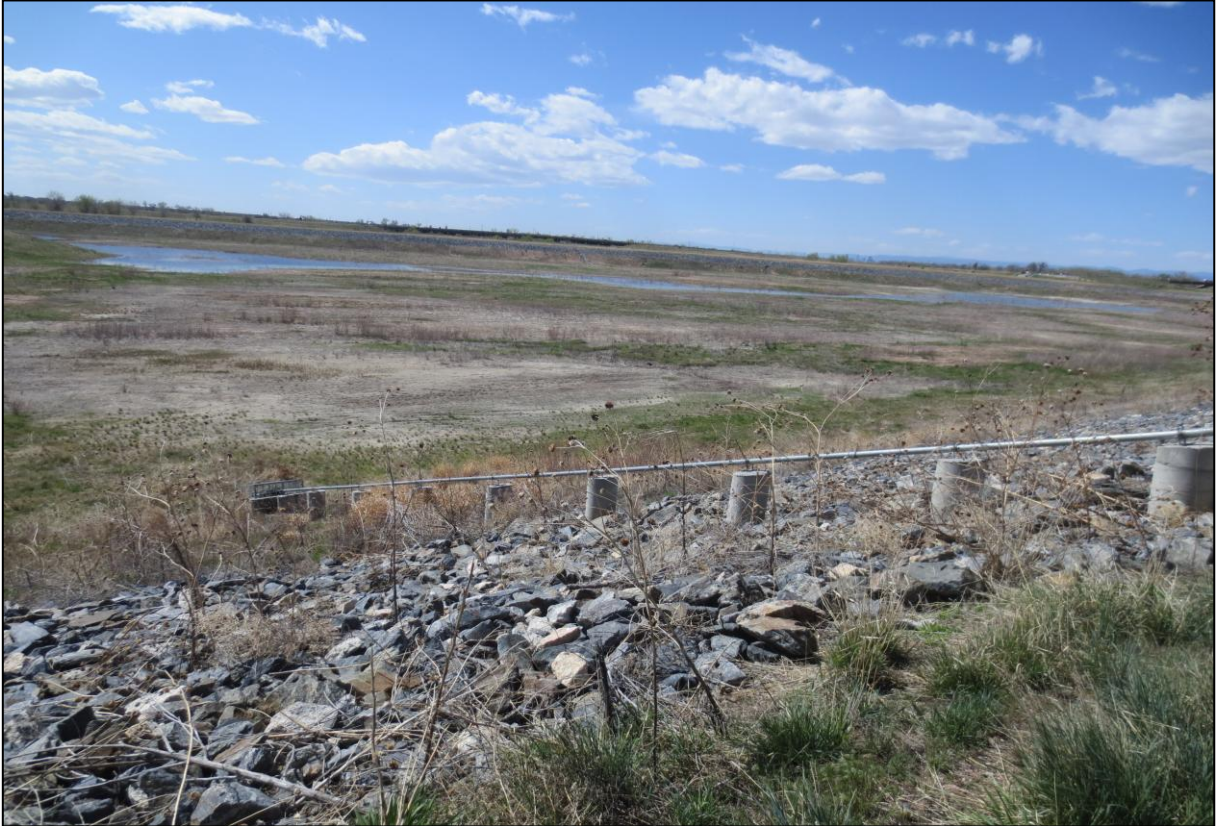
On June 23, 2010 the Operator submitted Technical Revision TR-03 which proved a revised interconnecting pipe design. TR-03 was approved on August 9, 2010. The Operator had completed construction of the interconnecting pipes between reservoirs 1, 2, and 3. The Operator constructed a large buttress in Lake 2 to tie the pipe back into the compacted clay liner. The Operator's representative stated that they are in the process of doing the required leak test with the State Engineer's Office (SEO). Please provide the Division with the results of the SEO's leak test.

Photo 5: View into Lake 3, interconnecting pipe which is connected to lake 2.

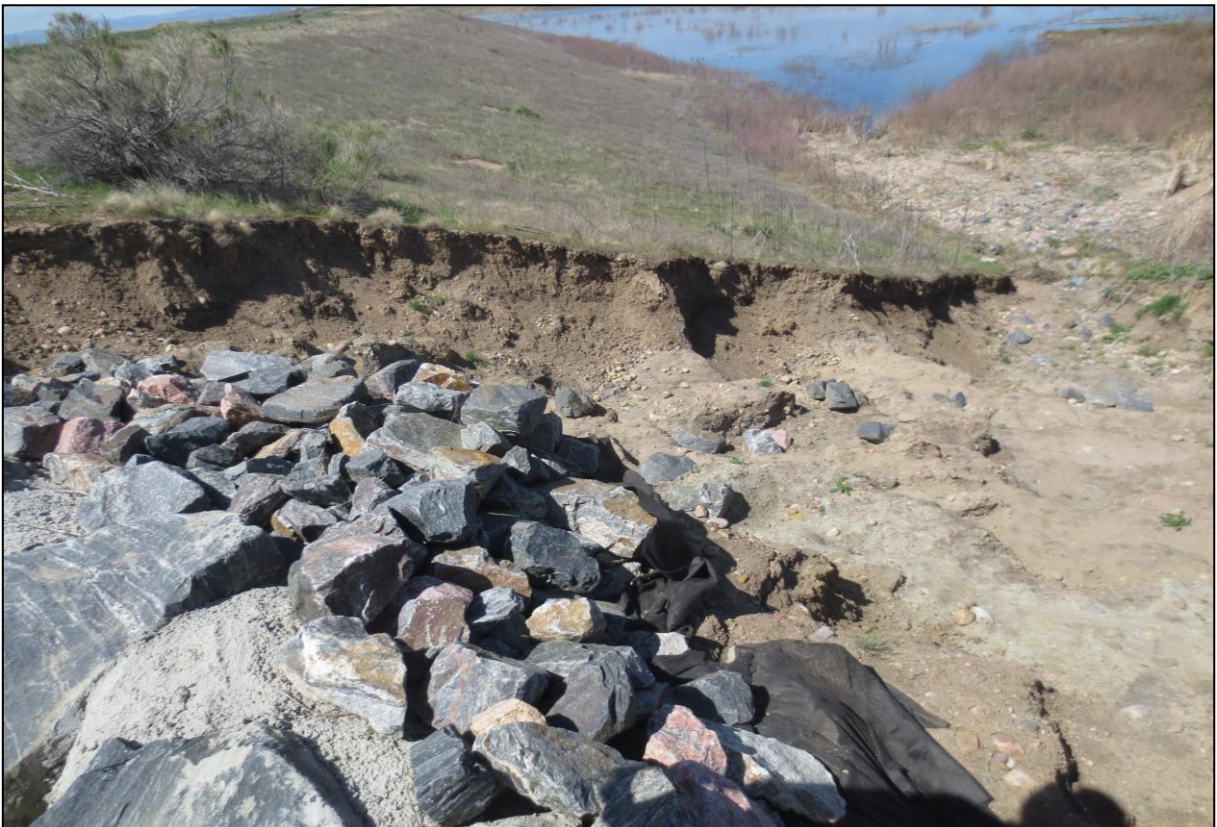
Photo 6: Spillway in the northeast corner of Lake 1, which was damaged by water flowing into the pit.
