**COLORADO DIVISION OF RECLAMATION, MINING AND SAFETY**  
**MINERALS PROGRAM INSPECTION REPORT**  
**PHONE: (303) 866-3567**

| <b>MINE NAME:</b><br>Pueblo East Pit | <b>MINE/PROSPECTING ID#:</b><br>M-1986-015 | <b>MINERAL:</b><br>Sand and gravel | <b>COUNTY:</b><br>Pueblo |

**Re: Summary of Soils Investigation 5-13-14: Cooper Property/M-1986-015**

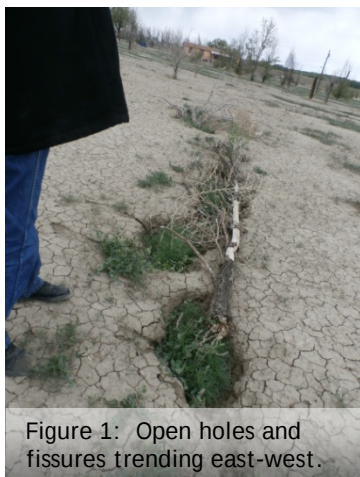
Multiple open fissures and open holes were noted on the property, both around the residence and in the open land south and west of the residence. The openings appear to trend generally east-west, as does the vegetation (trees and weed growth) on the site. A secondary set of cracks were noted trending north-south across the property in several locations. Ms. Cooper's family has owned the land since the 1970s. Ms. Cooper stated that the land had historically been irrigated until about 10 years ago (~2004) and that she started to notice the openings appearing about 3-4 years ago (~2010/2011 - present).

Figure 1: Open holes and fissures trending east-west.

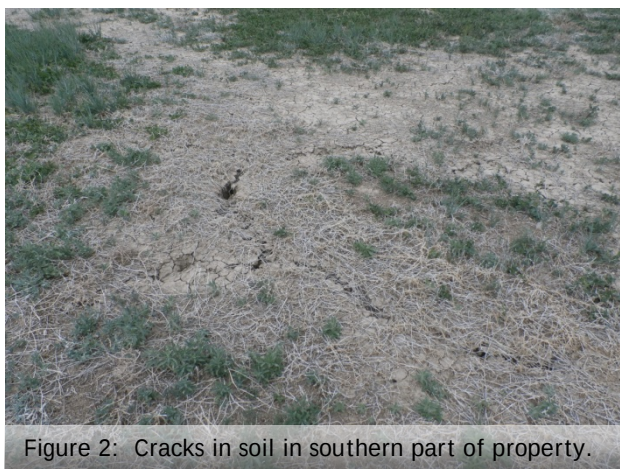
Figure 2: Cracks in soil in southern part of property.

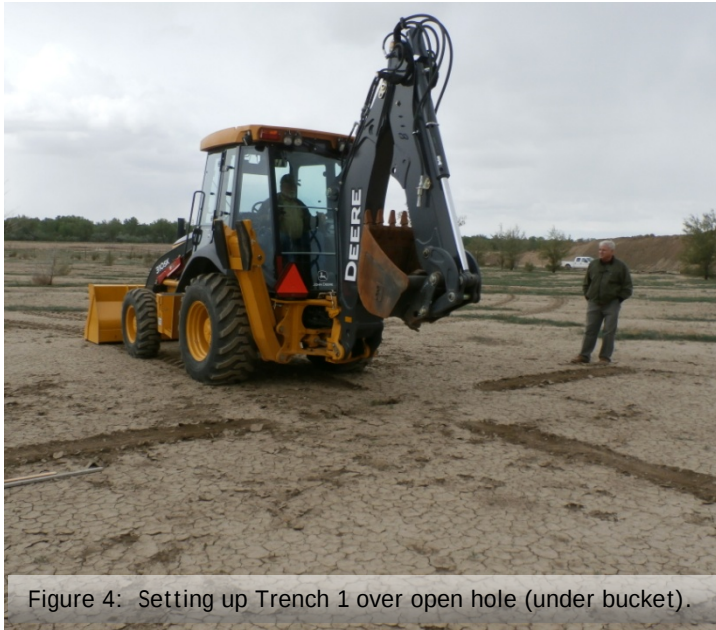
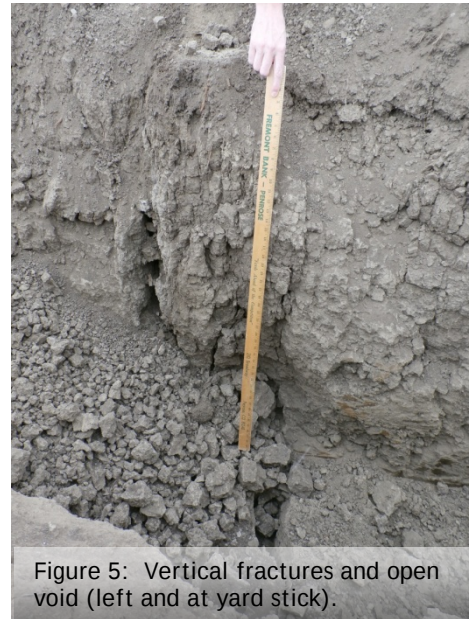
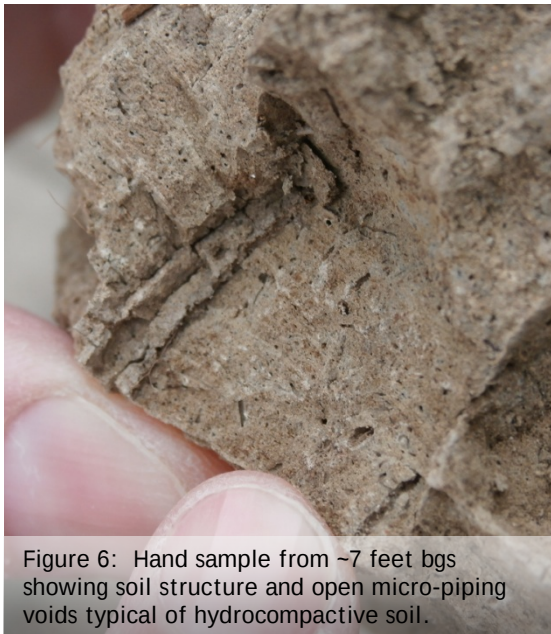
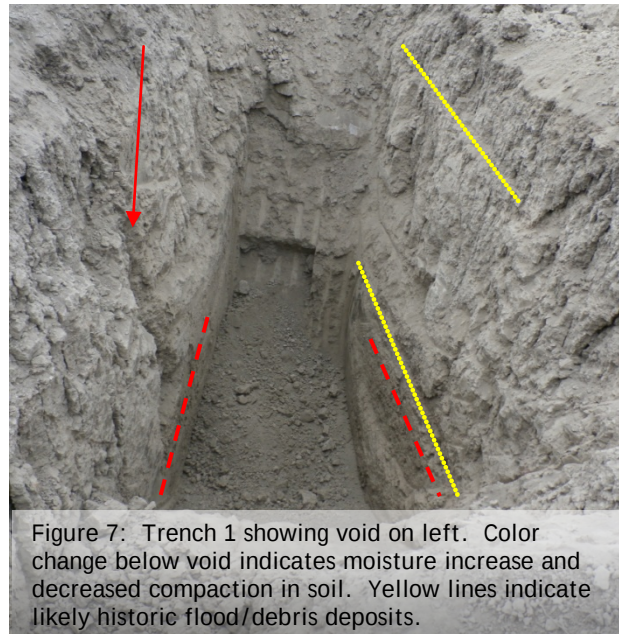
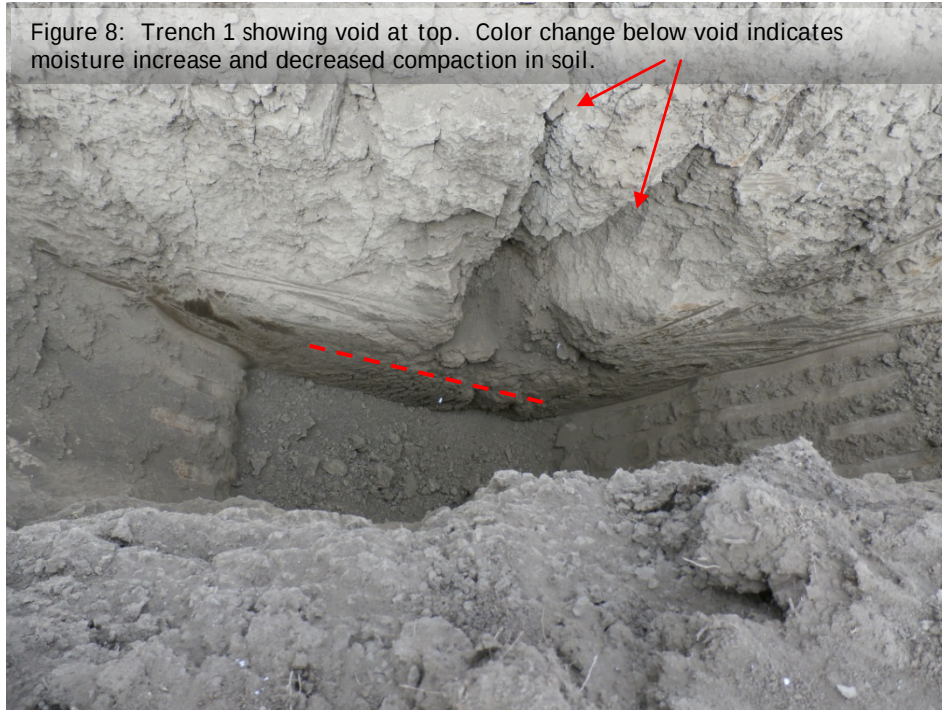
Trench 1. The open hole observed at the surface was excavated to a depth of approximately 7 feet bgs. The top 2 feet of soil was loose clayey silts and easily excavated. Below about 2 feet, the soil was stiffer, with greater clay content, and hard. The subsurface clay was compacted to the point that the excavator had some difficulty keeping the foot pads from dragging. Vertical fracture patterns were observed between about 3 and 7 feet bgs. As noted above, small, discontinuous lenses of poorly sorted sands and gravels, about 2-4 inches thick were found at approximately 3 feet bgs and 6 feet bgs. The void emanating from the deep fissure observed at the surface appeared to be oriented along this vertical fracturing, with two primary open areas joining at a depth of approximately 6.5 feet bgs to an opening that was about 12-18 inches across. Below the bottom of the open void, the clay was again stiff and included classic micro-piping voids in hand samples. As soluble material is dissolved from the soils (i.e. from prolonged irrigation), voids in the soil structure are left behind. At approximately 8 feet bgs, the clay had higher moisture content and was less compact. Hand samples had high clay content and plastic deformation characteristics. Based on conversations with Transit Mix, the depth to groundwater in this area is about 20-28 feet bgs. Total depth of the trench was approximately 10.5 feet bgs.

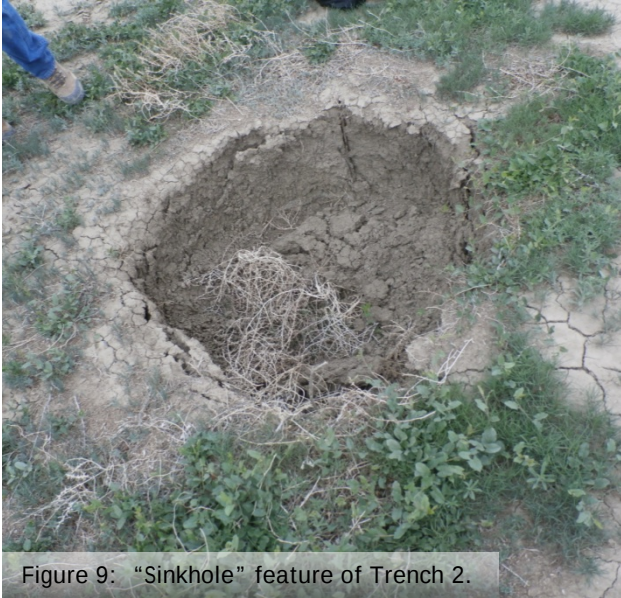
Trench 2. This trench was located over a 3-4 ft diameter, 18 inches deep “sinkhole” type opening that was in the center of a line of relatively larger openings trending east-west on the south side of Ms. Cooper’s property. Several trees and weed growth were also aligned with this location. The trench was excavated from south to north across the center of the opening. The subsurface conditions were somewhat different from those in Trench 1, primarily due to fewer vertical cracks in the hard-packed clay. As with Trench 1, the excavator had some difficulty keeping the foot pads from dragging initially, due to the compacted clay. Vertical fracturing was apparent at the boundary of the sinkhole feature, and soil was looser within the opening. Unlike Trench 1, no large open voids were observed. Wetter clay was found about 3 feet bgs in the vicinity of the opening and stayed moist to the bottom of the hole, at 8 feet bgs. Preferential root growth from weeds to a depth of 3-4 feet bgs was observed within the area of the opening.

Figure 9: "Sinkhole" feature of Trench 2.

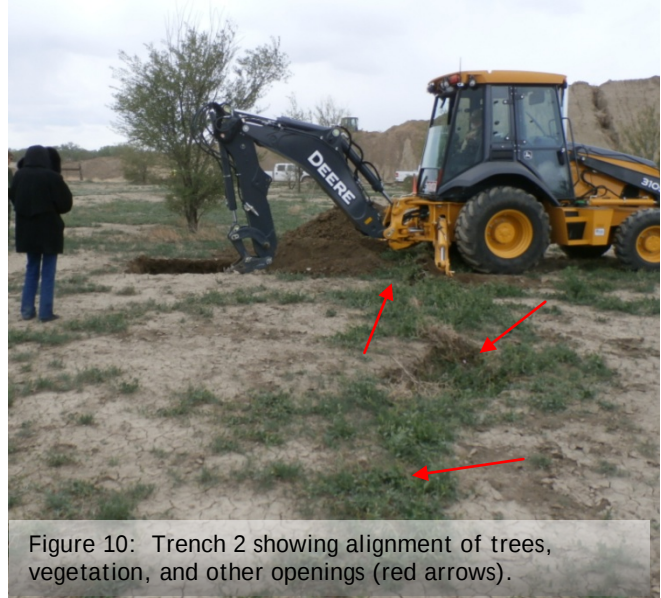
Figure 10: Trench 2 showing alignment of trees, vegetation, and other openings (red arrows).

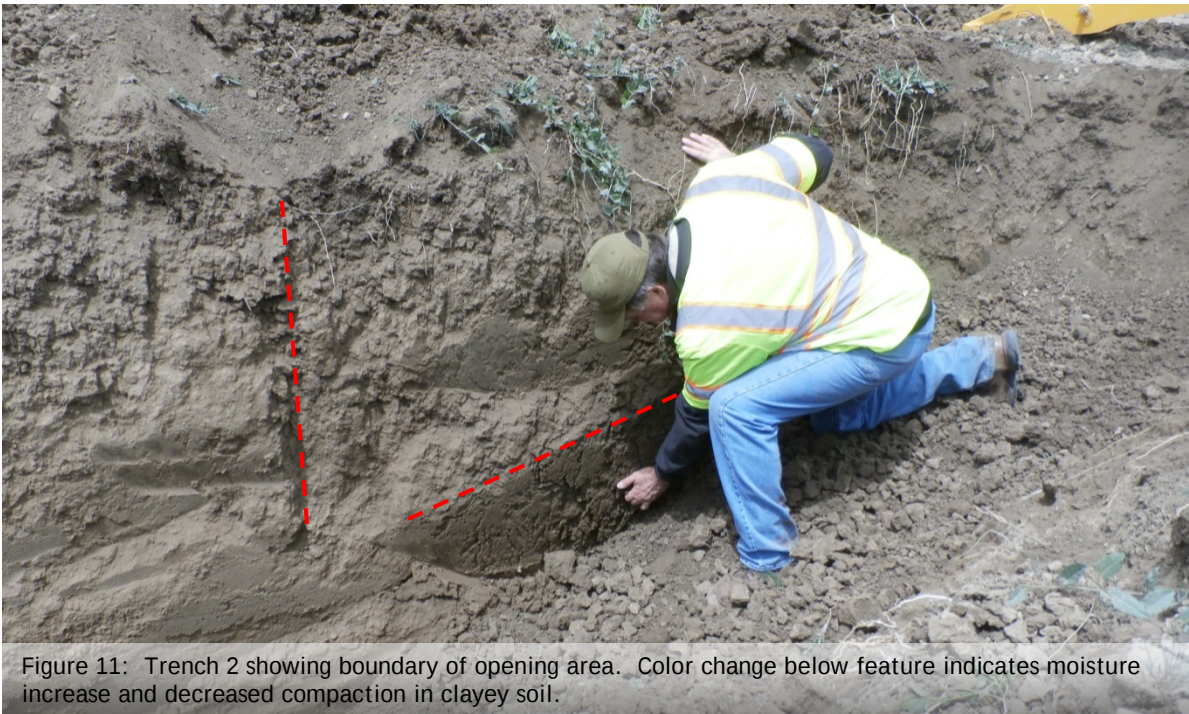
Figure 11: Trench 2 showing boundary of opening area. Color change below feature indicates moisture increase and decreased compaction in clayey soil.

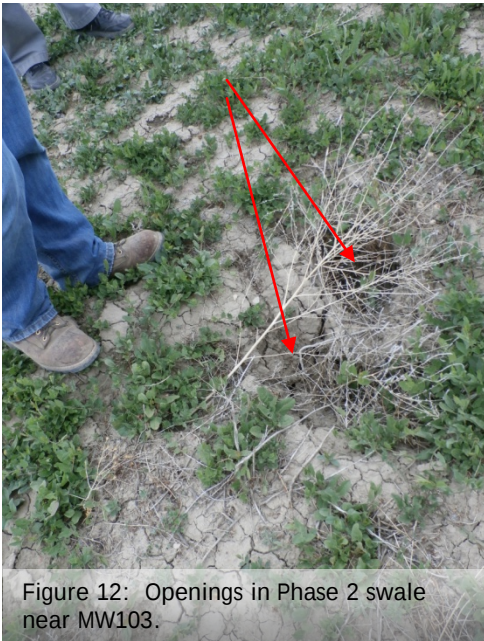
Other Features. In addition to Ms. Cooper's property, DRMS toured areas both west and east of the property to observe recent openings as noted by Transit Mix. On the northwest side of Phase 2 of the Pueblo East pit, several small openings and piping were found both in the swale north and adjacent to the slurry wall in the vicinity of MW103, and also the un-graded ground north of the swale. These features were noticed in the past couple of weeks by Transit Mix personnel.

Figure 12: Openings in Phase 2 swale near MW103.

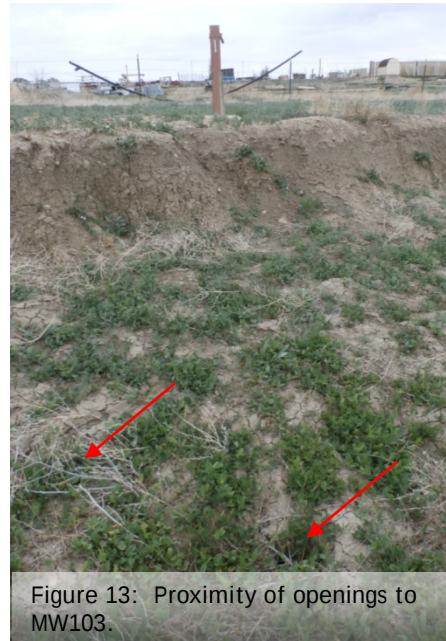
Figure 13: Proximity of openings to MW103.

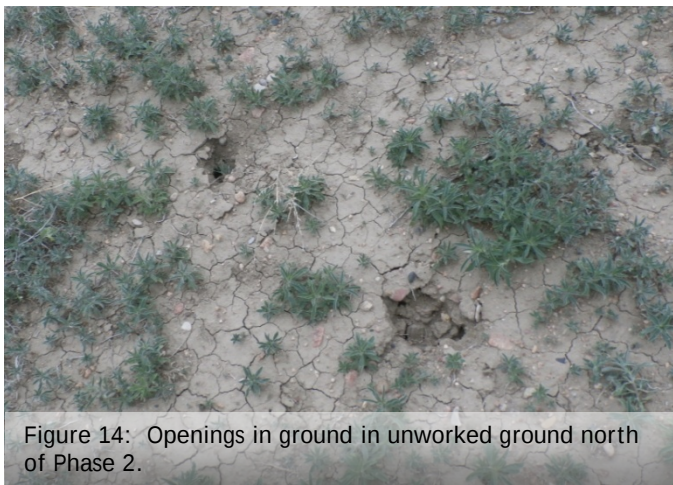
Figure 14: Openings in ground in unworked ground north of Phase 2.

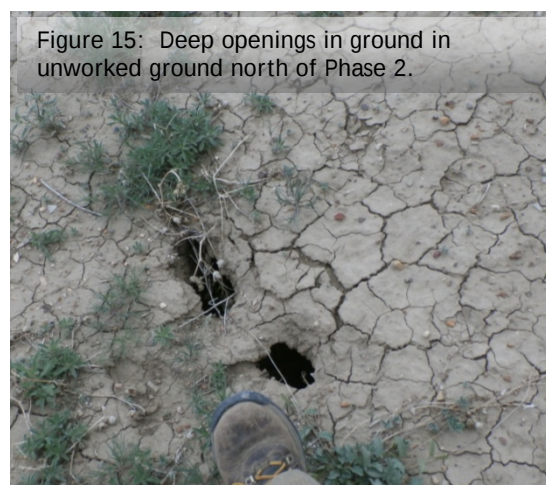
Figure 15: Deep openings in ground in unworked ground north of Phase 2.

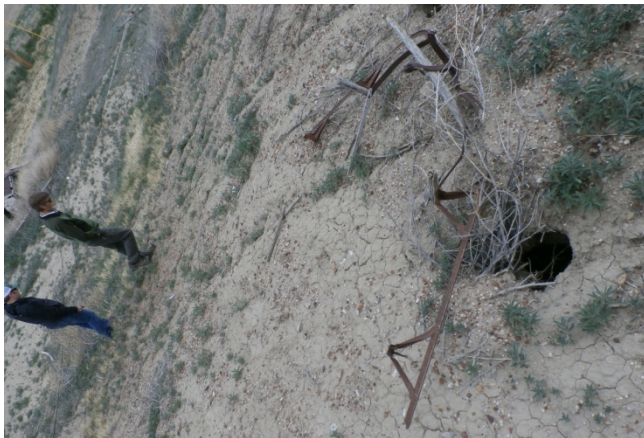
In the area northwest of Phase 1 of the Pueblo East pit, on and below the slope east of the Moore property, several openings were also observed, including piping and salt deposits on the slope. There is an old irrigation ditch that runs through this area that appears to be abandoned. The ditch was dry and full of sediment and weeds.

Figure 16: Openings in ground northwest of Phase 1.

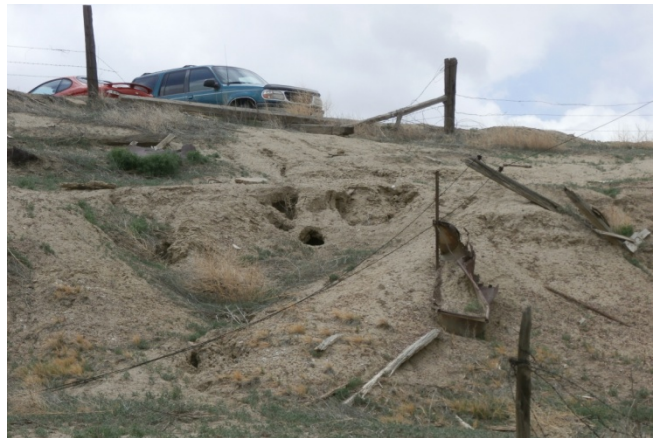
Figure 17: Openings on the slope northwest of Phase 1.
