COLORADO DIVISION OF RECLAMATION, MINING AND SAFETY
MINERALS PROGRAM INSPECTION REPORT
PHONE: (303) 866-3567

MINE NAME: Revenue Mine	MINE/PROSPECTING ID#: M-2012-032	MINERAL: Ag, Pb, Zn	COUNTY: Ouray
INSPECTION TYPE: Monitoring	INSPECTOR(S): Bob Oswald	INSP. DATE: May 20, 2014	INSP. TIME: 08:00
OPERATOR: Star Mine Operations, LLC	OPERATOR REPRESENTATIVE: John Trujillo	TYPE OF OPERATION: 112d-1 - Designated Mining Operation

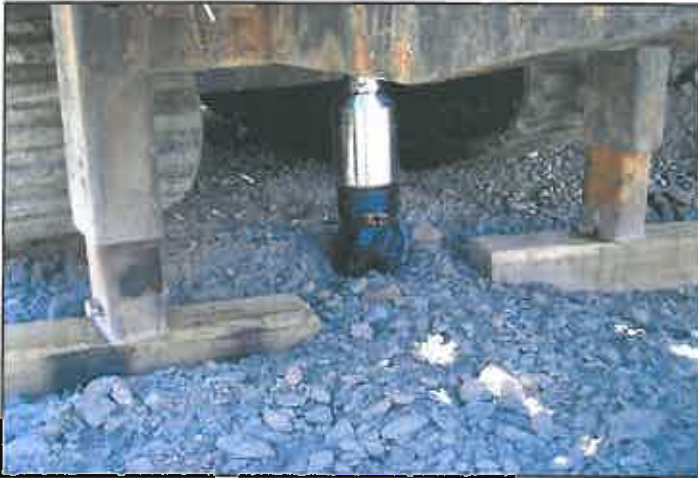
The drilling contractor was Core-One from Delta. The 4-inch diameter drill stems were steam cleaned to remove surface rust and any residual hydrocarbon lubricants. The drill bit was 10 inches in diameter. The drill hole was located about 25 feet (measured horizontally) from the edge of Sneffels Creek and over 10 feet in elevation higher than the creek. Drilling the first hole began at 11:05 am. Drill water was supplied by pumping from Sneffels Creek to the drill sump. The drill hole did not advance very well, due to the drill bit being wider than the stem, and the loose alluvium and waste rock falling back into the hole. Drilling proceeded fairly continuously until about 4:00 pm, with final depth reached only 10 feet. A different drilling method and well design were discussed as being necessary to successfully finish the six well installations. The operator and the engineering consultant will provide revised designs to the Division for review and incorporation into the EPP.

Monitoring well drill bit, 10-inch diameter

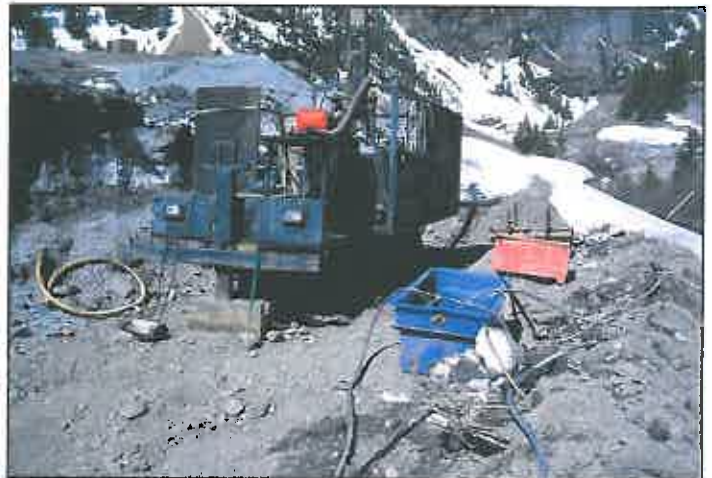
Drill rig on drill pad location

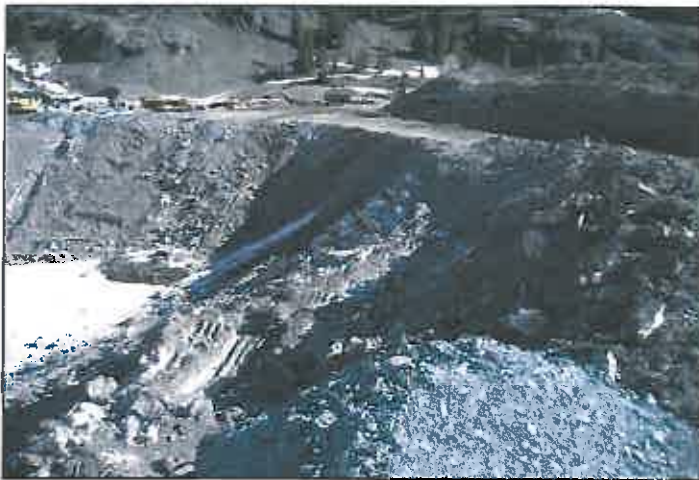
The southern side of the pre-existing low-grade ore stockpile had to be moved to accommodate the weep line trench; with moved material replaced on the northern side of the pile. The east end of the old mine pond (which was drained in 2013) is where waste rock from recent underground mine development is being placed. Equipment and parts are stored on the mine waste dumps, especially near the mill and filter building, including timbers, steel pipe, plastic pipe, copper cable and electrical supplies, rail and track supplies, explosives magazines, mill balls, steel welding supplies, and wood debris (for burn pile). Very little milling equipment remains on the surface, most of it having been installed.

New waste rock placed in east end of old mine pond

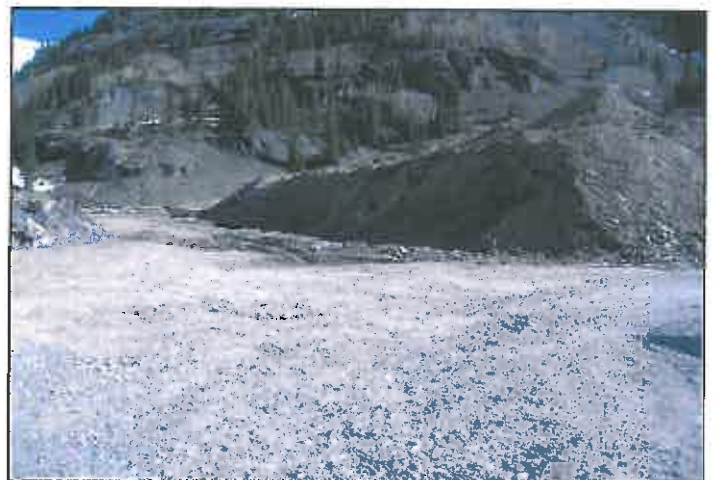
Disturbed surface (south) of historic low-grade ore pile

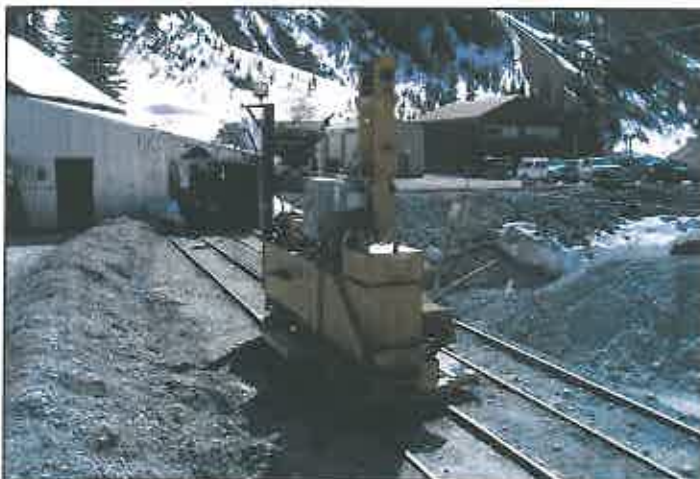
There is a new stockpile of ore that has been dumped below the loadout, adjacent to the inert waste rock. The ore is not placed on an impermeable pad nor covered against the weather. The Division does not know when this was placed here, but the operator must ensure that this pile of ore does not remain in this unprotected location for longer than 180 days.

Equipment at ore and waste loadout (ore pile visible on right)

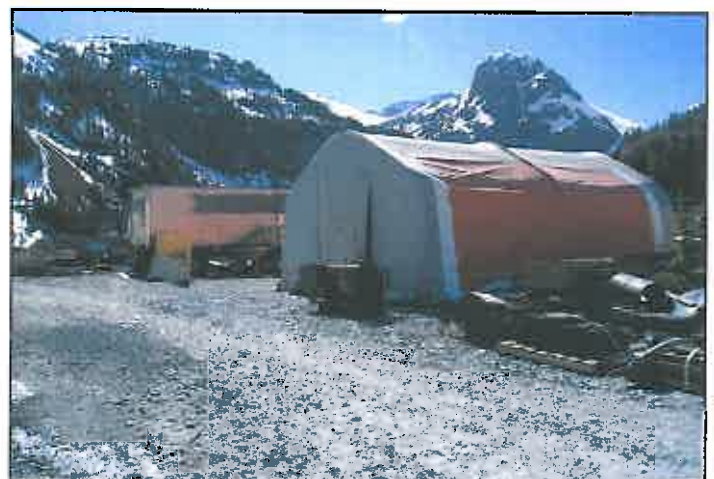
Steel and electric storage, near filter building

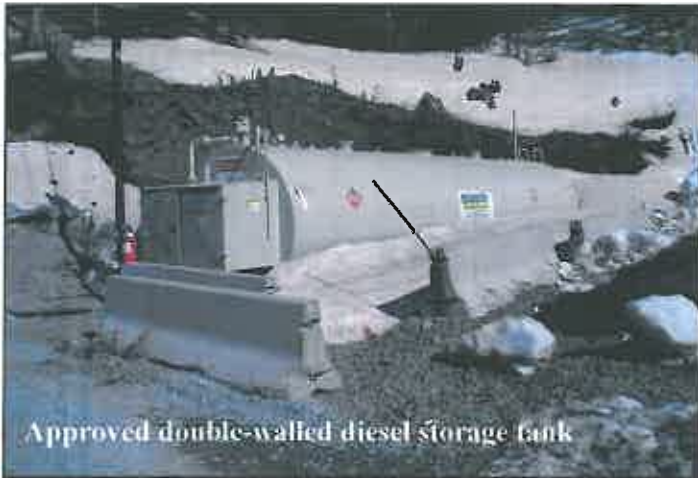
Approved double-walled diesel storage tank

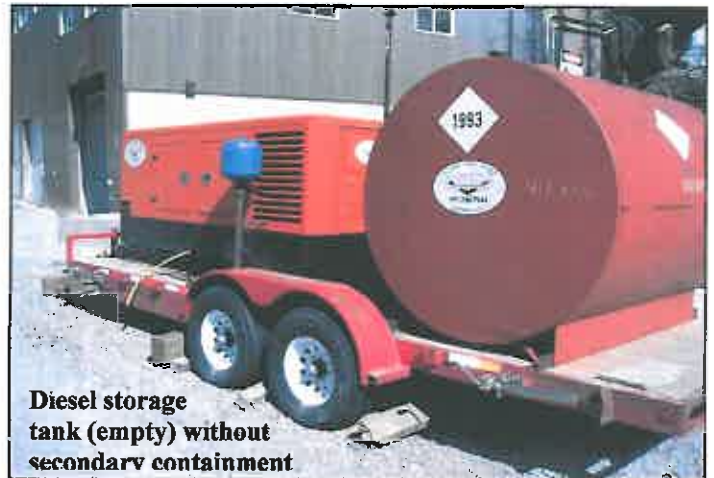
Diesel storage tank (empty) without secondary containment

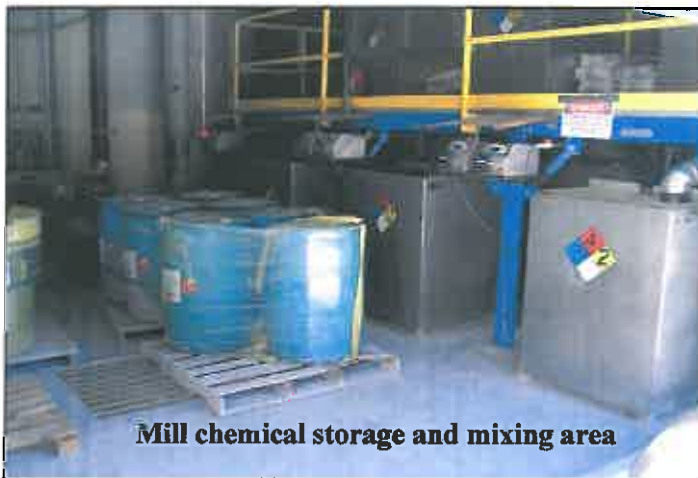
Mill chemical storage and mixing area

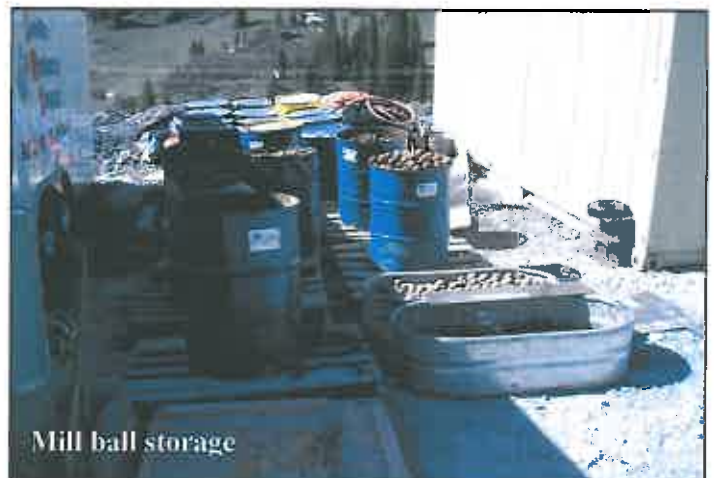
Mill ball storage

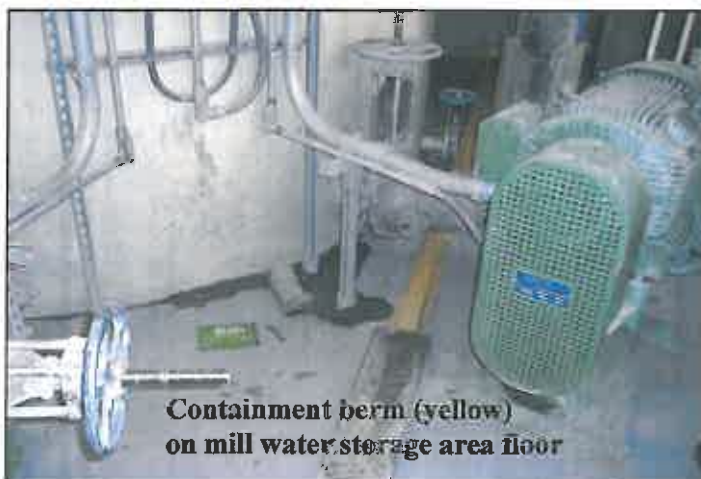
Containment berm (yellow) on mill water storage area floor

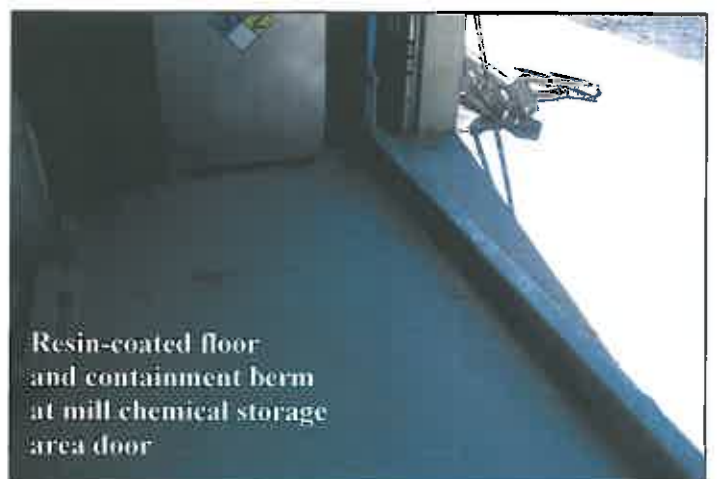
Resin-coated floor and containment berm at mill chemical storage area door

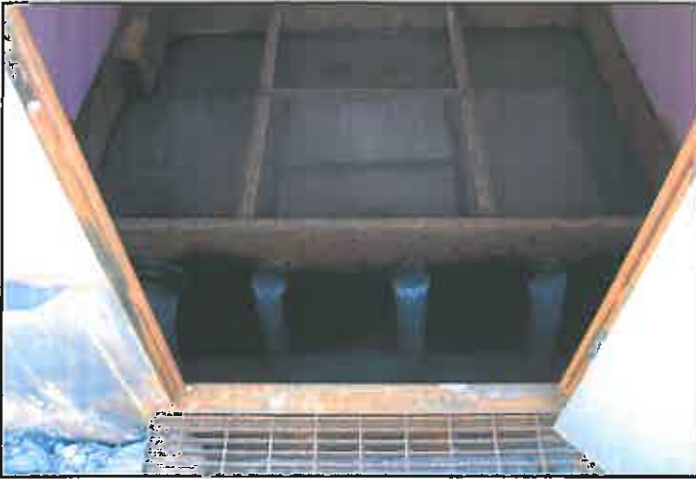
The constructed components of the approved mine water handling plan were inspected. These included: (1) the vault immediately outside the Revenue portal in which the discharge water can be routed to any of several pipelines (although only one line was installed). (2) The one currently-installed discharge line is an 8-inch diameter, thick-walled poly pipe (8" IPS, DR-11), laid in an open trench around the south side of the former mine pond. This will be perforated to become a permanent weep line after the leach field is installed. Water from its outlet currently reports to the new mine pond, though that is temporary. (3) The downstream sediment pond is constructed and is functional. The middle sediment pond is not constructed yet, but its location is being prepared as old waste dump material is pulled back and a bench is created. (4) The earthwork for the new mine pond was completed in late 2013, but final shaping was not completed and no liner is installed yet. This pond currently has piped portal water discharging into it (as described in #2, above) and it percolates through from there. All structures associated with this plan are to be completed this construction season (2014). Since they are all parts of the EPP, they need to be constructed and installed according to the approved plan, inspected during installation, and certified that they conform to the plan.

Discharge water vault (interior of building structure)

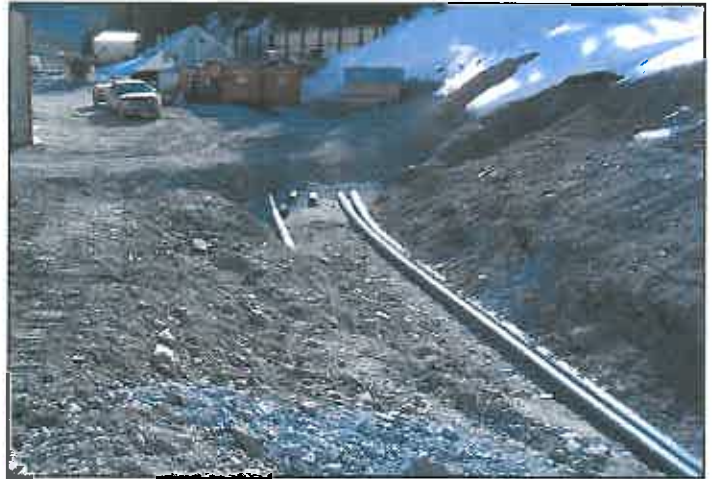
View toward Revenue portal: drainage/weep line in trench

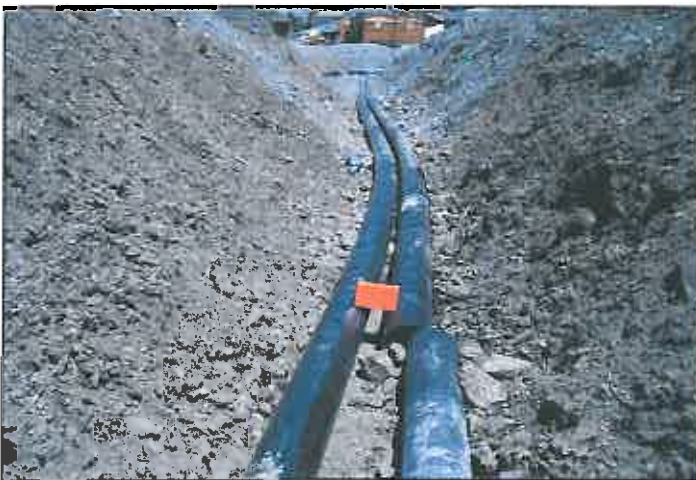
Drainage/weep line: one line not connected

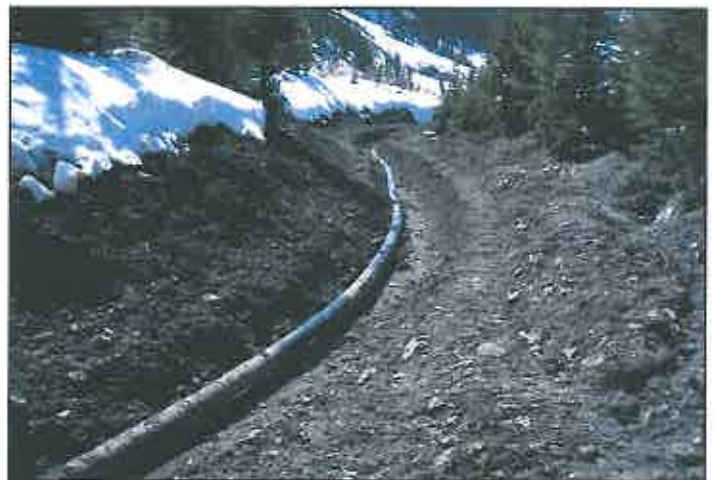
Drainage/weep line, conveying toward new mine pond

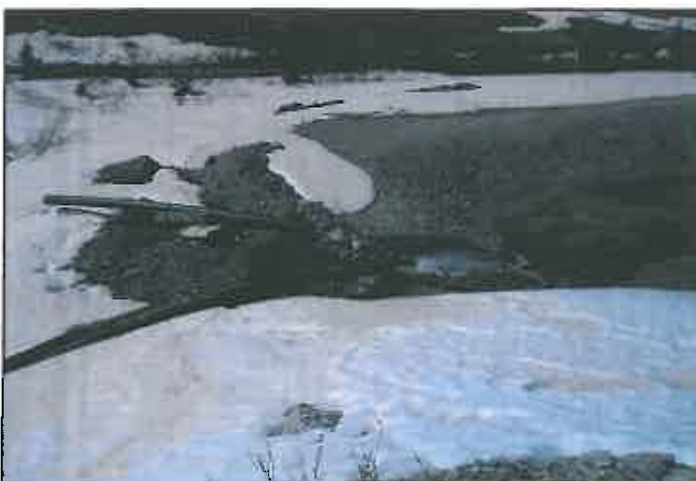
Drainage/weep line: outlet (discharge) in new mine pond

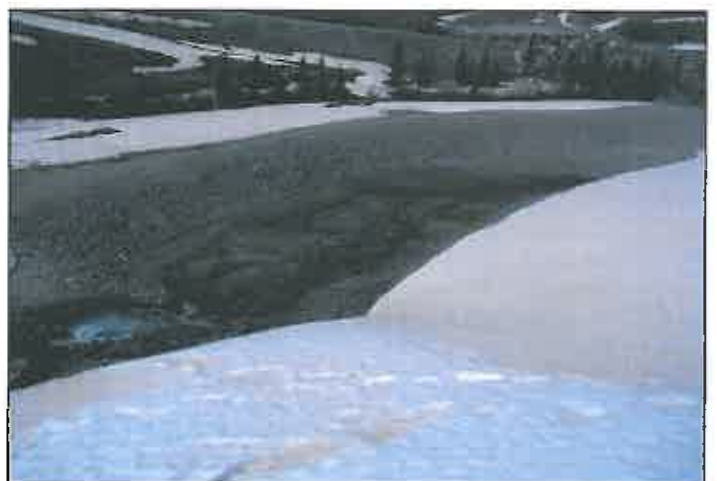
New mine pond
