COLORADO DIVISION OF RECLAMATION, MINING AND SAFETY
MINERALS PROGRAM INSPECTION REPORT
PHONE: (303) 866-3567

MINE NAME: May Day Idaho Mine Complex	MINE/PROSPECTING ID#: M-1981-185	MINERAL: Gold and silver	COUNTY: La Plata
INSPECTION TYPE: Monitoring	INSPECTOR(S): Kate A. Pickford	INSP. DATE: May 22, 2014	INSP. TIME: 11:00
OPERATOR: Wildcat Mining Corporation	OPERATOR REPRESENTATIVE:	TYPE OF OPERATION: 112d-1 - Designated Mining Operation

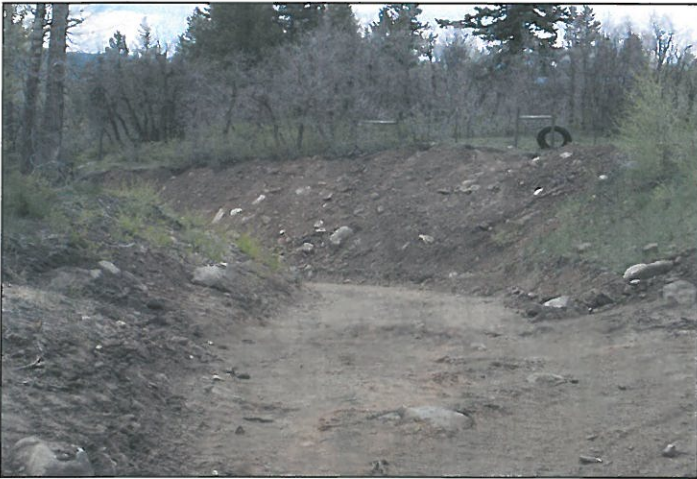
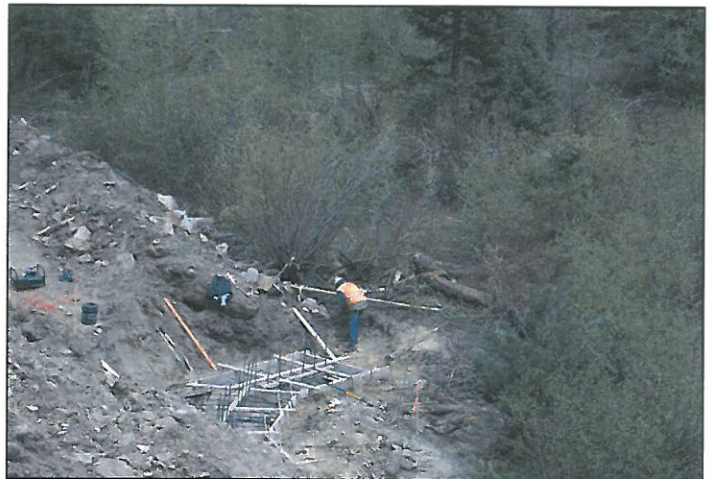
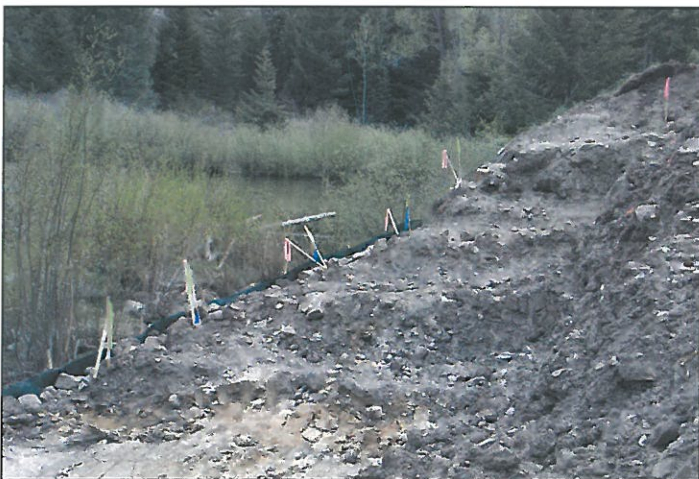
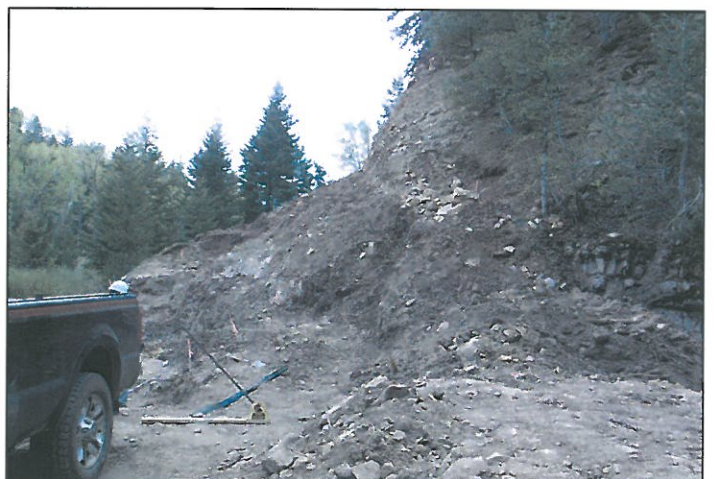
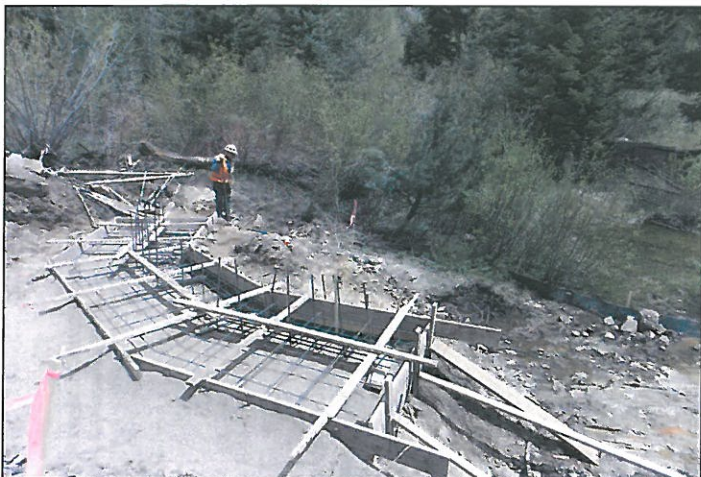
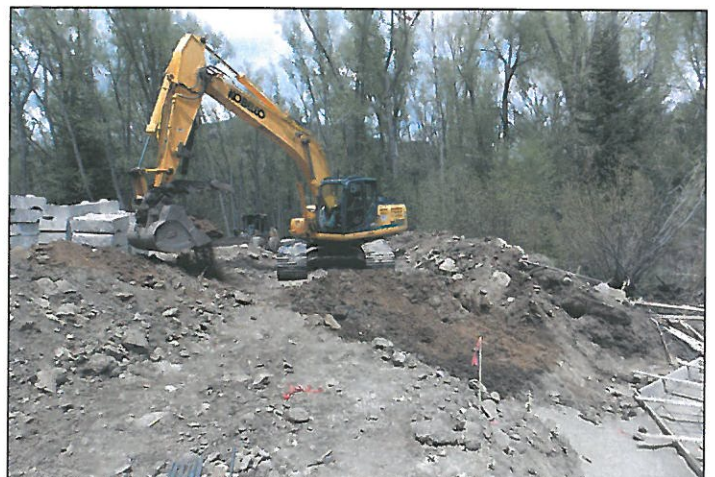
The backfill up to the fence adjacent to the road at the top of the hill looks adequate. Seeding and vegetation will add to the stability of the slope.

The site was also accessed from below, via the Forest Service road. The slope of the road has been cut down to the level of the adjacent water. A form was present, into which concrete was to be poured and the drain pipe installed from the sediment basin. Michael Taylor, the contractor, advised that a modification to the approved plan was going to be implemented because the bedrock was closer to the wetlands than was expected, once the road was cut down. Therefore, it was planned to move the road itself closer to the retaining wall. Dustin Czapla was advised of this proposed change and he was going to contact George Robinson to advise of the steps necessary to make the change in design.
