COLORADO DIVISION OF RECLAMATION, MINING AND SAFETY
MINERALS PROGRAM INSPECTION REPORT
PHONE: (303) 866-3567

MINE NAME: Hazeltine Mine	MINE/PROSPECTING ID#: M-2004-031	MINERAL: Sand and gravel	COUNTY: Adams
INSPECTION TYPE: Mineral Monitoring	INSPECTOR(S): Tyler V. O'Donnell	INSP. DATE: May 27, 2014	INSP. TIME: 13:30
OPERATOR: Aggregate Industries - WCR, Inc.	OPERATOR REPRESENTATIVE: Connie Davis	TYPE OF OPERATION: 112c - Construction Regular Operation	
REASON FOR INSPECTION: Citizen Complaint	BOND CALCULATION TYPE: None	BOND AMOUNT: \$670,602.00	
DATE OF COMPLAINT: March 19, 2014	POST INSP. CONTACTS: None	JOINT INSP. AGENCY: None	
WEATHER: Clear	INSPECTOR'S SIGNATURE:

INSPECTION TOPIC: Hydrologic Balance

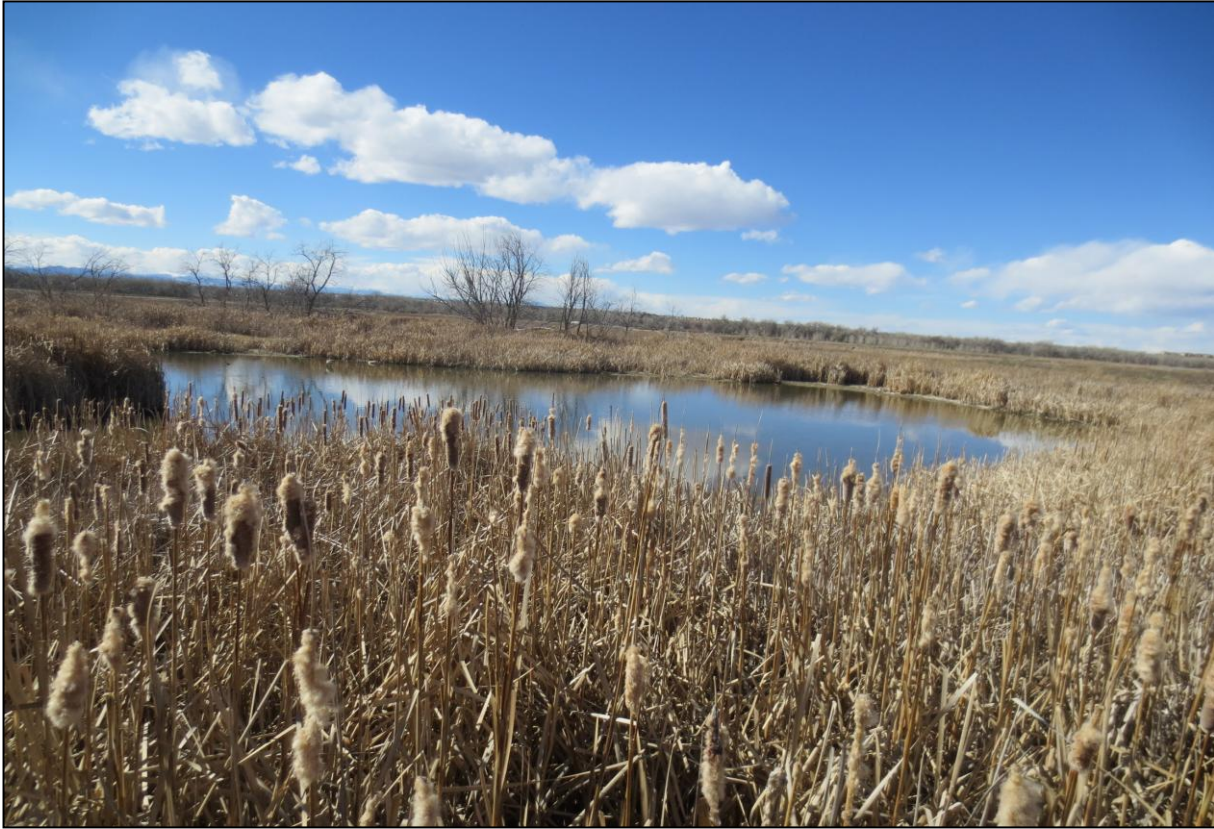
The inspection began at the Orr property. The inspection consisted of a visual examination of the Orr property and a discussion of the ongoing issues detailed in the written complaint. The visual inspection of the Orr property found that the land surface was still wet. The Division believes that the water level in the depression in the central part of the Orr property has dropped approximately 4 to 6 inches since the Division's March 27, 2014 inspection. The Division came to this conclusion by comparing photos taken during the March 27, 2014 (see photo 1) inspection and this inspection (see photo 2 and 3).

Photo 1: Photo of the depression in the central part of the Orr property taken on March 27, 2014.

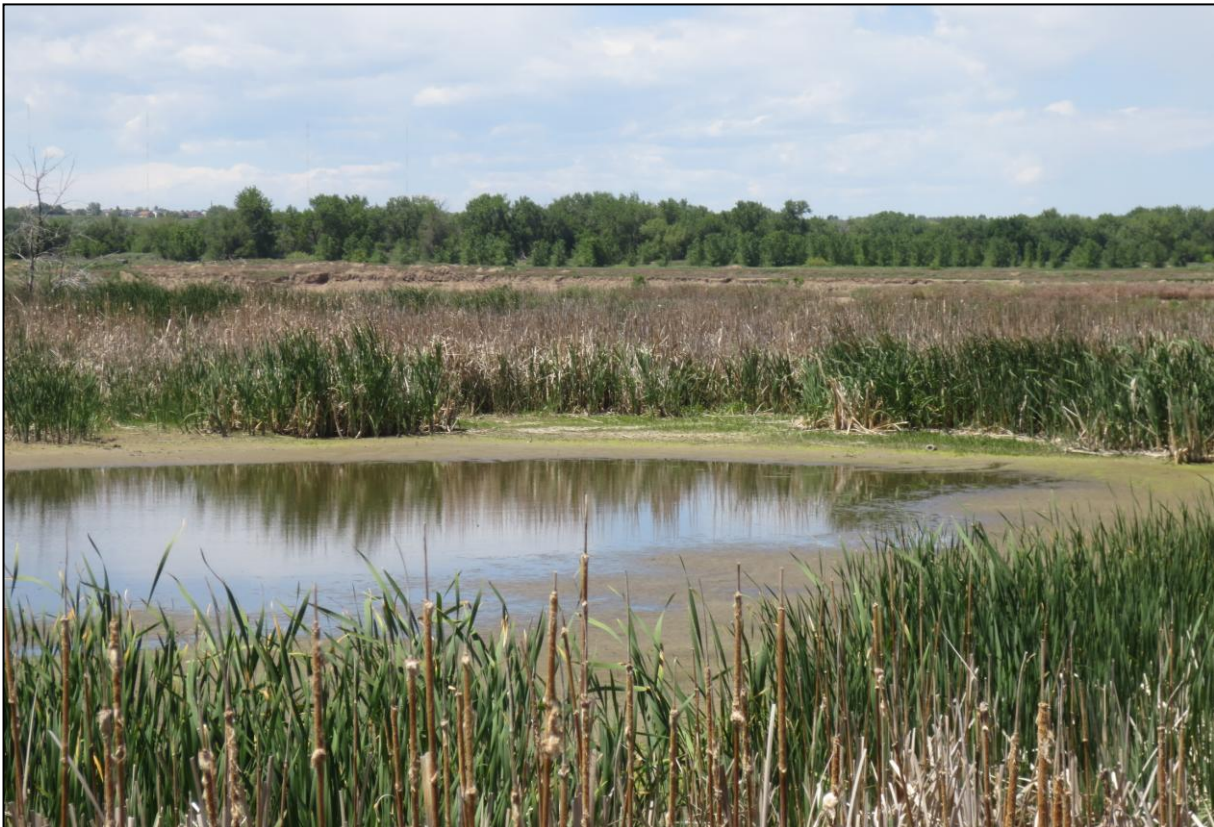
Based on observations made during the inspection it appears that the water level on the Orr's property has dropped, drying portions of that land surface that were previously submerged during the March 27, 2014 inspection. However at this time the Division believes that the Operator has failed to resolve the problem cited in the October 5, 2011 inspection report for failure to minimize disturbance to the prevailing hydrologic balance pursuant to C.R.S. 34-32.5-116(4)(h). Although it appears at the present time that the Operator could be making progress resolving this problem. The Division requested the Operator to commit to weekly monitoring of the Agridrain during the March 27, 2014 inspection report. The Operator submitted TR-03 on May 15, 2014. TR-03 will incorporate in to the approved permit a weekly monitoring and maintenance plan for the Agridrain and an improved inlet screen design. TR-03 also incorporated a surface water monitoring gauge (staff gauge at the inlet pipe of the Agridrain). The Operator will report the results of the monitoring plan to the Division monthly. The results of the monitoring and maintenance plan will help the Division determine if the Operator is minimizing the disturbance to the prevailing hydrologic balance.

Photo 2: Photo of the depression in the central part of the Orr property taken on May 27, 2014.

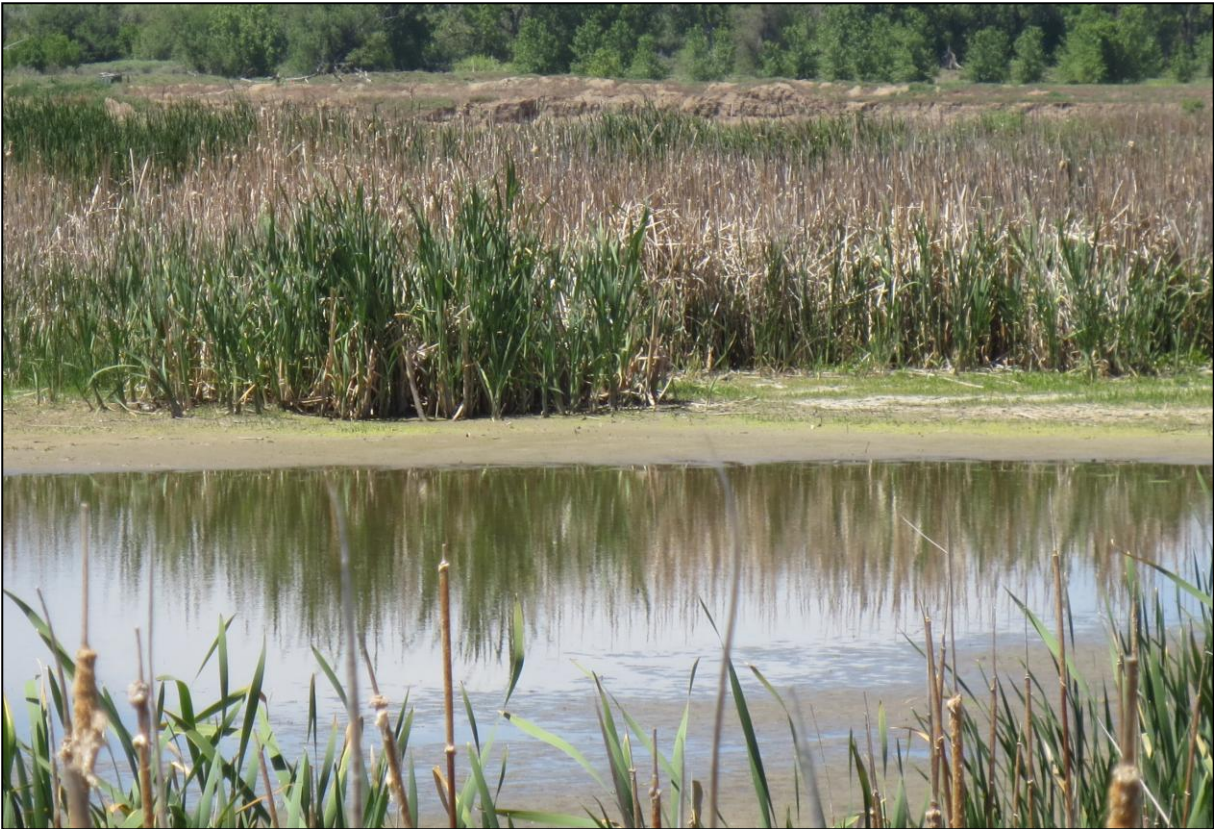
Photo 3: Photo of the depression in the central part of the Orr property taken on May 27, 2014.

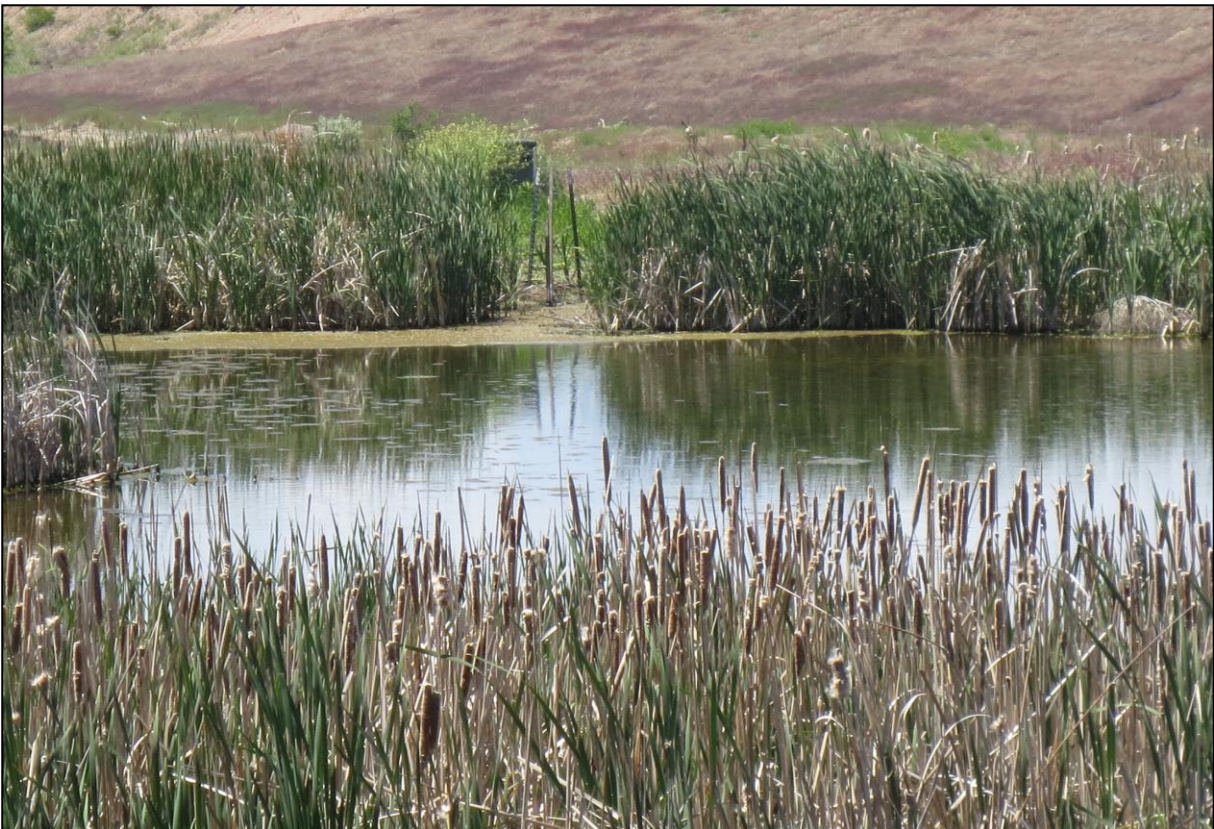
Following the investigation at the Orr property, the Division entered the mine site with the intention to observe the operation of the Agridrain. The Operator's representative explained to the Division that the haul/mine road to the northeast corner of the mine site was impassible due to recent rains. The Operator's representative stated the best option to access the Agridrain would be to drive on the bike path along the western edge of the permitted mine site. The Division decided not to drive on the bike path to access the northeast corner of the mine site where the Agridrain is located. Therefore the Division was not able to access the Agridrain during the inspection. The Operator's representative provided photos of the new inlet screen design and the staff gauge which will be incorporated into the approved permit through TR-03. The Operator's representative stated they would email the photos of the new inlet screen and the staff gauge to the Division.

Photo 4: View looking northwest from the ditch access road. The Agridrain is near the center of the photo.
