COLORADO DIVISION OF RECLAMATION, MINING AND SAFETY
MINERALS PROGRAM INSPECTION REPORT
PHONE: (303) 866-3567

MINE NAME: East Wolf Creek Pit	MINE/PROSPECTING ID#: M-2011-038	MINERAL: Stone	COUNTY: Mineral
INSPECTION TYPE: Monitoring	INSPECTOR(S): Bob Oswald	INSP. DATE: May 30, 2014	INSP. TIME: 14:00
OPERATOR: KW Enterprises LLC	OPERATOR REPRESENTATIVE: None	TYPE OF OPERATION: 111 - Construction by Government Agency

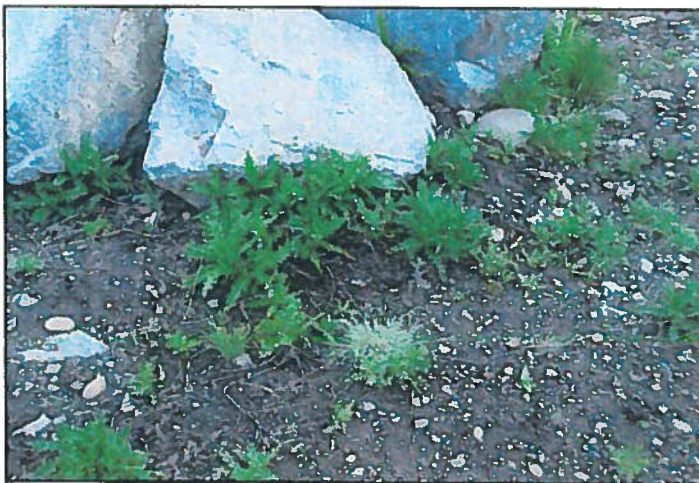
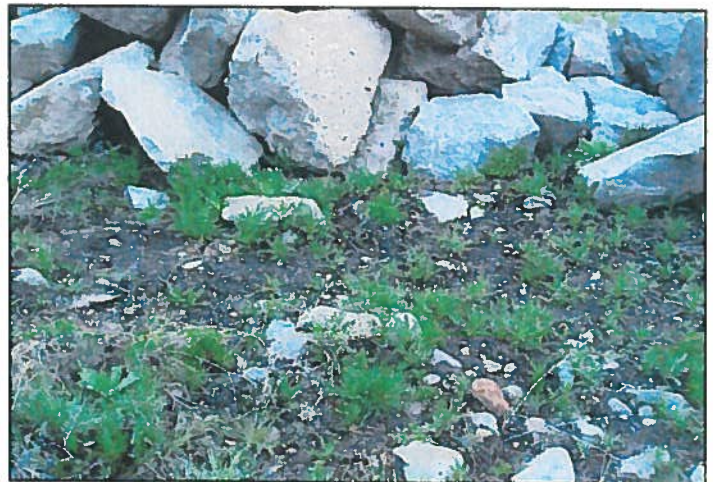
PROBLEM/POSSIBLE VIOLATION: Problem: There are state-listed noxious weeds present on site. This is a problem for failure to employ weed control methods for state listed noxious weed species within the permitted area, and to reduce the spread of weeds to nearby areas as required by Section 3.1.10 (6) of the rule.

Of the areas within permitted area boundaries where there are no stockpiles of rock, much of the soil surface is populated predominantly by Canada thistle (a state-listed noxious weed) and woolly mullein (an aggressive and persistent non-noxious weed). The presence of these weed species was brought to the operator's attention in the 2013 inspection report, with instructions to treat the Canada thistle as required by law, and encouragement to treat the mullein (so that post-mining reclamation may proceed more easily). Thistle is still very plentiful, and no effective weed control of any kind is apparent. (Again, there is no 2013 annual report to determine whether any treatment was attempted.) Since the noxious weeds are required to be controlled within the permitted area, and they have increased during the year following the Division's 2013 inspection and report, this is now noted as a problem in this report (see page 1).

Canada thistle around rock stockpiles (both upper photos)

CORRECTIVE ACTIONS: Implement approved weed control plan and provide proof to the Division that this has been done. If a weed control plan is not already in place, the operator shall develop a weed control and management plan in accordance with Section 3.1.10 (6) of the Rule. This plan should be developed in consultation with the county extension agency, or weed control district office and should include specific control measures to be applied, a schedule for when control measures will be applied and a post-treatment monitoring plan. This weed control plan shall be submitted to the Division as a Technical Revision to the approved plan with the appropriate Technical Revision fee of \$216.00 by the corrective action date.

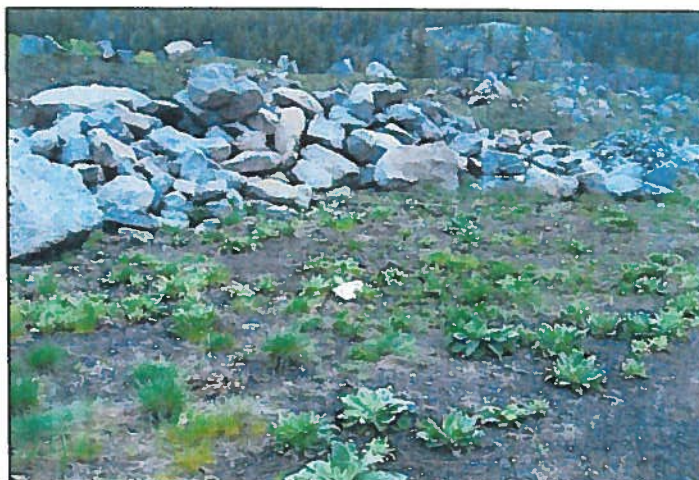
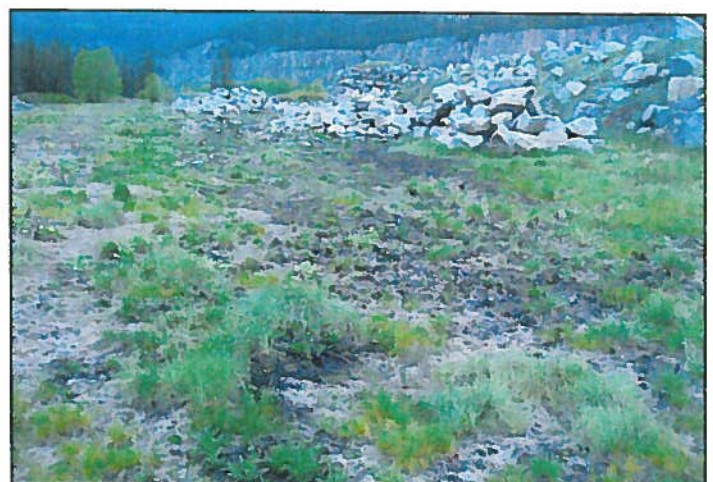
Mullein and grasses in eastern stockpile area (both lower photos)

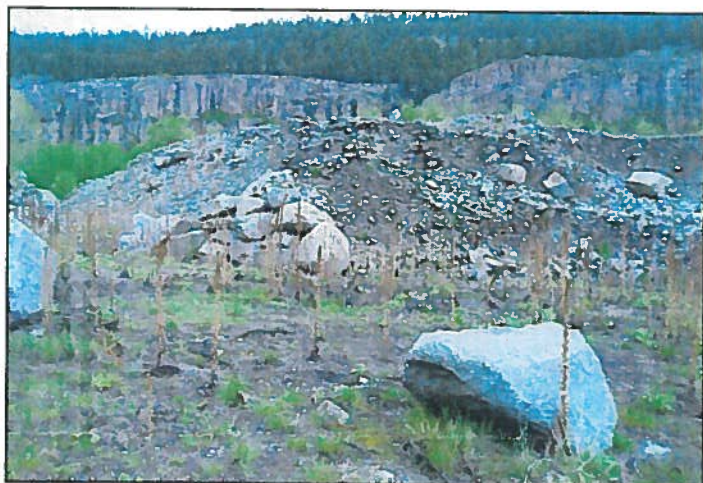
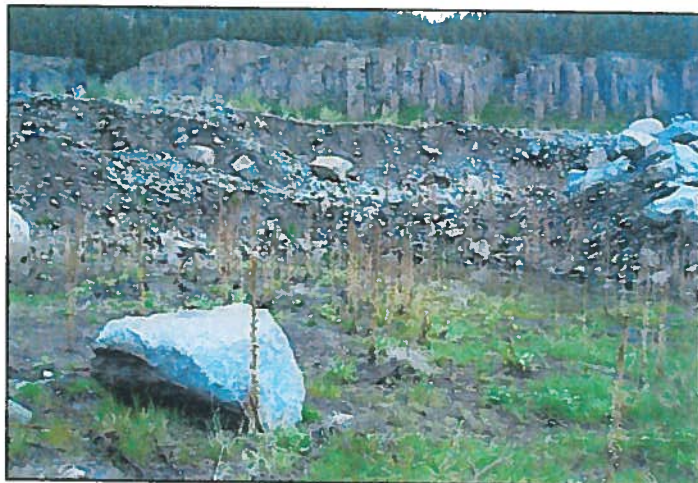
Excavation in western stockpile area, note abundance of mullein (both upper photos)

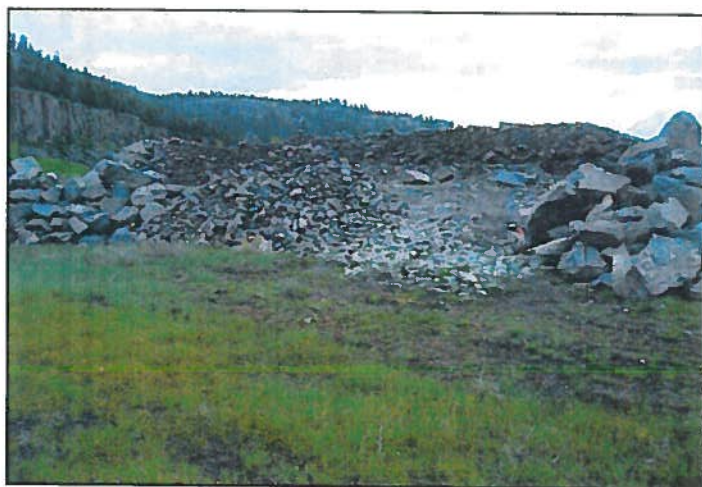
Access ramp in western excavation area

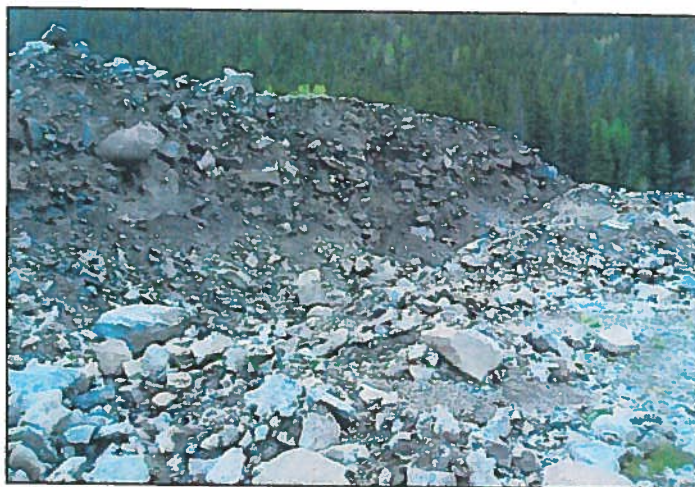
Vertical highwall in western excavation area

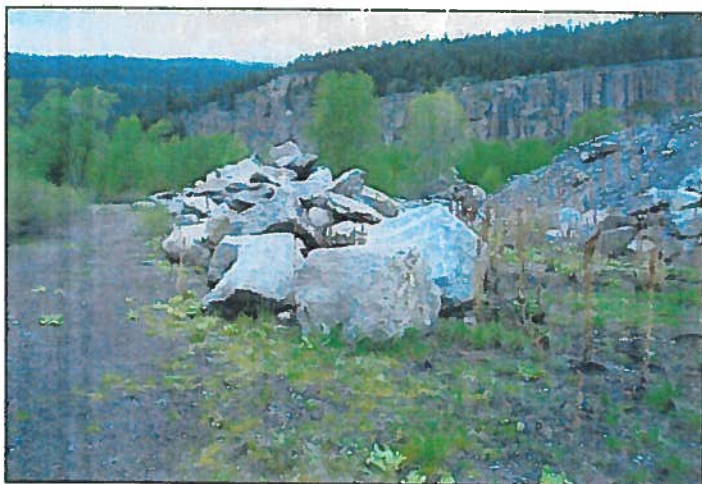
Stockpile in western area

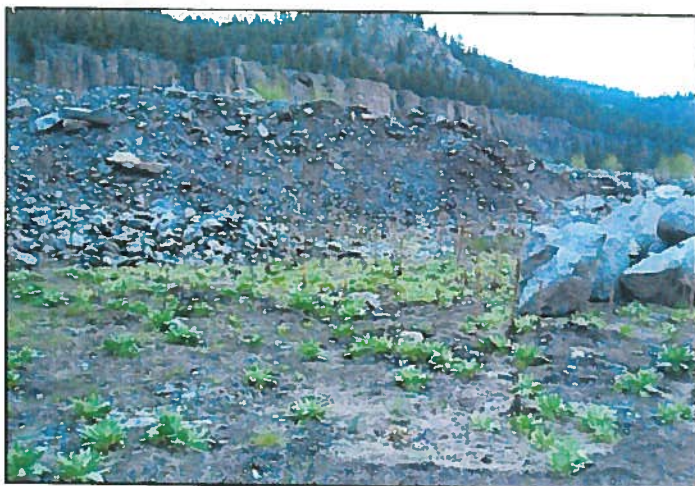
Excavation and mullein in western area
