COLORADO DIVISION OF RECLAMATION, MINING AND SAFETY
MINERALS PROGRAM INSPECTION REPORT
PHONE: (303) 866-3567

MINE NAME: Crystal Pit	MINE/PROSPECTING ID#: M-1989-116	MINERAL: Gravel	COUNTY: Teller
INSPECTION TYPE: Monitoring	INSPECTOR(S): Timothy A. Cazier	INSP. DATE: September 3, 2013	INSP. TIME: 13:15
OPERATOR: City of Colorado Springs	OPERATOR REPRESENTATIVE: Dave Jordan	TYPE OF OPERATION: 110c - Construction Limited Impact

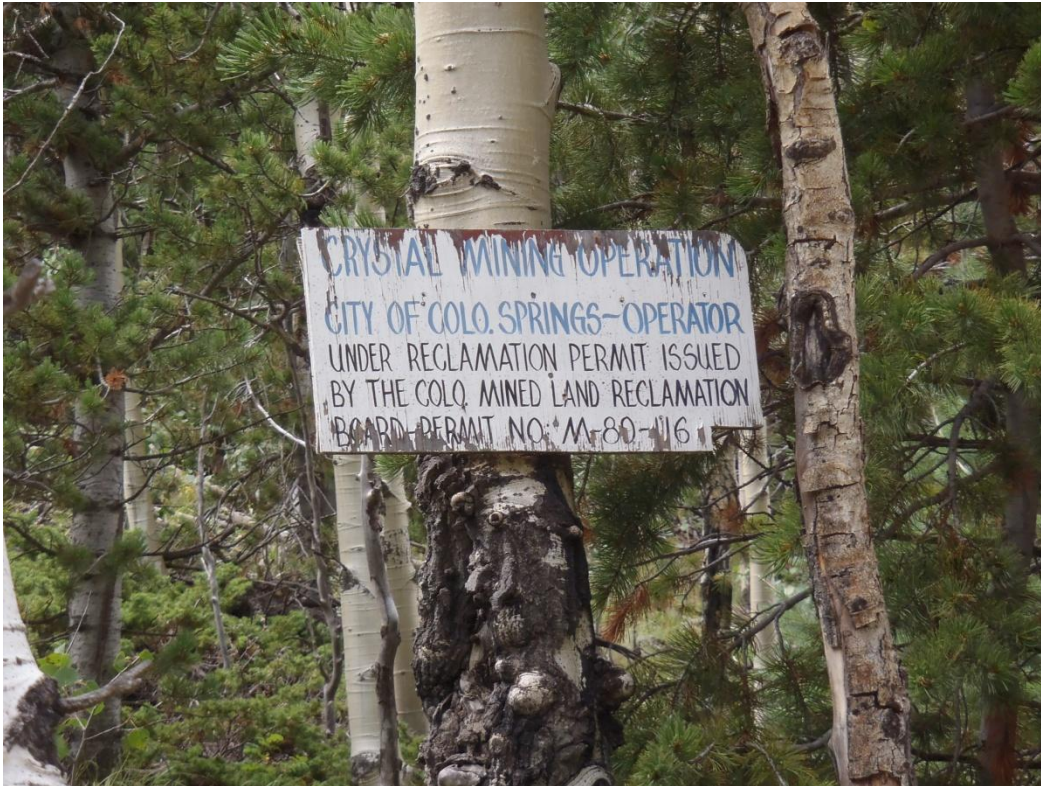
Permit Boundary: A permit sign was displayed at the site entrance (see **Photo 1**). Unauthorized entry to the site is controlled by its remote location and a locked gate controlling access to the City's maintenance buildings.

Photo 1. Permit Sign (near east phase).

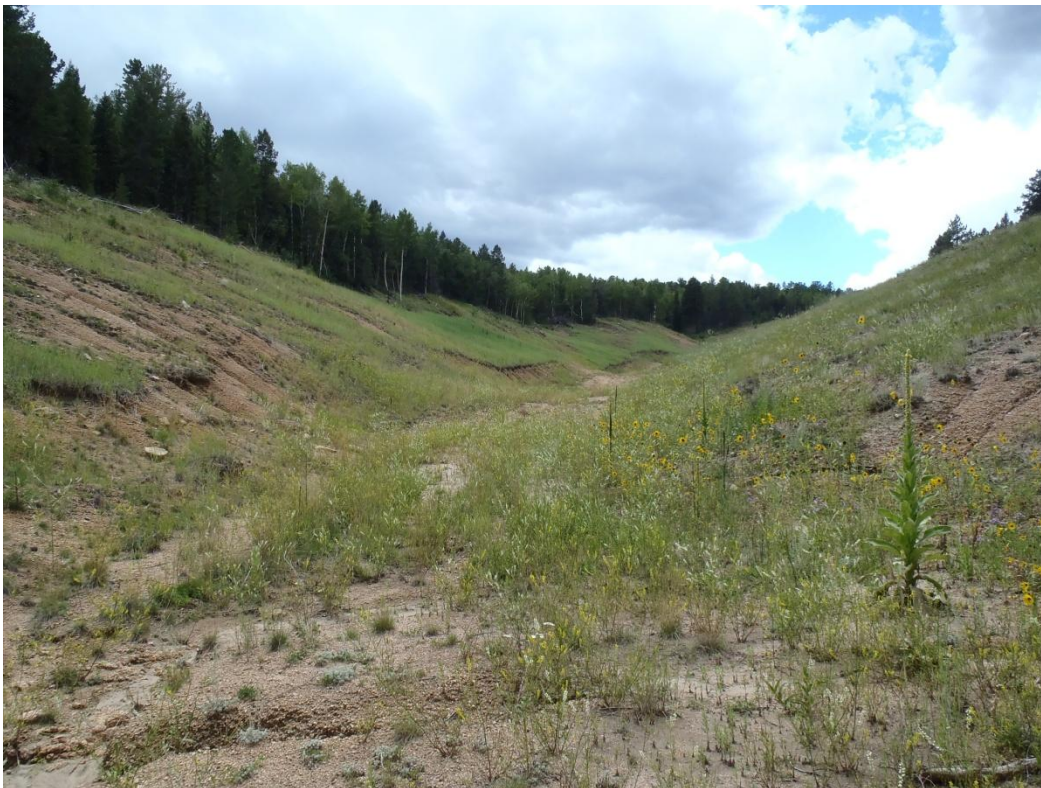
Pit & Permit Area: The site is split into two distinct areas: an east phase (**Photos 2 - 3**) and a west phase (**Photos 4 - 5**). Mr. Jordan explained both phases are in final reclamation.

Photo 2. Lower east phase (looking SW).

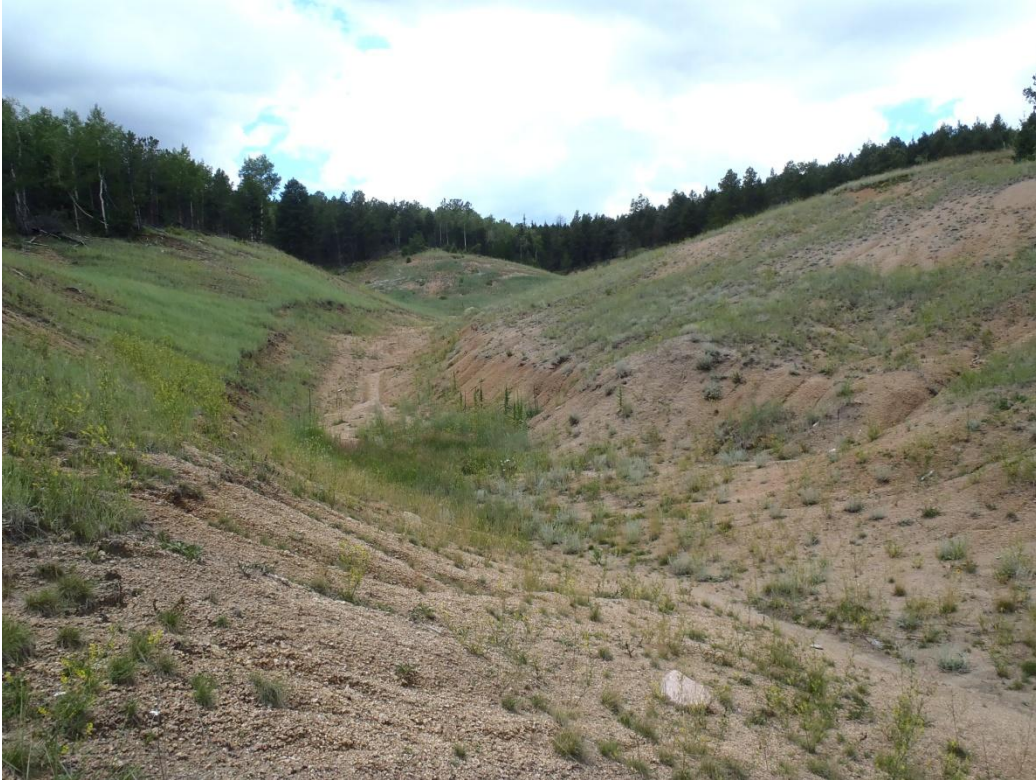
Photo 3. Upper east phase (looking SW).

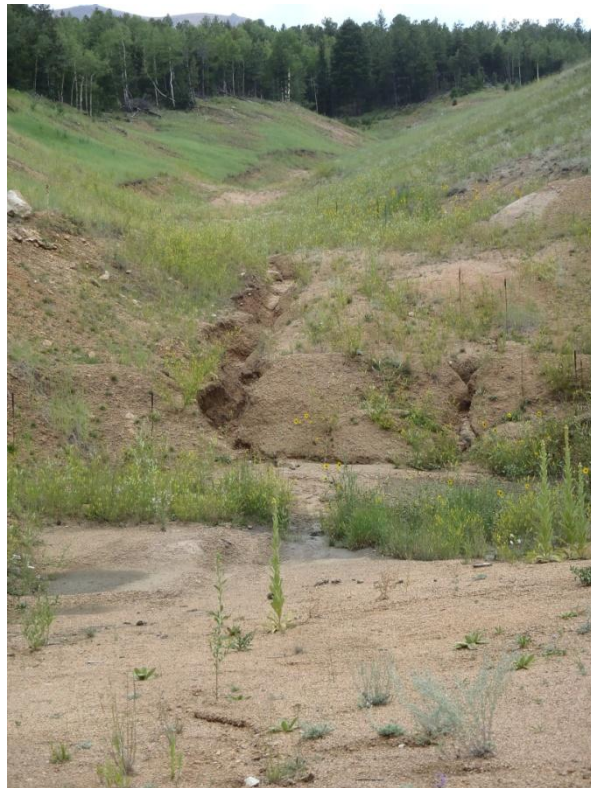
Photo 4. Lower west phase (looking SW).

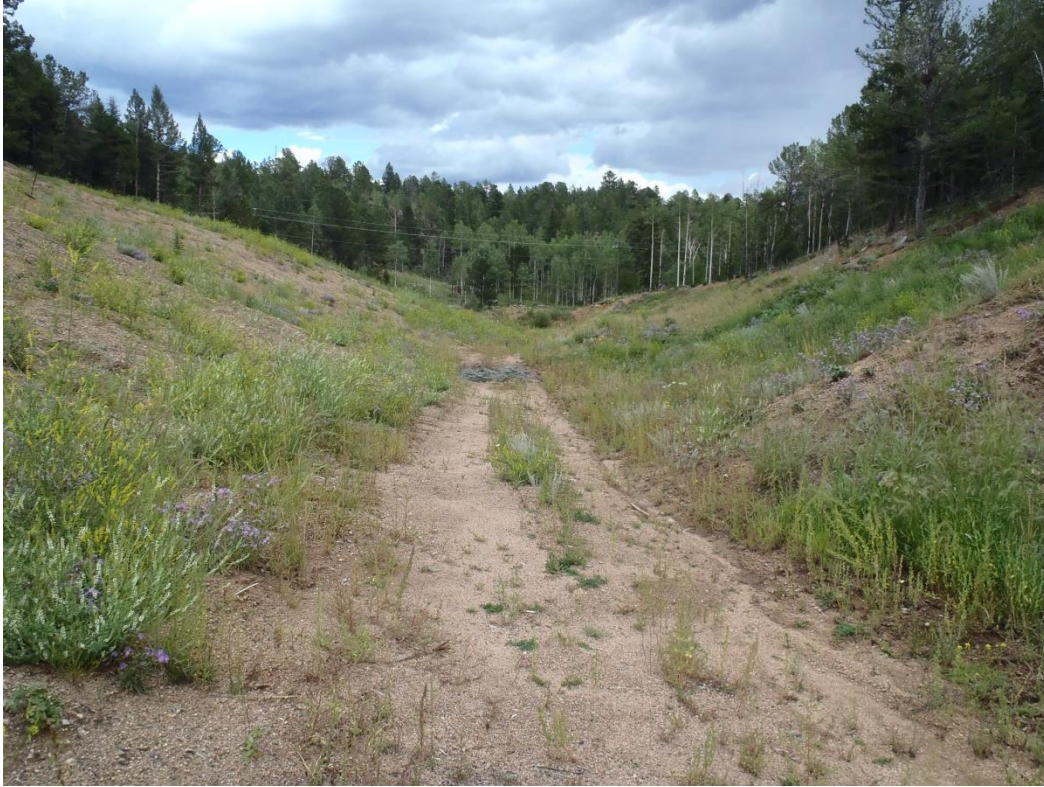
Photo 5. Upper west phase (looking SW).

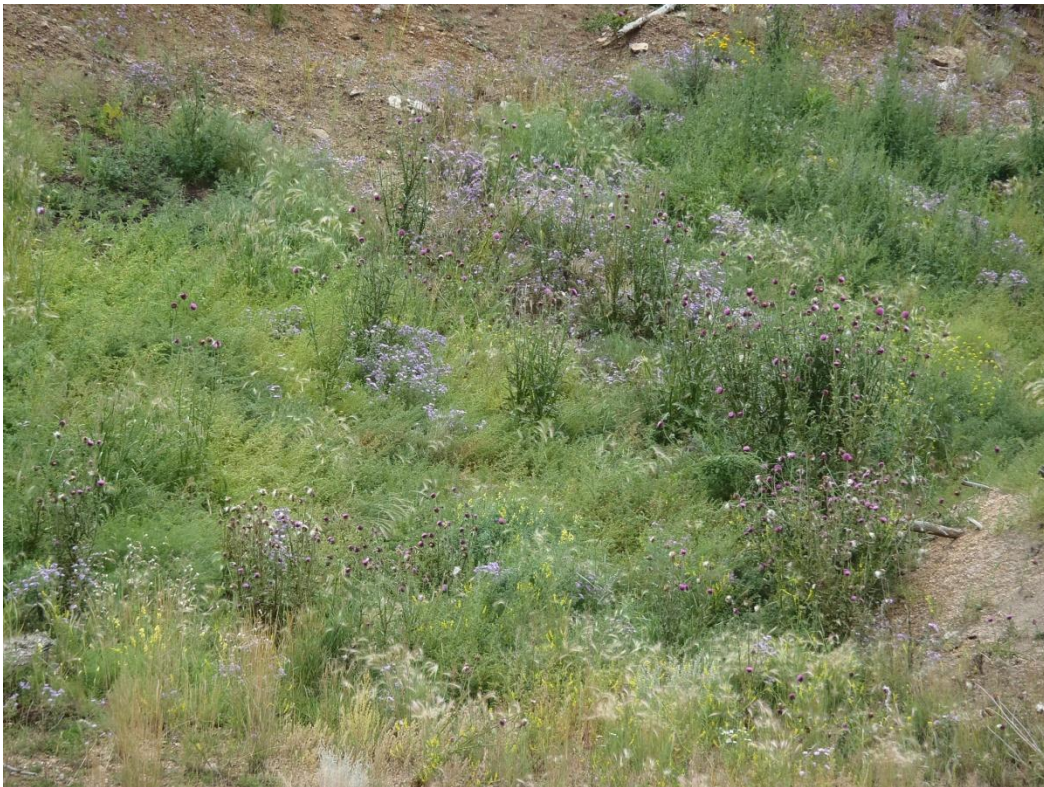
Vegetation appears to be establishing well on the flatter upper slopes, but not as well on the steeper valley bottom slopes. A few small patches of Canada Thistle (a Colorado List B noxious weed) were observed in the west phase (see **Photos 6 – 7**). The small patches are not considered enough to be cited as a problem, but these weeds should be controlled to prevent them from becoming a problem.

Photo 6. Small Canada thistle patch (1 of 2 – west phase).

1. The Canada thistle needs to be controlled before becoming a problem. The Division recommends implementing a noxious weed control program, developed with input from the local or county extension office.
2. Best management practices (BMPs) should be implemented in the valley bottoms to reduce the erosion potential until the vegetation becomes established.

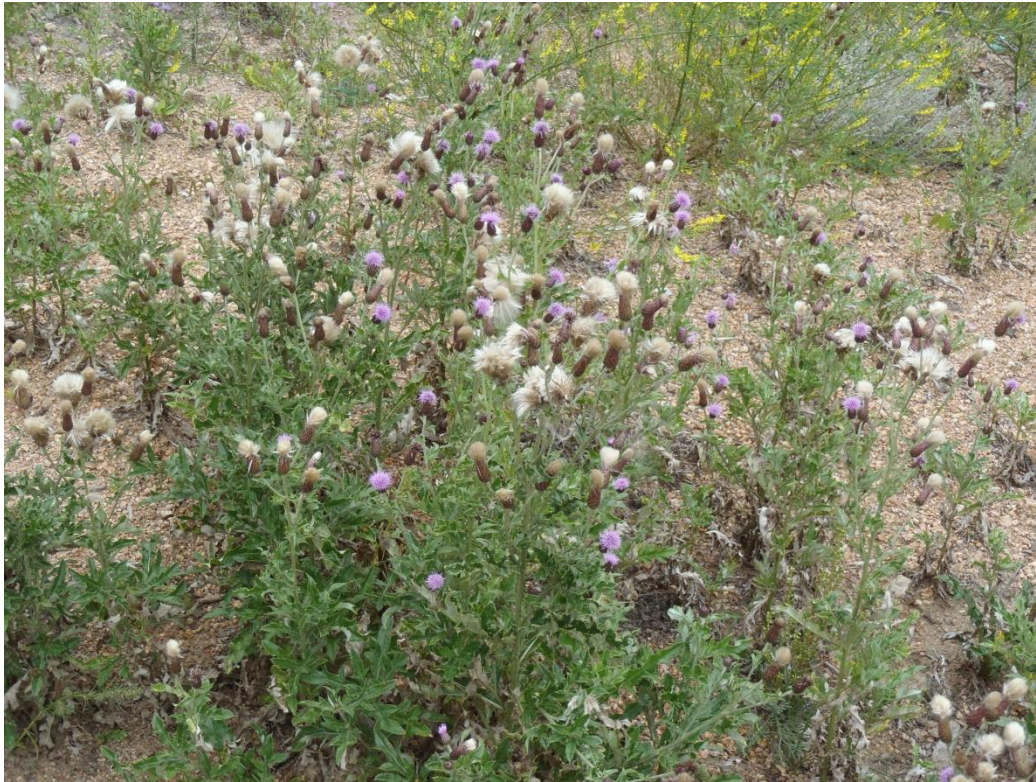
Photo 7. Small Canada thistle patch (2 of 2 – west phase).
