**COLORADO DIVISION OF RECLAMATION, MINING AND SAFETY**  
**MINERALS PROGRAM INSPECTION REPORT**  
**PHONE: (303) 866-3567**

<b>MINE NAME:</b> Caldwell-Nesselhuf Pit No. 1	<b>MINE/PROSPECTING ID#:</b> M-1997-071	<b>MINERAL:</b> Sand and gravel	<b>COUNTY:</b> Crowley
<b>INSPECTION TYPE:</b> Monitoring	<b>INSPECTOR(S):</b> Amy Eschberger	<b>INSP. DATE:</b> May 8, 2014	<b>INSP. TIME:</b> 10:00
<b>OPERATOR:</b> William & Beverly Caldwell and Albert & Lola Nesselhuf	<b>OPERATOR REPRESENTATIVE:</b> Dennis Caldwell	<b>TYPE OF OPERATION:</b> 112c - Construction Regular Operation

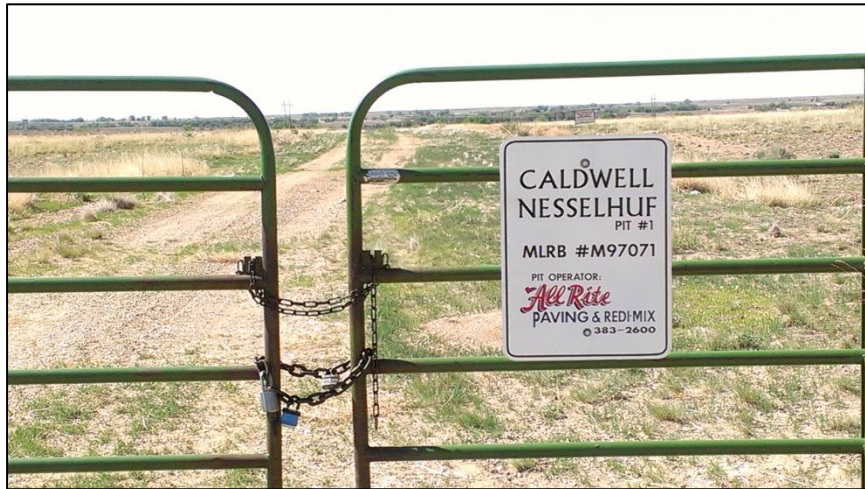
At the time of the inspection, the weather was clear, warm, and sunny, and the ground was dry. A permit sign was posted at the gated entrance to the site (Photo 1), and the boundaries were marked with metal posts. No mining equipment was present. A large stockpile of material is located along the southern boundary of the permit area (Photo 2). This stockpile appears to be stable. Slopes at this site are primarily 2H:1V or steeper. Vegetation has volunteered throughout the majority of the affected area (Photo 3). Cows were seen grazing in the far southeastern portion of the permit area. Mr. Caldwell said the cows belong to Cliff Walters, whom owns land adjacent to the western boundary of the permit area. When the affected land is undergoing reclamation, the cows will need to be restricted from grazing in the area until the desired vegetation has been established pursuant to Rule 3.1.10(4).

**Photo 1.** Permit sign posted at gated entrance to site.

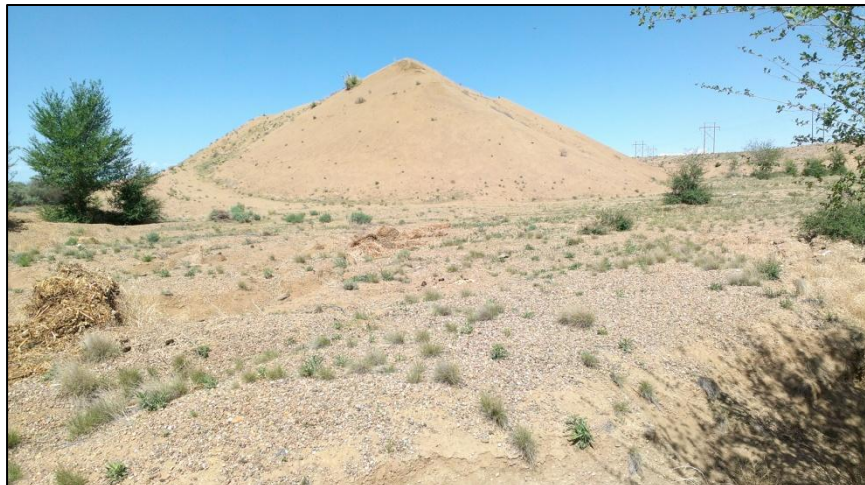
**Photo 2.** View looking west from southeastern portion of permit area, showing large material stockpile near southern boundary.

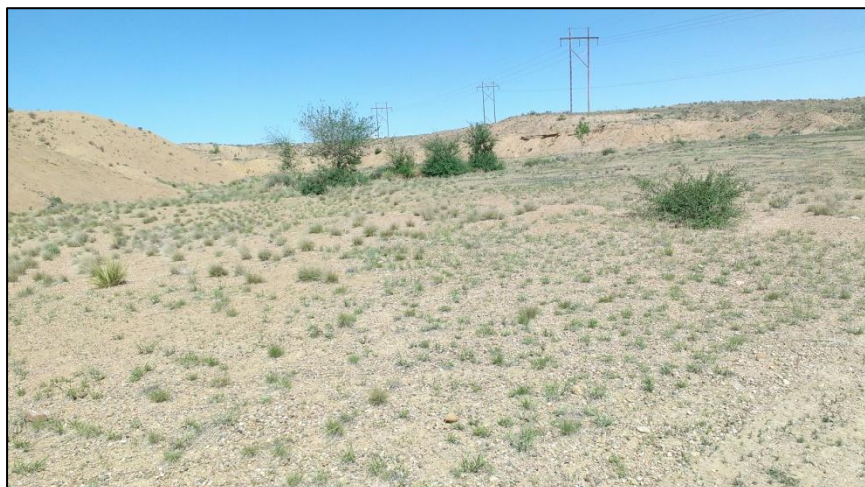
**Photo 3.** View looking west from eastern portion of permit area, showing volunteer vegetation on pit floor.

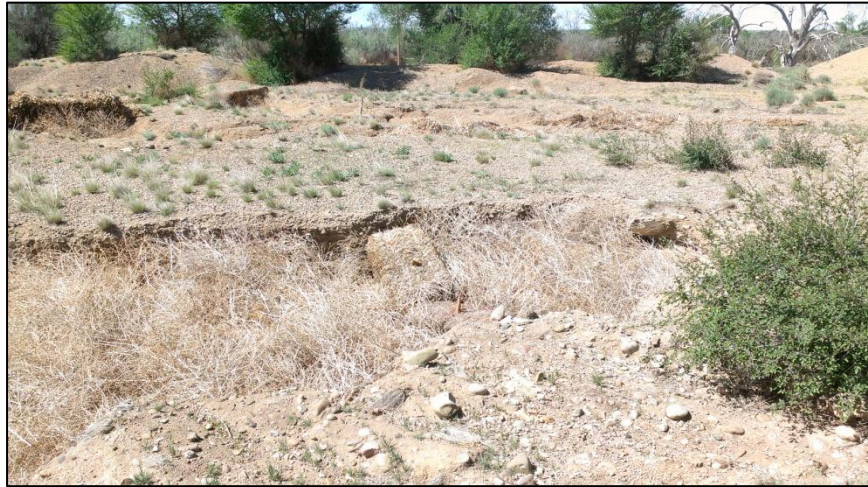
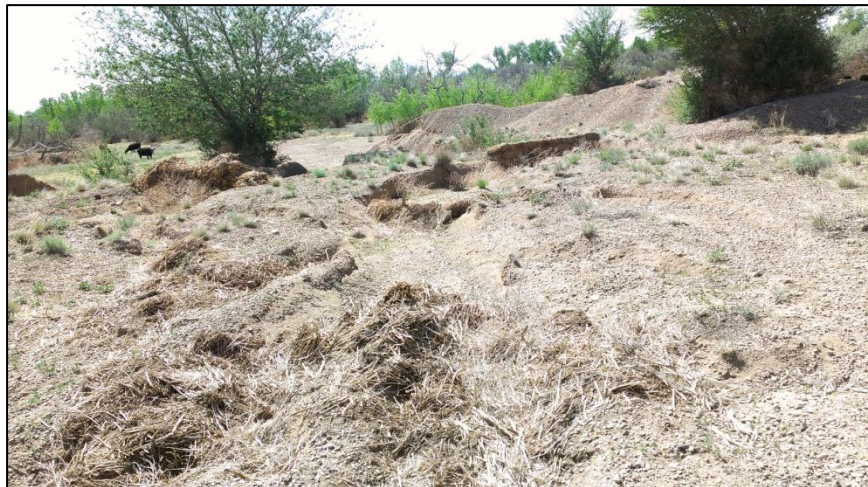
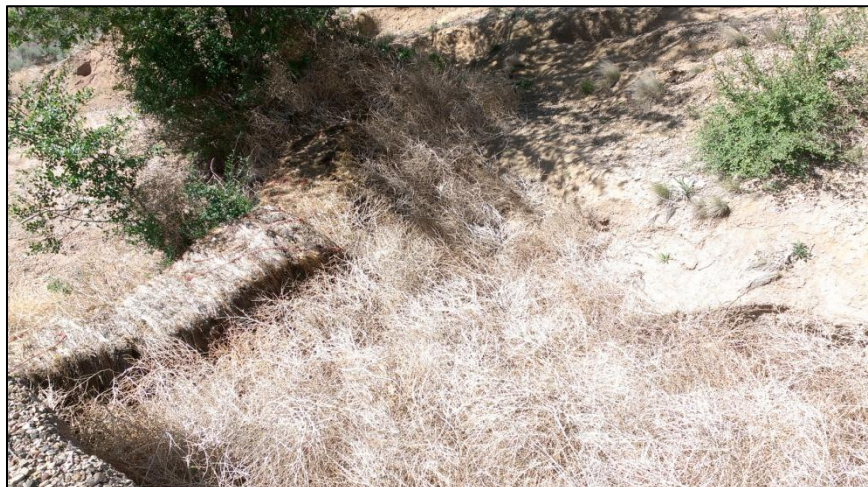
In the November 26, 2013 inspection report, the Division noted the presence of several rills and gullies on pit slopes, stockpiles, and the access road. This was cited in the report as a sediment control problem for failure to protect the affected land from erosion pursuant to Rule 34-32.5-116(4)(j). The current resolution date for this problem was set for May 12, 2014. During the current inspection, it was observed that reasonable efforts have been made by the Operator to stabilize the site and prevent more erosion damage from occurring. In the southeastern portion of the site, where erosion damage was most significant, the Operator has filled the gullies with hay (Photos 4-6). Bales of hay have been strategically placed in primary drainage areas in efforts to slow stormwater runoff (Photos 7-8).

**Photo 4.** View looking southwest from southeastern portion of permit area, showing hay put in gullies by Operator to help control erosion.

**Photo 5.** View looking southeast from southeast portion of permit area, showing hay put in gullies by Operator to help control erosion.

**Photo 6.** View of hay put in gullies by Operator to help control erosion in southeastern portion of permit area.

After conducting this inspection, the Division has determined that the Operator has made reasonable efforts to stabilize the site; therefore, the problem cited for sediment control is considered abated. However, the Operator shall continue to monitor the stability of all surface areas of the affected land and implement erosion control procedures as needed.

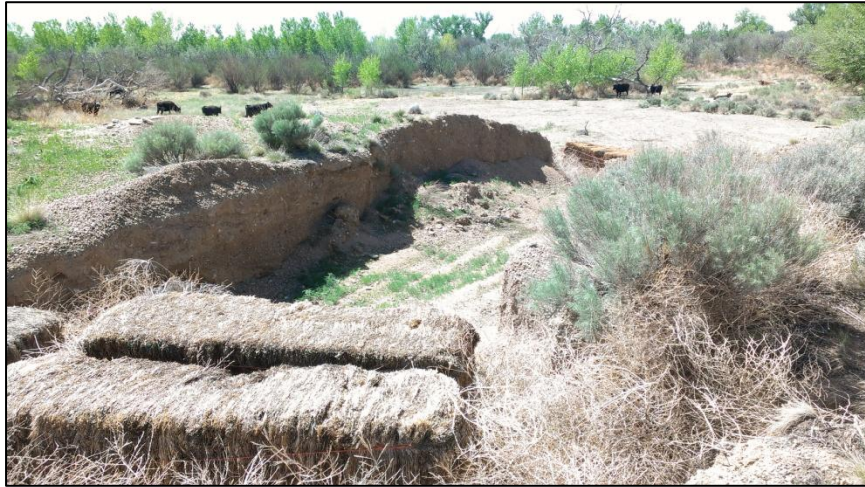
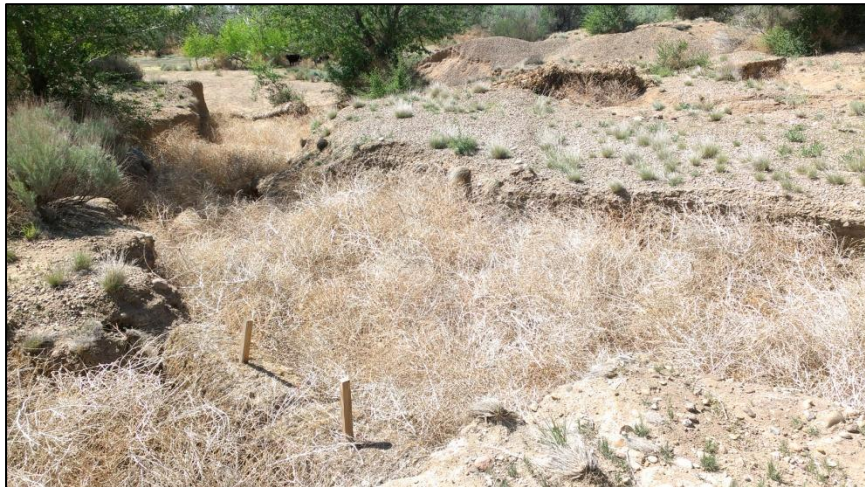
**Photo 7.** View looking southeast from southeastern portion of permit area, showing bales of hay placed in primary drainage area by Operator. Note cows grazing at top left.

**Photo 8.** View looking southwest from southeastern portion of permit area, showing bales of hay staked down in primary drainage area by Operator.

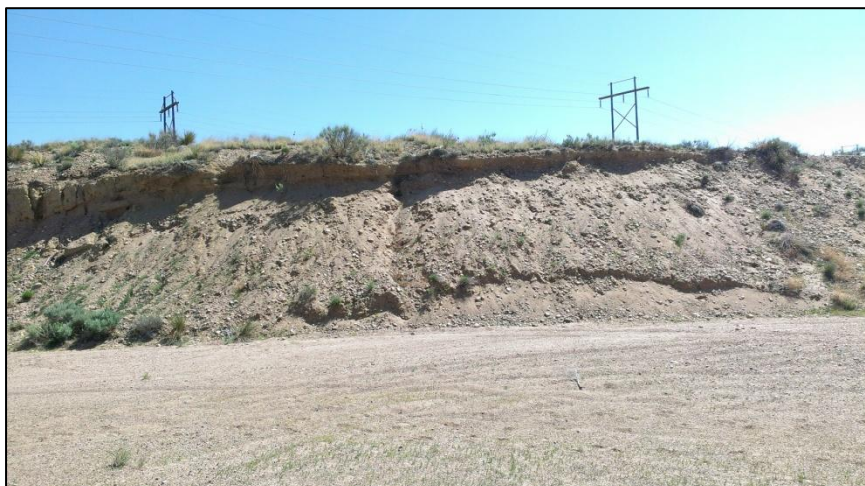
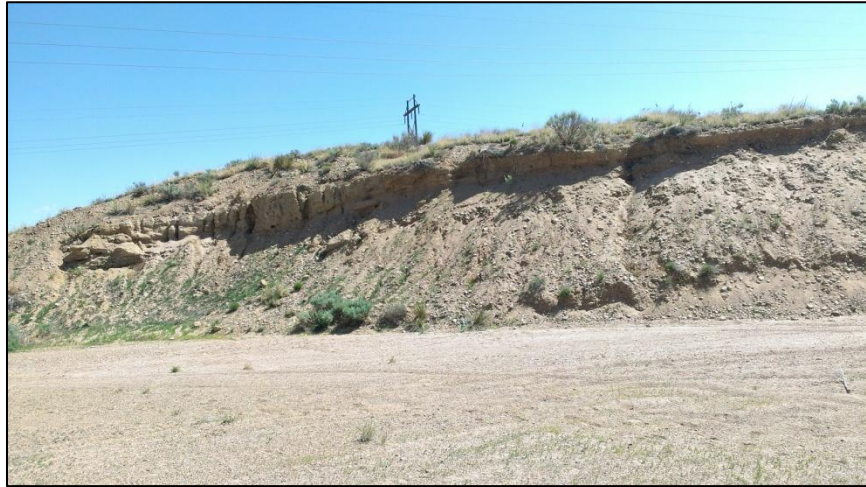
The west-facing highwall located near the eastern boundary of the affected area (Photos 9-10) showed some improvement since the last inspection where several rills and gullies were present along its slope. Mr. Caldwell said the highwall was seeded with approximately 200-300 pounds of wheat grass in January or February of this year. Some germination was observed, but the Division recommends that the Operator continue to monitor the stability of this highwall. Reseeding may be necessary to produce enough stabilizing vegetation to prevent further erosion damage.

**Photo 9.** View looking east at highwall located near eastern boundary of permit area. Some new vegetation can be seen on the slope.

**Photo 10.** View looking northeast at highwall located near eastern boundary of permit area. Some new vegetation can be seen on the slope.

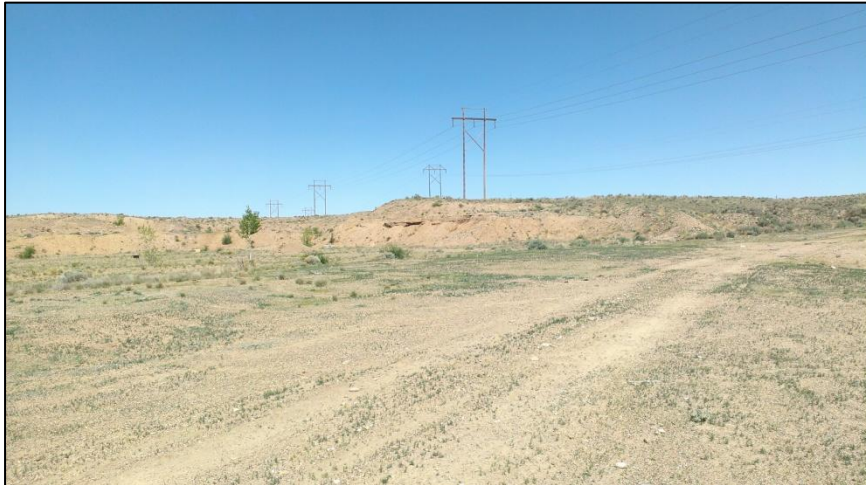
In the November 26, 2014 inspection report, erosion damage was also observed along the access road. During the current inspection, the access road was graded over and no erosion damage was observed (Photo 11).

**Photo 11.** View looking northwest from southeastern portion of permit area, showing access road in foreground. No erosion damage was observed on the access road.
