# COLORADO DIVISION OF RECLAMATION, MINING AND SAFETY MINERALS PROGRAM INSPECTION REPORT

<b>MINE NAME:</b> Blue Water Claim	<b>MINE/PROSPECTING ID#:</b> P-2013-014	<b>MINERAL:</b> QTZ	<b>COUNTY:</b> Teller
<b>INSPECTION TYPE:</b> Possible Illegal(Unpermitted Operation)	<b>INSPECTOR(S):</b> Timothy A. Cazier	<b>INSP. DATE:</b> September 4, 2013	<b>INSP. TIME:</b> 14:55
<b>OPERATOR:</b> Richard Bolen	<b>OPERATOR REPRESENTATIVE:</b> NONE	<b>TYPE OF OPERATION:</b> ILL - Illegal

## Blue Water Claim Inspection: September 4, 2013

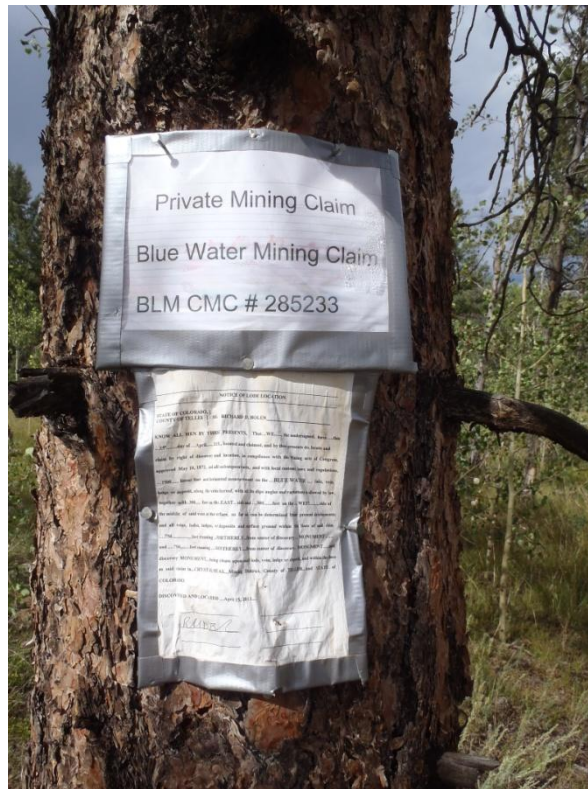
A posted mining claim (see **Photo 1**) was observed on a tree at the end of the pioneered access road (see **Photo 2**) east of the structures on site identifying the site as the “Blue Water Mining Claim”. Observed surface excavation disturbances were limited to three small pits (see **Photos 3 and 4**). In addition to the small camping trailer, large and small utility trailers, a four-wheeler, and a 16’ x 16’ permanent structure (under construction) were also observed (see **Photos 5 – 7**).

Photo 1. Private mining claim (on tree at edge of disturbed area).

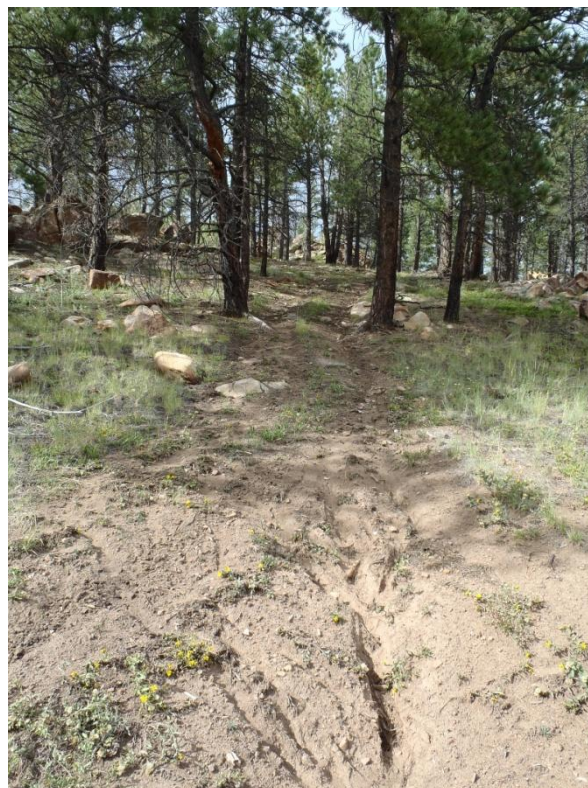
Photo 2. Access road (looking west).

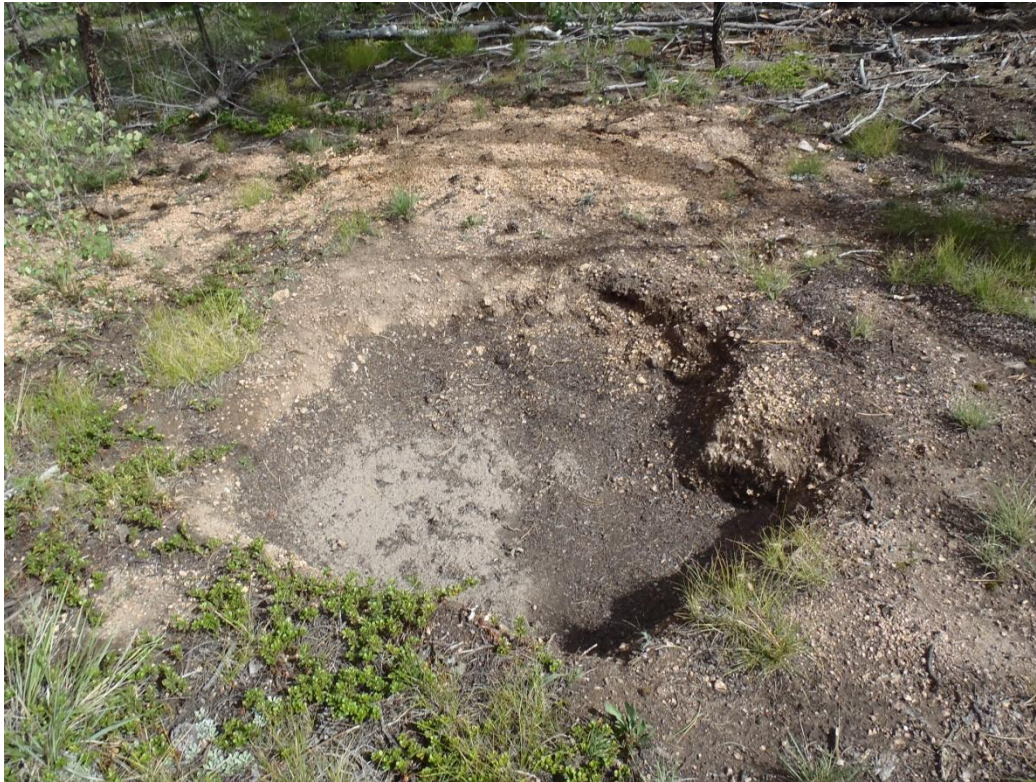
The prospecting/mining activity (three small holes) were estimated to be less than 150 square feet (combined). Due to the limited prospecting/mining disturbance (i.e., < 1,600 sq. ft.), the Division does not require a permit at this time.

Photo 3. Typical small excavated pit (west side of disturbed area).

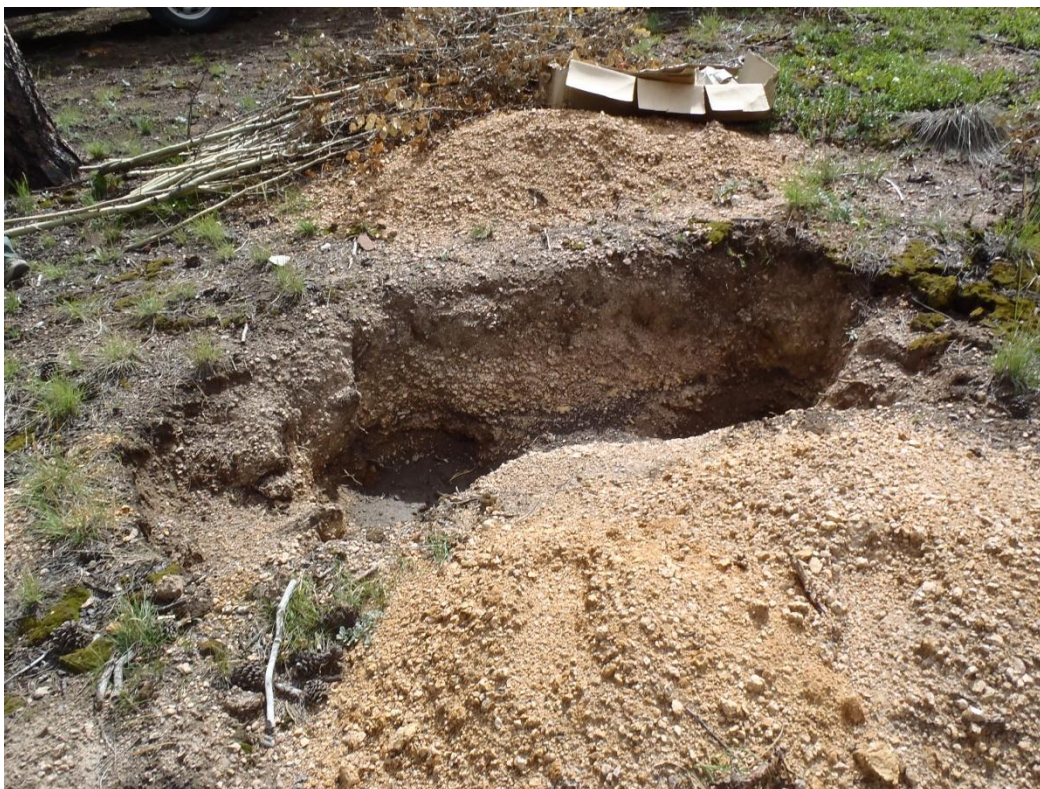
Photo 4. Typical small excavated pit (near trailer).

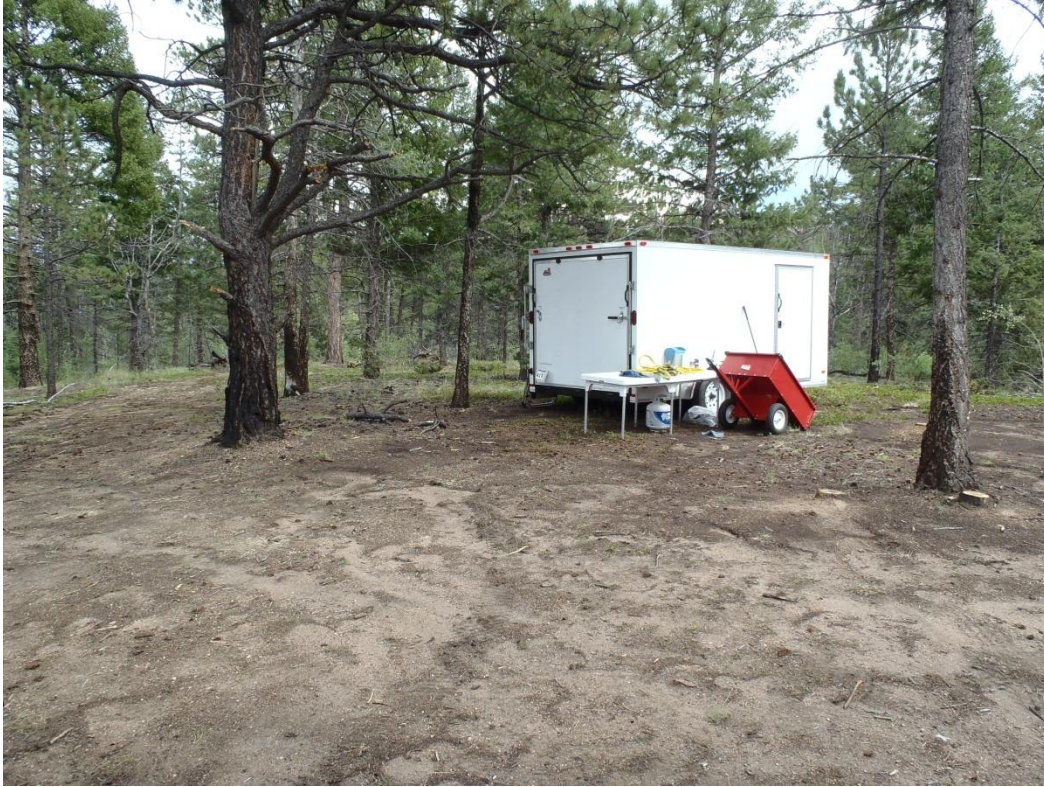
Photo 5. Utility trailers (looking east).

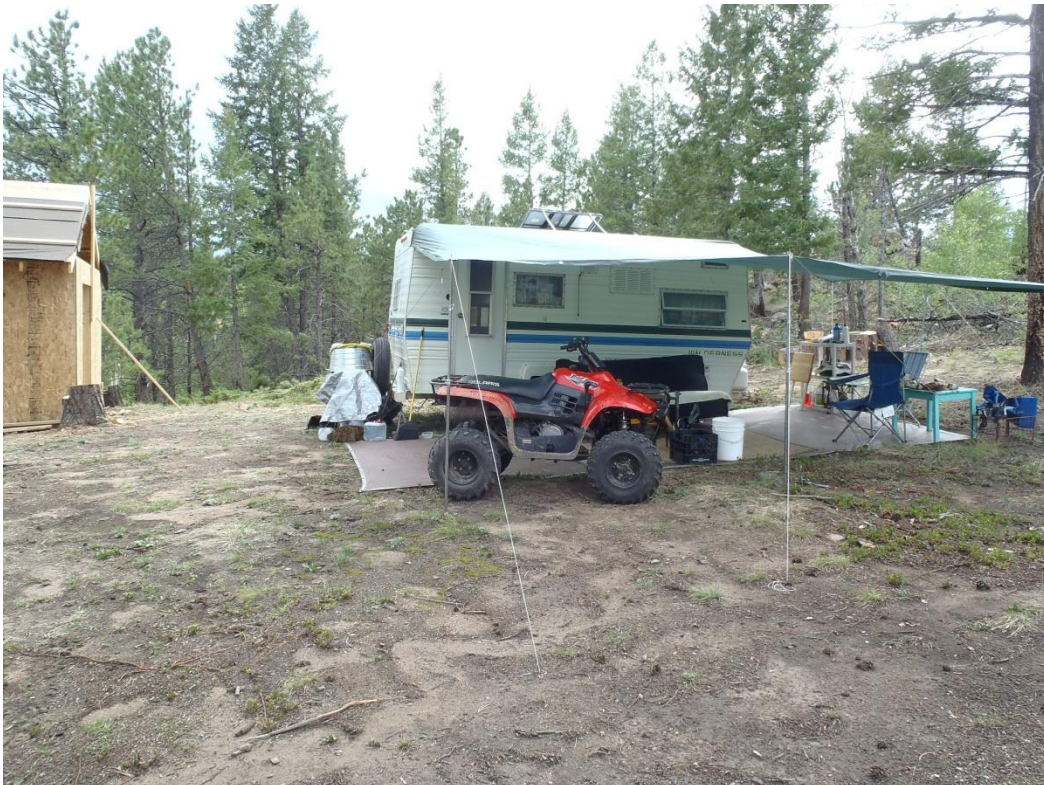
Photo 6. Camping trailer and four-wheeler.

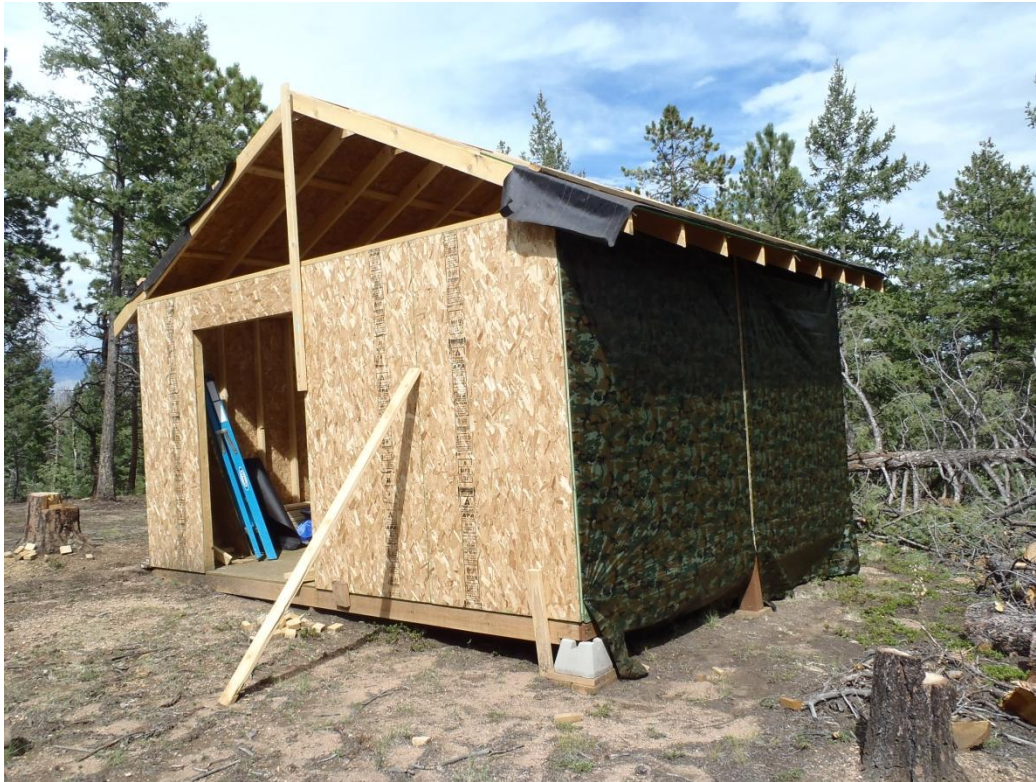
Photo 7. Permanent structure (under construction).

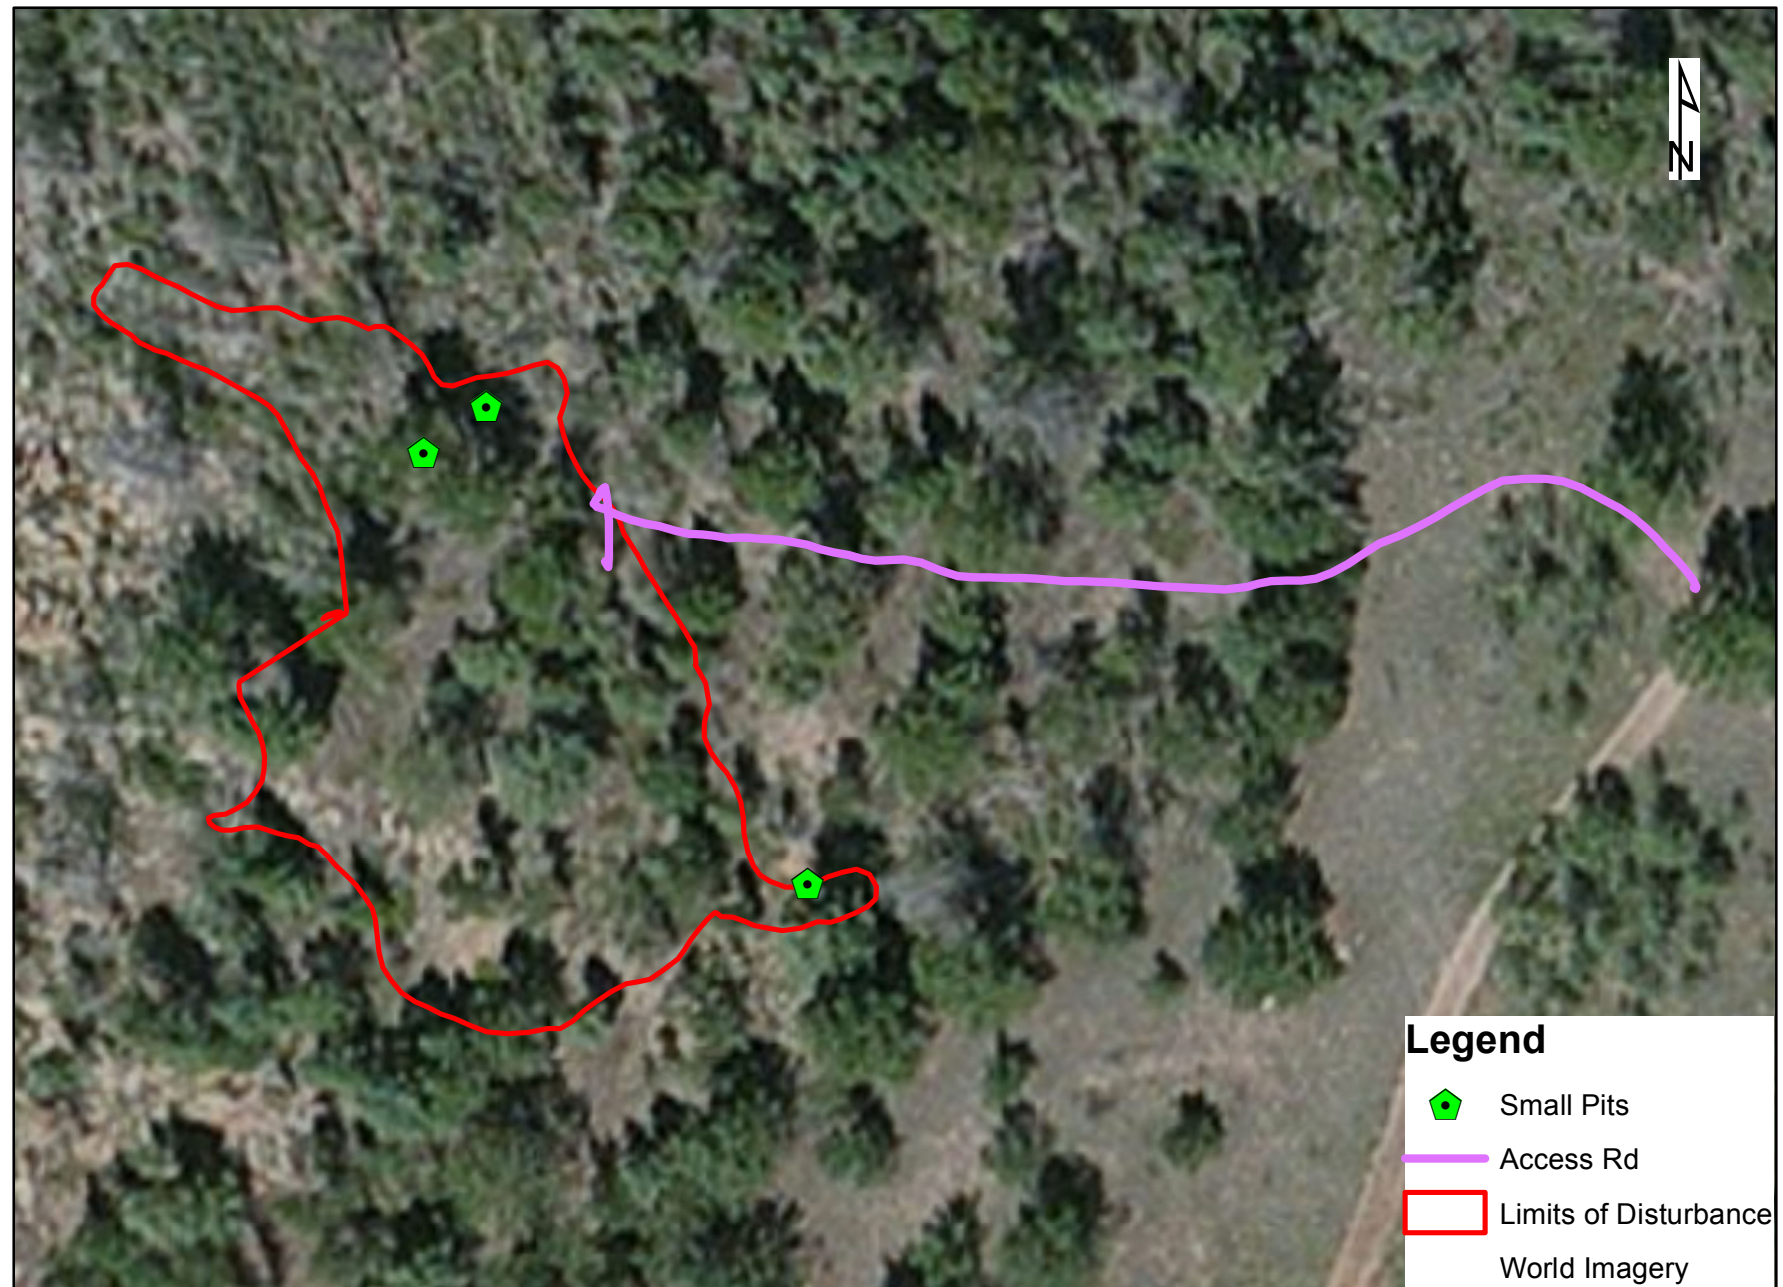
The three excavation holes were located using a hand-held Trimble Juno GPS. The same unit was used to measure the length of the access road and establish the perimeter of the combined camping and prospecting/mining disturbances. The attached “Blue Water Claim Inspection” map shows the extent of these disturbances. An additional image captured from Google Earth, dated September 27, 2013(after the inspection) shows the location of the structure and the trailers.
