COLORADO DIVISION OF RECLAMATION, MINING AND SAFETY
MINERALS PROGRAM INSPECTION REPORT
PHONE: (303) 866-3567

MINE NAME: Schmidt Site	MINE/PROSPECTING ID#: M-2011-014	MINERAL: Topsoil	COUNTY: Archuleta
INSPECTION TYPE: Monitoring	INSPECTOR(S): Kate A. Pickford	INSP. DATE: April 11, 2014	INSP. TIME: 10:10
OPERATOR: Dale and Ellen Schmidt	OPERATOR REPRESENTATIVE: Dale Schmidt	TYPE OF OPERATION: 110c - Construction Limited Impact

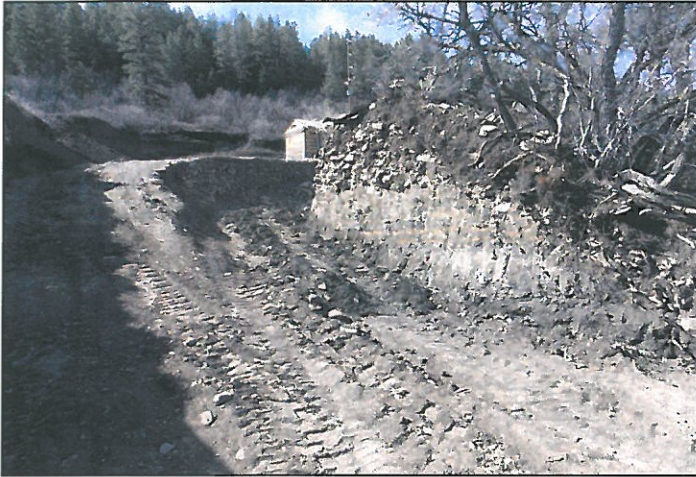
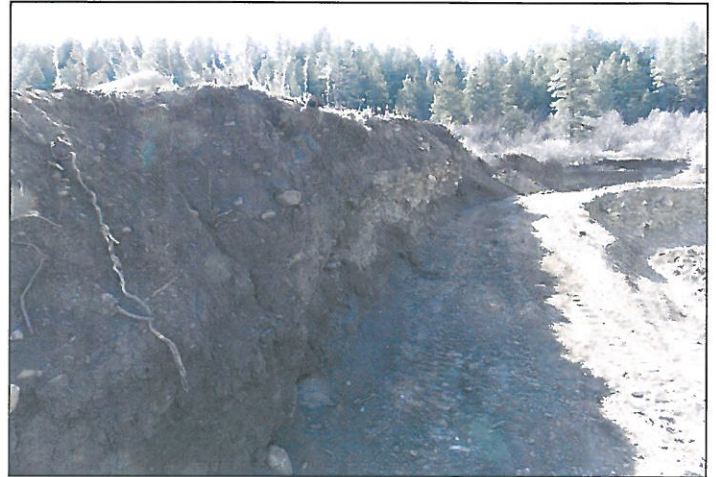
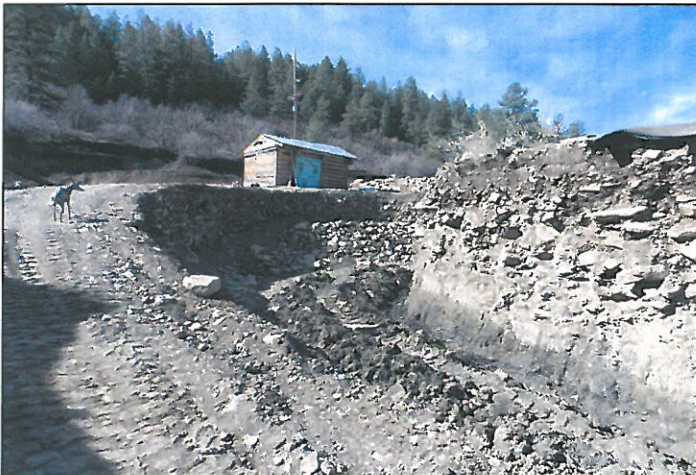
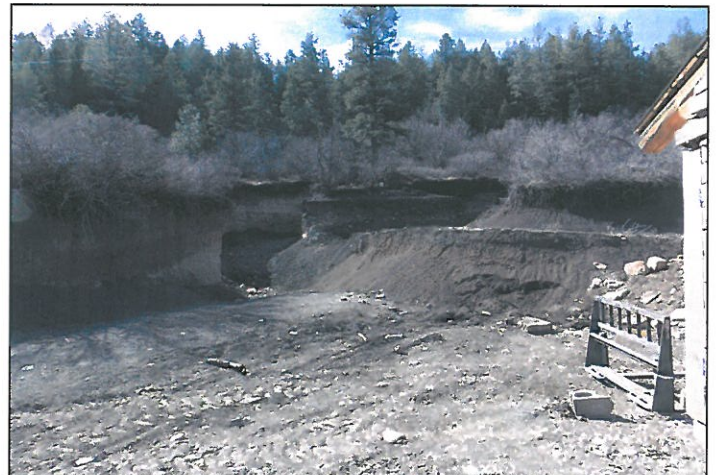
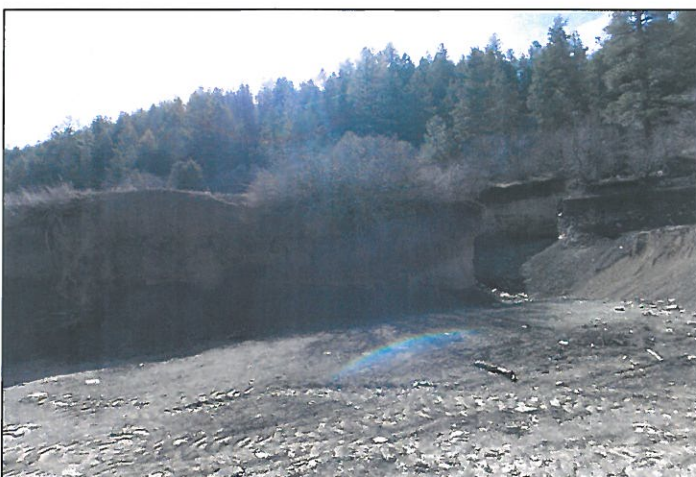
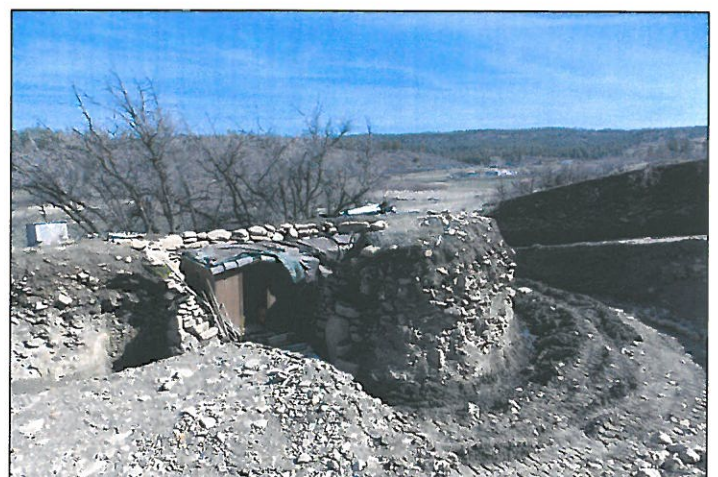
PHOTOGRAPHS

This inspection was conducted as part of the Division of Reclamation, Mining and Safety monitoring program. The site is more extensively excavated than at the time of the previous inspection. Much of the original slope has been cut out, resulting in a vertical highwall adjacent to the neighboring property to the east. The current highwall is approximately 20 feet high, but Mr. Schmidt states he wants to extract it even deeper, to the level that is about 10 feet lower. The cut extends well into the slope and vertical highwalls are the most evident feature at the site. Mr. Schmidt has placed a storage shed into a spiraled wall adjacent to the access road. He is installing rock walls to stabilize the vertical high walls around the shed. He stated that he has a lot of rock from the excavation, and he wants to armor the other vertical walls with rocks.

The rock walls do not appear stable. The reclamation plan shows engineered plans to use tire bales to stabilize the walls. The rock armoring is not a feature of the reclamation plan. The approved plan cited an alternative reclamation plan that involved grading and backfilling of the site, in order to keep reclamation costs down. The condition of the site does not allow for efficient backfilling or grading. The bulk of the extracted material has been exported off site. Therefore there is little material with which to backfill. Additionally, one vertical highwall is so close to the property line and so high that it will take a great deal of excavation around the site and moving of material to establish a stable configuration and may require the importation of fill.
