**COLORADO DIVISION OF RECLAMATION, MINING AND SAFETY**  
**MINERALS PROGRAM INSPECTION REPORT**  
**PHONE: (303) 866-3567**

<b>MINE NAME:</b> Schwartzwalder Mine	<b>MINE/PROSPECTING ID#:</b> M-1977-300	<b>MINERAL:</b> Uranium	<b>COUNTY:</b> Jefferson
<b>INSPECTION TYPE:</b> Monitoring	<b>INSPECTOR(S):</b> Tom Kaldenbach	<b>INSP. DATE:</b> October 11, 2013	<b>INSP. TIME:</b> 1:00 pm
<b>OPERATOR:</b> Cotter Corporation	<b>OPERATOR REPRESENTATIVE:</b> John Hamrick	<b>TYPE OF OPERATION:</b> 112d-2 - Designated Mining Operation

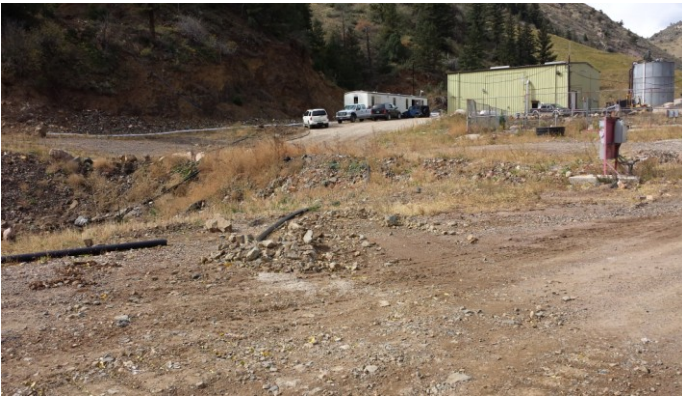
The ion exchange treatment plant was operating during the inspection. This plant removes uranium from groundwater that is collected in alluvial sumps. The treated water was discharging into Ralston Creek at BPL at about 50 gpm.

Photo 1 – Ion exchange treatment plant building.

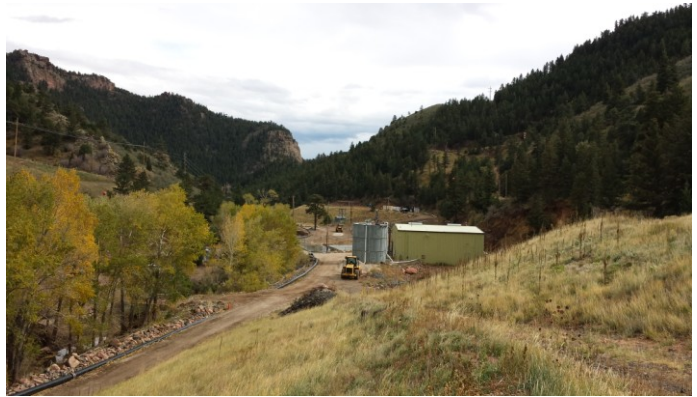
Photo 2 – View to east from on top of South Waste Rock Pile.

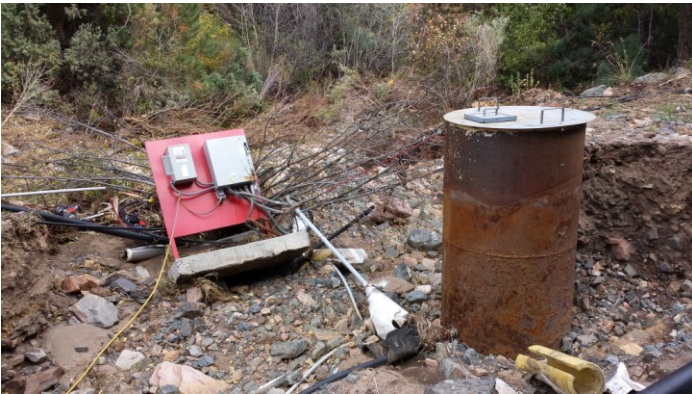
Photo 3 – One of alluvial ground water sumps damaged by storm waters.

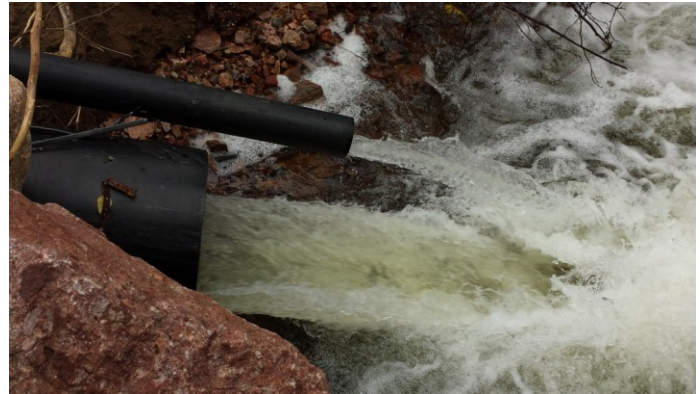
Photo 4 – Discharges into Ralston Creek near BPL from creek diversion (large HDPE) and ion exchange treatment plant (small HDPE).

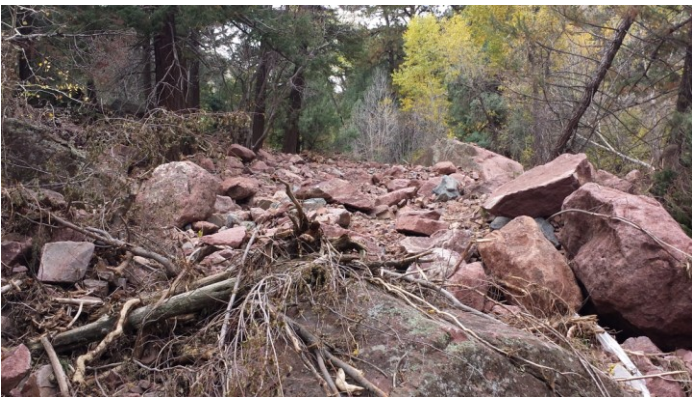
Although the surface facilities at the mine suffered relatively minor damage from the storms, there was ample evidence of heavy stormwater flows on the north slope of the Ralston Creek Valley. Large gullies and rock debris flows extended down the valley's north slope at three locations inside or next to the permit area. The debris flows included a few large trees that had been uprooted by the storm flows. One rock debris flow completely destroyed the mine's access road outside the permit boundary where the road approaches the entrance gate of the mine. The operator's representatives explained that the access road also was largely destroyed at other locations where the road crossed steep slopes between the mine entrance gate and Ralston Reservoir.

Photo 5 – Debris flow outside mine entrance gate on slope north of Ralston Creek.

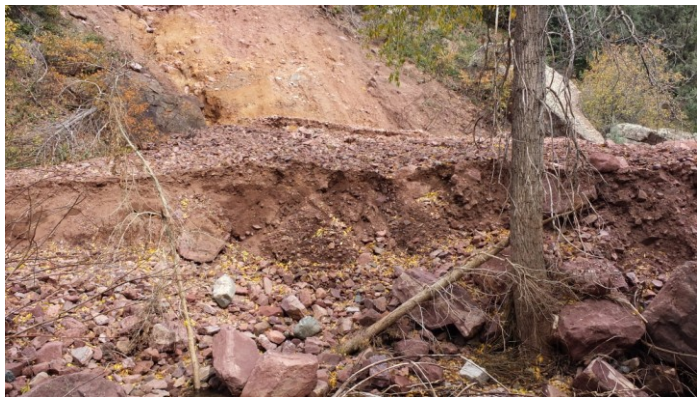
Photo 6 – Erosion cut-face on north side of Ralston Creek outside permit area near location of Photo 5.

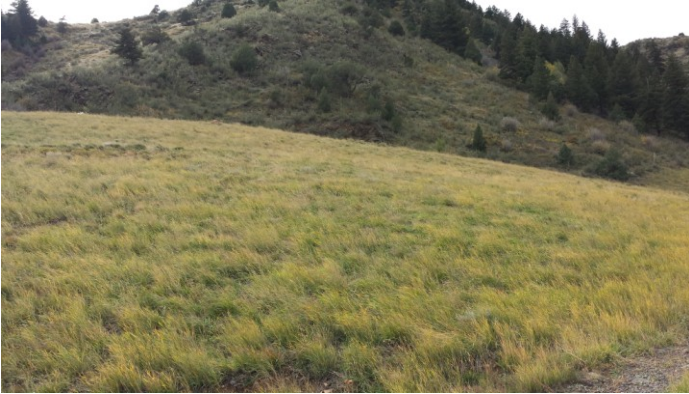
Photo 7 – Top of South Waste Rock Pile.

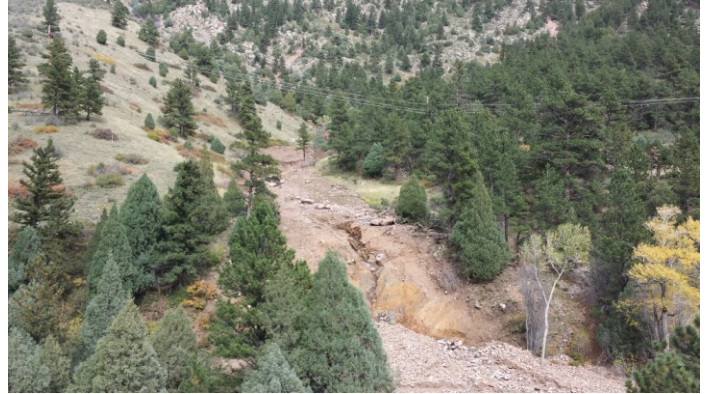
Photo 8 – Gully on north slope of Ralson Creek valley. Land is inside permit area, but has not been disturbed by mining activities.

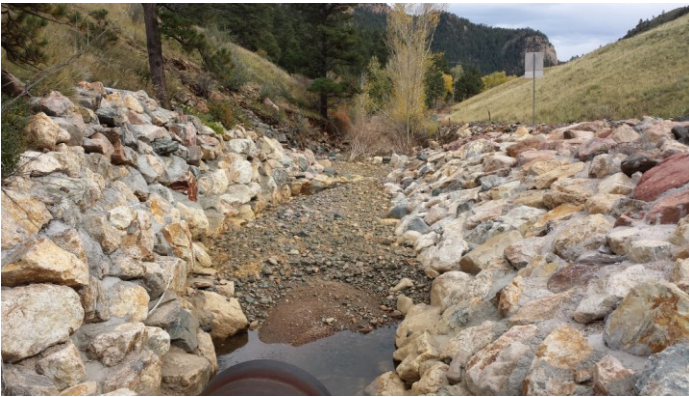
The channel of Ralston Creek in the permit area had been heavily scoured by the storm flows, resulting in the channel being significantly deeper, wider, and straighter than before the storms.

Photo 9 – Ralston Creek channel at outlet end of pipe that extends through diversion cut-off wall on west side of permit area

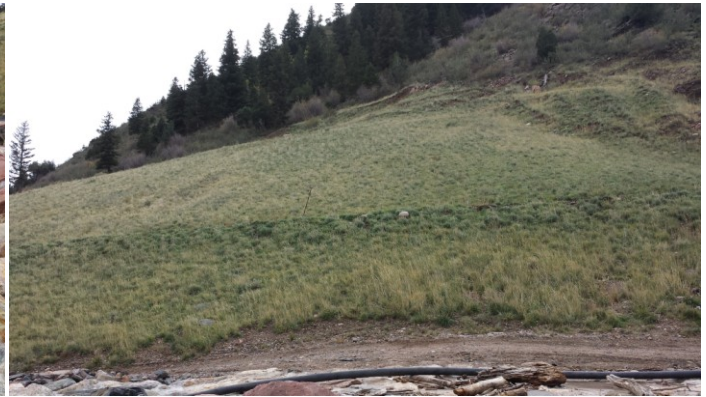
Photo 10 – South Waste Rock Pile.

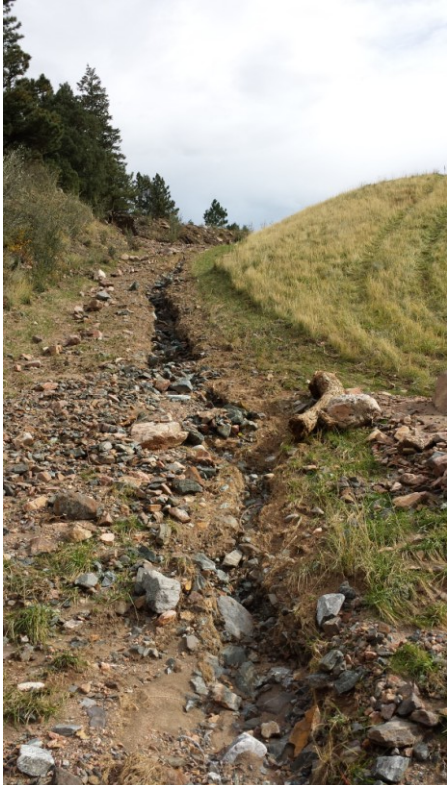
The North and South Waste Rock Piles withstood the storm flows very well with grass and shrub cover having protected the waste piles. There was an approximate 2-foot deep gully incised in the drainage that extends along the northwest side of the North Pile. Water was discharging at about 10 gpm from a 4-inch diameter black PVC pipe that extended from the upper part of the North Waste Rock Pile to the face of the pile. There were only a few small gullies on the South Pile.

Photo 11 – Gully behind North Waste Rock Pile.
