**COLORADO DIVISION OF RECLAMATION, MINING AND SAFETY
MINERALS PROGRAM INSPECTION REPORT**

MINE NAME: Smuggler Mine	MINE/PROSPECTING ID#: M-1995-097	MINERAL: Silver, lead, zinc and	COUNTY: Pitkin
INSPECTION TYPE: Monitoring	INSPECTOR(S): Dustin M. Czapla	INSP. DATE: June 10, 2014	INSP. TIME: 12:00
OPERATOR: New Smuggler Mine Company	OPERATOR REPRESENTATIVE: Roger Mestler	TYPE OF OPERATION: 110(2) - Hard Rock Limited Impact	
REASON FOR INSPECTION: Normal I&E Program	BOND CALCULATION TYPE: Complete Bond	BOND AMOUNT: \$79,888.00	
DATE OF COMPLAINT: NA	POST INSP. CONTACTS: None	JOINT INSP. AGENCY: None	
WEATHER: Clear	INSPECTOR'S SIGNATURE:

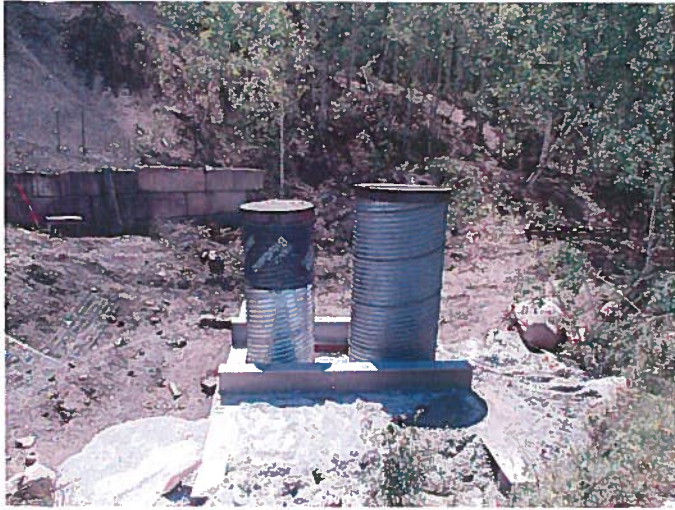
Figure 1: Smuggler Shaft

The Smuggler Shaft closure is currently under construction. Until construction is complete and found to be adequate by the Division, closure costs will be included in the updated financial warranty estimate.

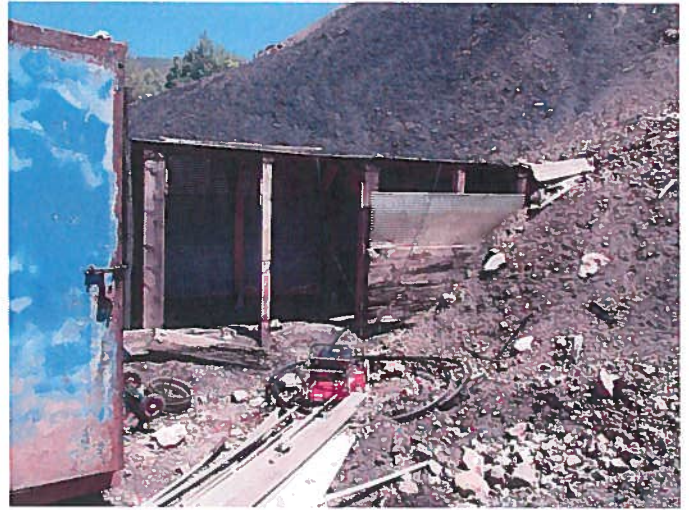
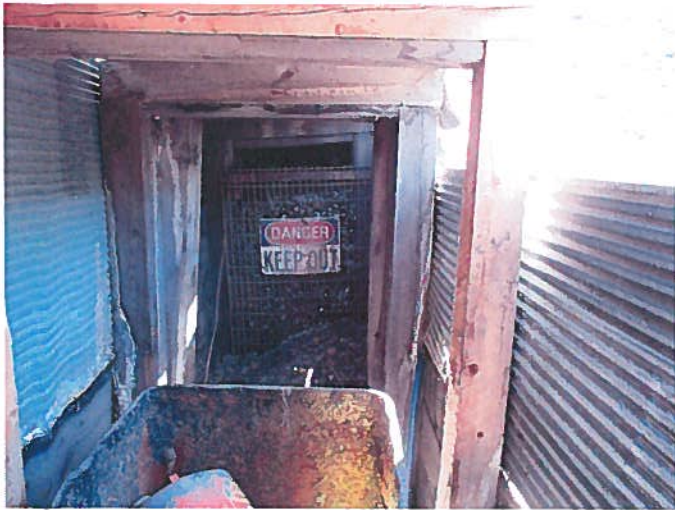
Figure 2: Tunnel No. 1A

Tunnel No. 1A and Tunnel No. 3 are collapsed. The Clark Tunnel and Tunnel No. 2 are adequately closed with steel gates with hooded locks. Closure costs for these openings will be removed from the updated financial warranty estimate.
