COLORADO DIVISION OF RECLAMATION, MINING AND SAFETY
MINERALS PROGRAM INSPECTION REPORT
PHONE: (303) 866-3567

MINE NAME: Schwartzwalder Mine	MINE/PROSPECTING ID#: M-1977-300	MINERAL: Uranium	COUNTY: Jefferson
INSPECTION TYPE: Monitoring	INSPECTOR(S): Tom Kaldenbach	INSP. DATE: March 27, 2014	INSP. TIME: 10:00 am
OPERATOR: Cotter Corporation	OPERATOR REPRESENTATIVE: John Hamrick	TYPE OF OPERATION: 112d-2 - Designated Mining Operation

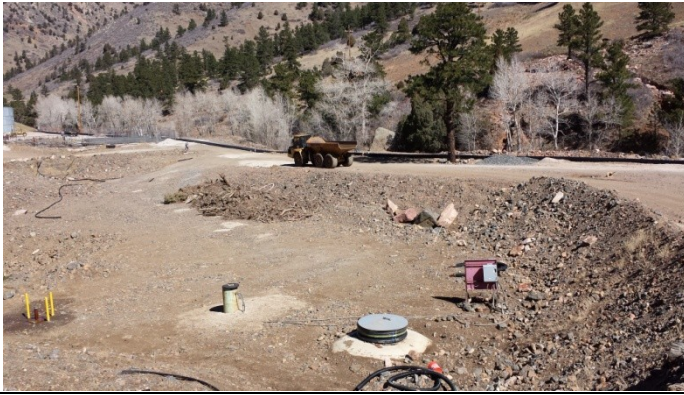
Photo 1 – Sump 10 and monitoring wells.

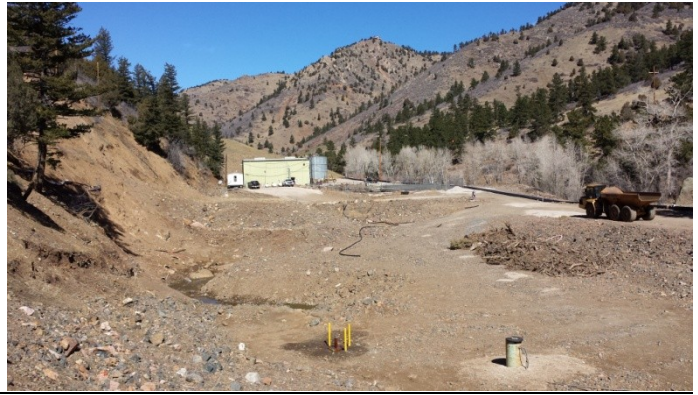
Photo 2 – Sump 10 in foreground; ion exchange treatment plant building in distance.

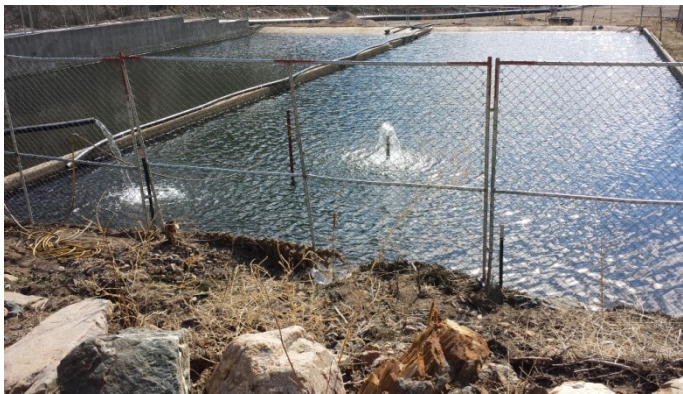
Approximately 180 gpm of alluvial ground water from sumps 1, 4, 5, 8, and 10 was being treated in the ion exchange plant. The treated water was being discharged into Ralston Creek near the BPL location. Water from the sumps was being cycled through the south concrete-lined pond outside the IX treatment plant in order to increase retention time. The in-situ and RO treatment plant at the Steve Level remains idle, pending Ralston Creek road repairs which will allow large trucks to bring in the chemicals necessary to operate the RO treatment plant.

Photo 3 – Concrete-lined ponds outside ion exchange treatment plant.

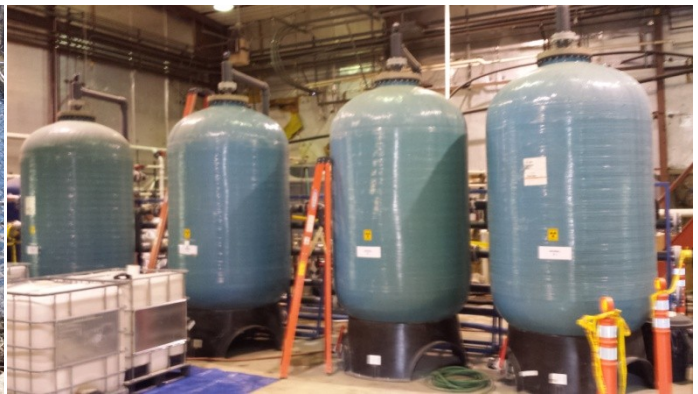
Photo 4 – Resin tanks in ion exchange treatment plant.

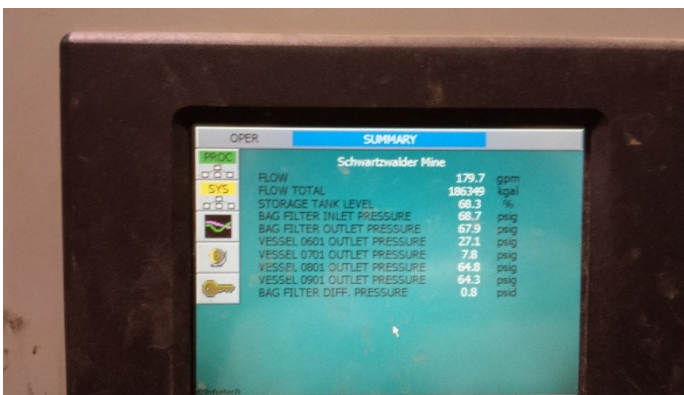
Photo 5 – Monitoring screen in ion exchange treatment plant, showing plant throughput of 179.7 gpm.

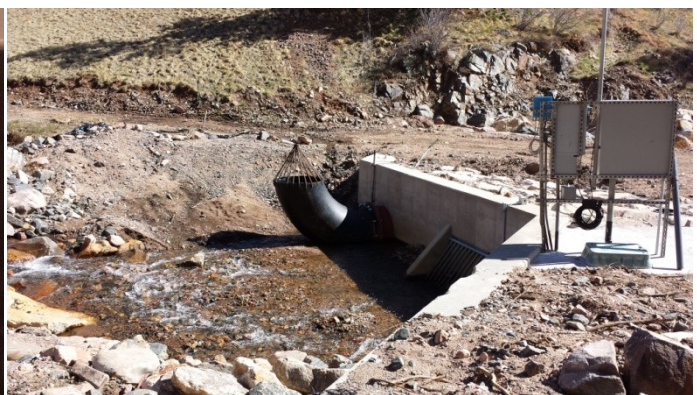
Ralston Creek flows were not high enough to feed the diversion pipeline.

Photo 6 – Ralston Creek diversion inlet pipe with trash rack at upper cutoff wall..

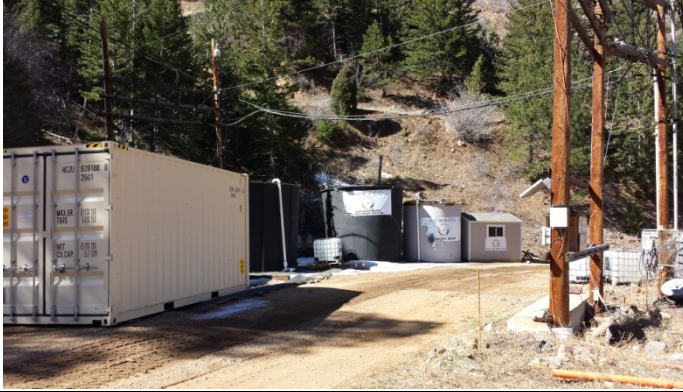
Photo 7 – Insitu-treatment plant at Steve Adit (currently idle).

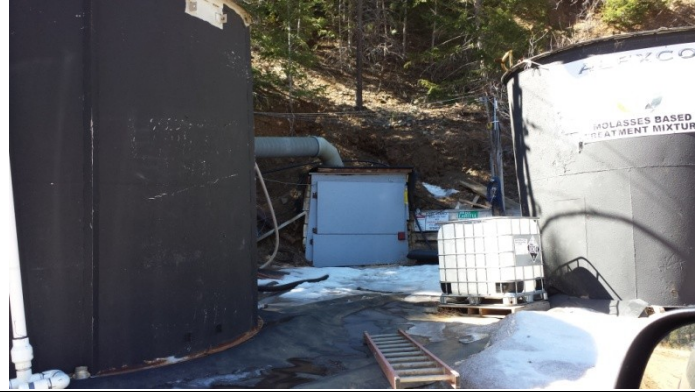
Photo 8 – Steve Adit portal.

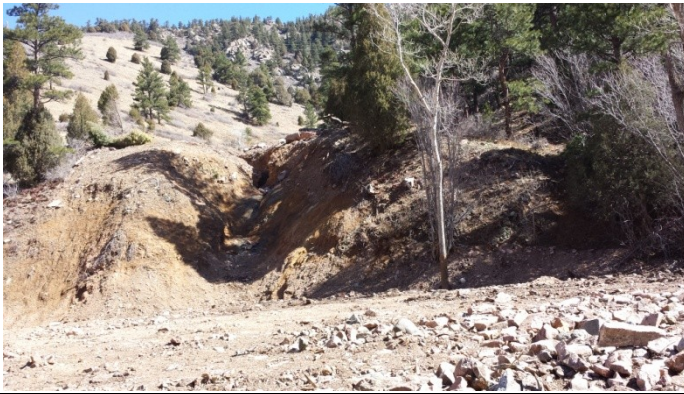
The operator has completed some regrading of storm-damaged areas in the permit area.

Photo 9 – Area recently regraded at mouth of gully on west side of Ralston Creek.

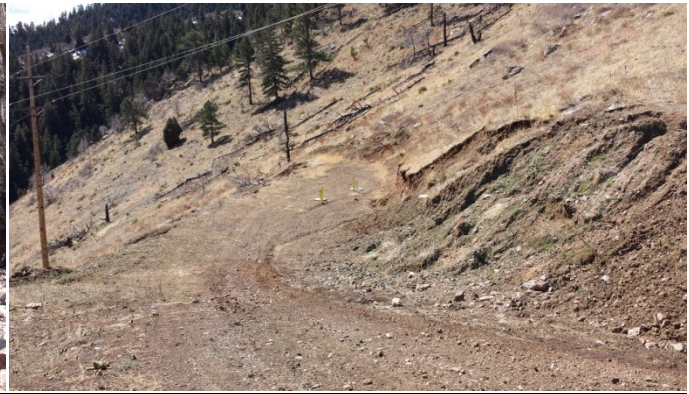
Photo 10 – Bedrock monitoring well MW-15.
