COLORADO DIVISION OF RECLAMATION, MINING AND SAFETY
MINERALS PROGRAM INSPECTION REPORT
PHONE: (303) 866-3567

MINE NAME: Winkler Light Aggregate Quarry	MINE/PROSPECTING ID#: M-1989-065	MINERAL: Crushed stone	COUNTY: Douglas
INSPECTION TYPE: Acreage Release	INSPECTOR(S): Tom Kaldenbach	INSP. DATE: November 7, 2014	INSP. TIME: 10:30 am
OPERATOR: Schmidt Construction Company	OPERATOR REPRESENTATIVE: Mark Heifner	TYPE OF OPERATION: 112c

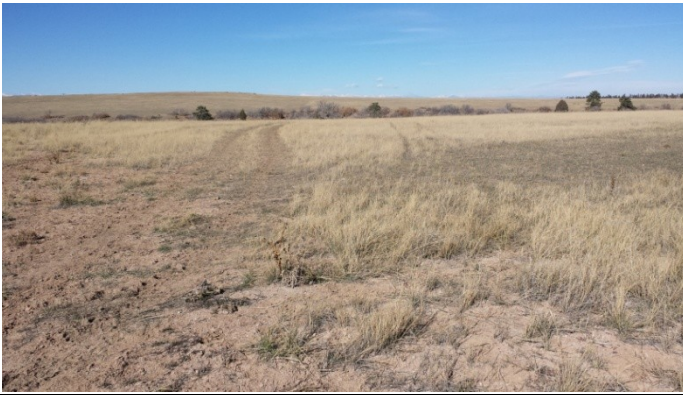
The approved post-mining land use of the acreage release area is rangeland. The release area is well-vegetated with a dense stand of grasses, with abundant western wheatgrass and blue grama. No weed problems or bare areas were found. No erosional problems were found. The release area blends well with the adjacent undisturbed land to the east and north. The diversity and density of the grasses can be expected to be self-sustaining and support grazing by livestock and wildlife. . The observations made during this inspection support approval of the acreage release.

Photo 1 – Acreage release area.

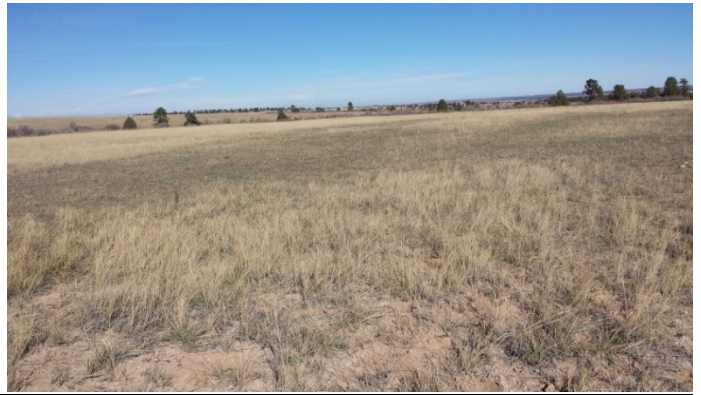
Photo 2 – Acreage release area.–

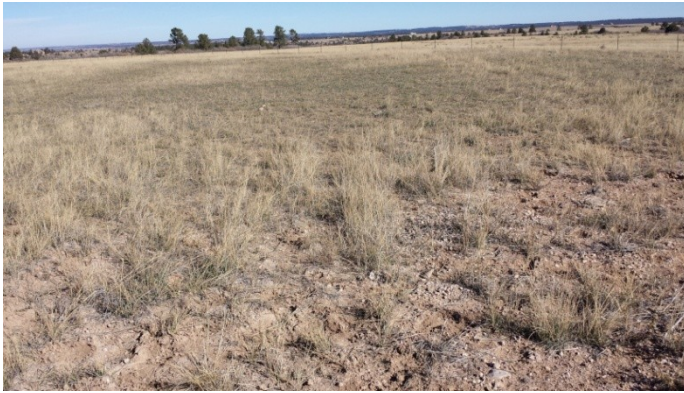
Photo 3 – – Acreage release area.

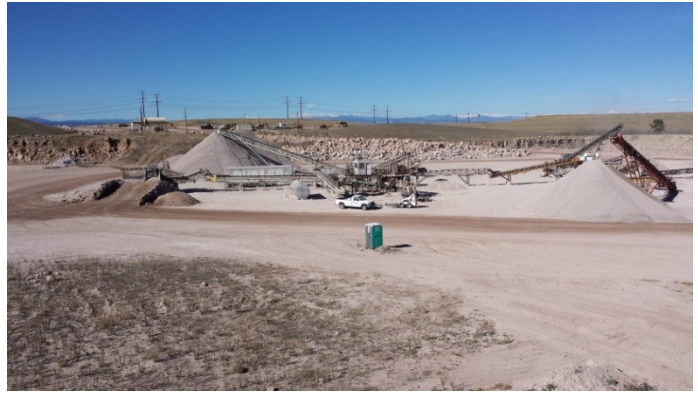
Photo 4 – Active pit area.

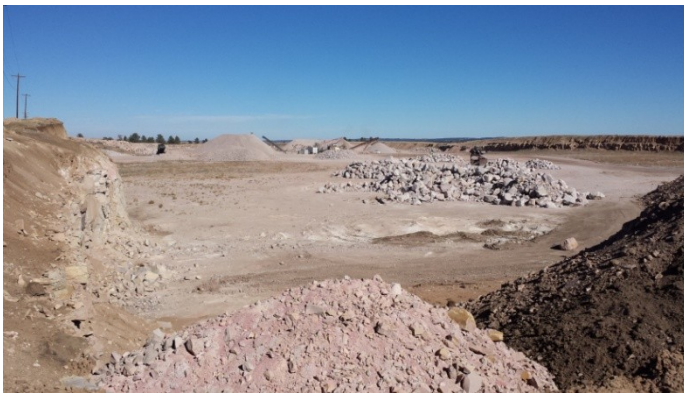
Photo 5 – Active pit area.

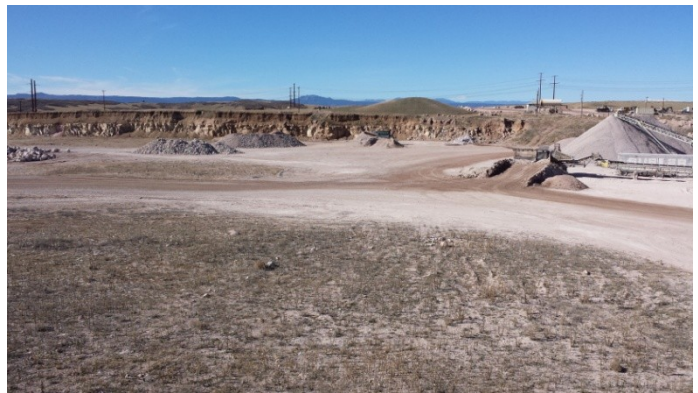
Photo 6 – Active pit area.

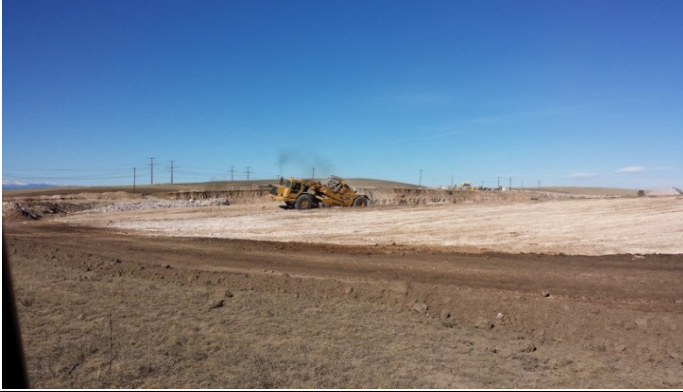
This was an acreage release inspection conducted by Tom Kaldenbach of DRMS. The operator was represented by their consultant, Mark Heifner.. The ground was dry. The site was active with crushing and screening operations in the pit and trucks hauling material from the site. A scraper was removing topsoil in an area along the south side of the pit.

Photo 7 – Scraper removing topsoil.

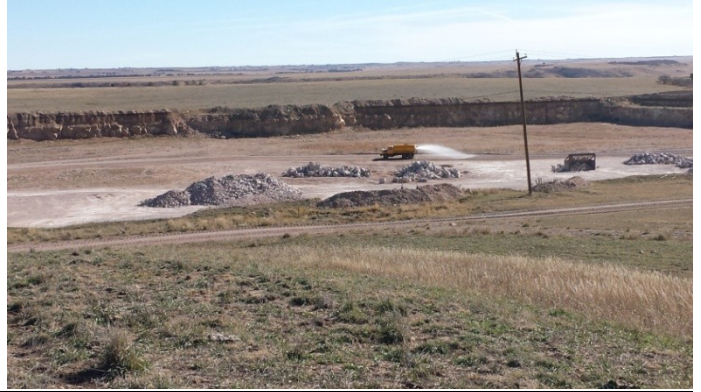
A water truck was spraying for dust control. The total disturbed area of the mine is less than the 100 acres that is approved to be disturbed at any one time. The \$375,000 of reclamation bond on deposit is adequate. The mine appeared to be operating in compliance with the mine plan.

Photo 8 – Water truck spraying for dust control.

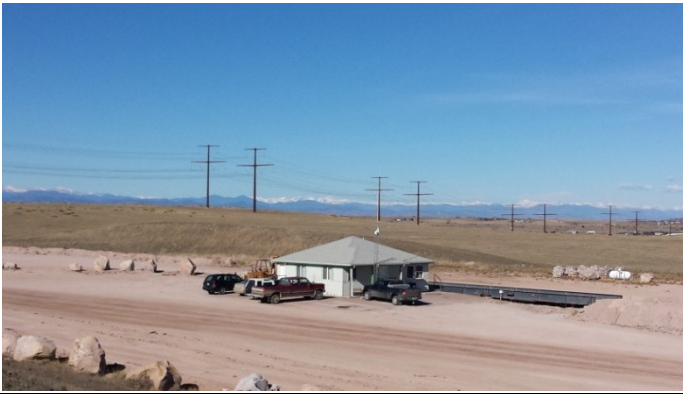
Photo 9 – Office.
