COLORADO DIVISION OF RECLAMATION, MINING AND SAFETY
MINERALS PROGRAM INSPECTION REPORT
PHONE: (303) 866-3567

MINE NAME: Rocky Ford South Pit	MINE/PROSPECTING ID#: M-1977-222	MINERAL: Sand and gravel	COUNTY: Otero
INSPECTION TYPE: Monitoring	INSPECTOR(S): Amy Eschberger	INSP. DATE: May 8, 2014	INSP. TIME: 11:45
OPERATOR: ALL-RITE PAVING & REDI-MIX, INC.	OPERATOR REPRESENTATIVE: Herb Pearson	TYPE OF OPERATION: 112c - Construction Regular Operation

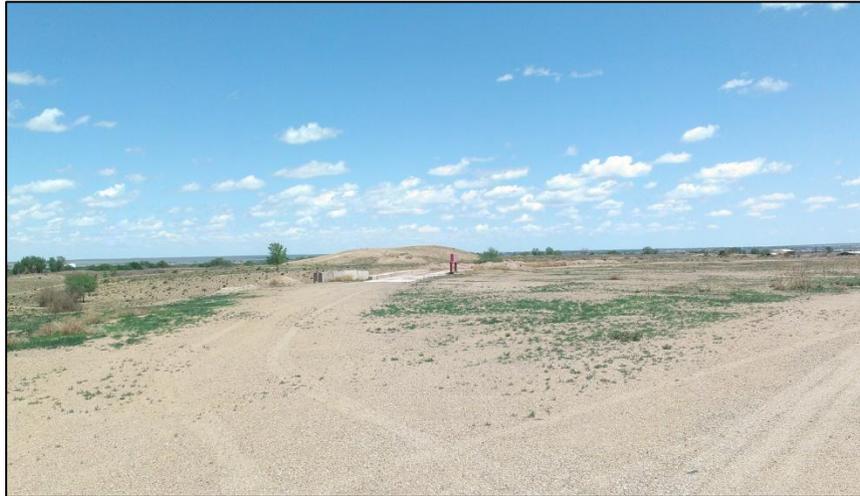
Photo 1. View looking northeast from near site entrance, showing road with scale (at left).

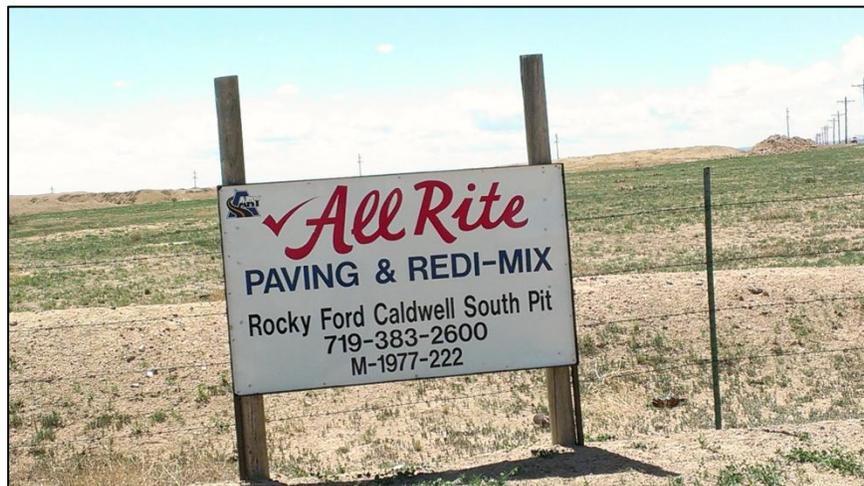
At the time of the inspection, it was clear, warm, and sunny, and no standing water was observed in the permit area. The permit sign was posted at the gated entrance to the site off of Co Rd 18 (Photo 2). However, the permit boundary was not marked. **This is cited as a Possible Problem for failure to mark the boundary of the affected area as required by Rule 3.1.12(2), and will require corrective action (see page 1).** During the inspection, a front-end loader and trailer were present on site. It appeared that the loader was being used to clean up stockpiles inside the pit.

Photo 2. Permit sign posted at gated entrance to site.

CORRECTIVE ACTIONS: The operator shall conduct a survey and replace the boundary markers in the correct location(s). The operator shall provide proof to the Division that this has been done by the corrective action date.

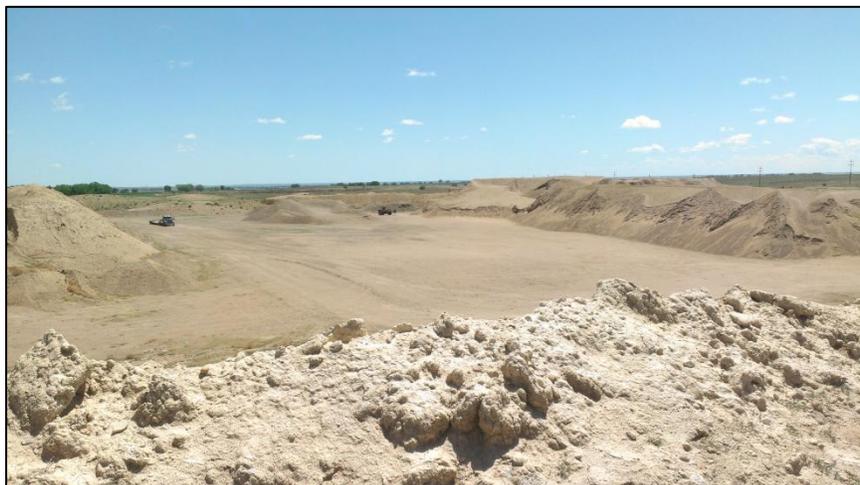
The active pit is located in the western portion of the permit area, and is 35-40 feet deep on average (Photo 3). Numerous stockpiles of mined material are stored inside the pit (Photo 4). Several smaller material stockpiles are present northeast of the pit along the haul road (Photo 5). Stockpiles of mined material and overburden are located in irregularly shaped berms around the edges of the pit (Photo 6). The northern, south-facing wall of the pit is approximately 250 feet long, with a 2H:1V slope (Photo 7). The western, east-facing wall is approximately 430 feet long, with a 3H:1V slope (Photo 8). The southwestern corner of the pit has a cut approximately 150 feet long with a 1H:1V slope (Photo 9). The southern wall of the pit is lined with large

Photo 3. View looking east from western permit boundary into active pit.

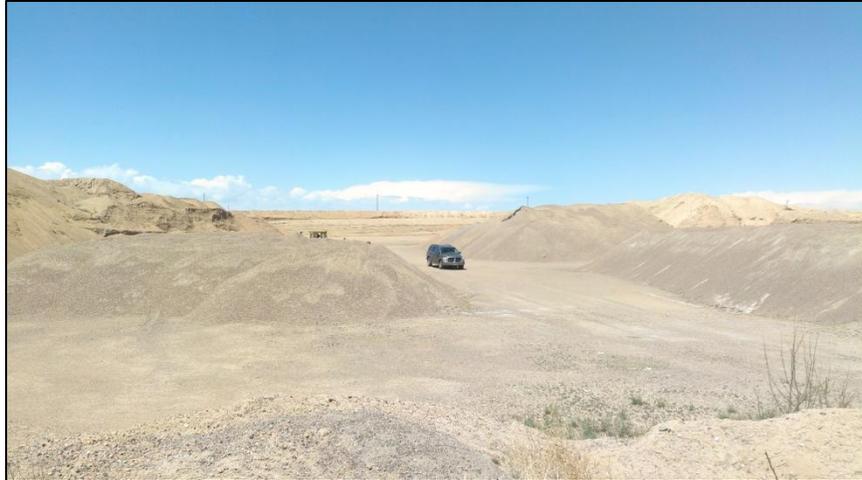
Photo 4. View looking into pit area from southeastern edge of pit, showing numerous stockpiles of material.

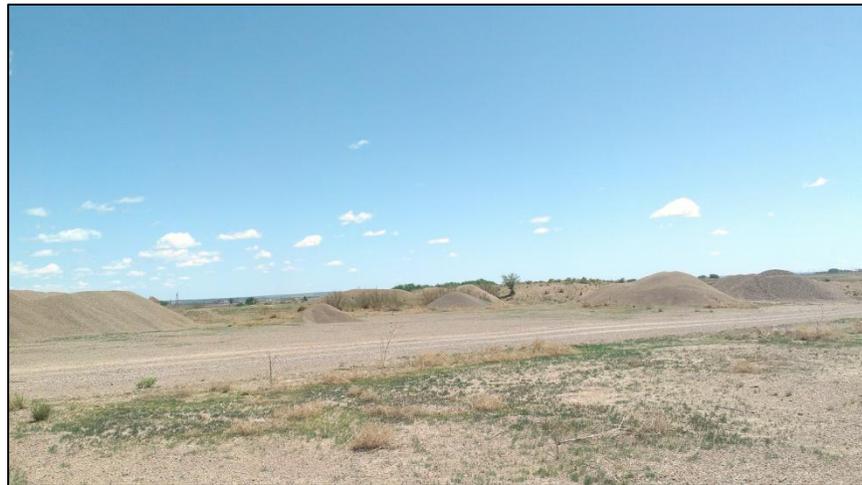
Photo 5. View looking east at several small stockpiles of material stored northeast of pit along haul road.

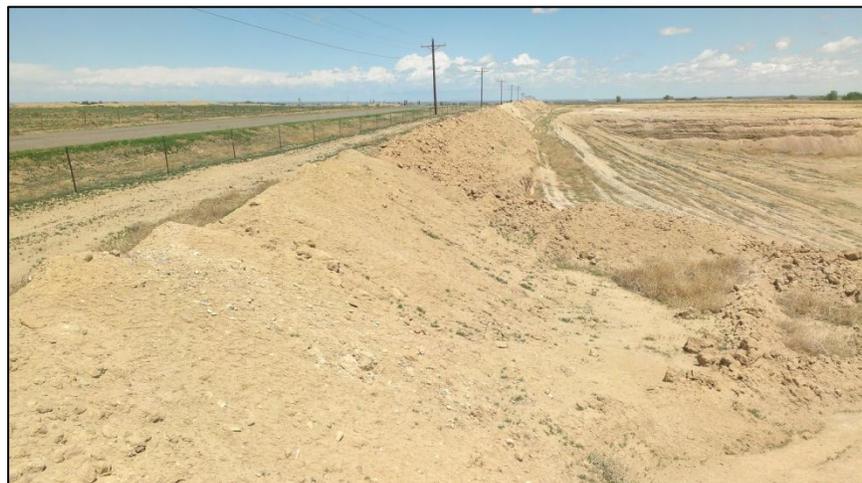
Photo 6. View looking north from southwestern corner of pit, showing overburden berm along western edge of pit.

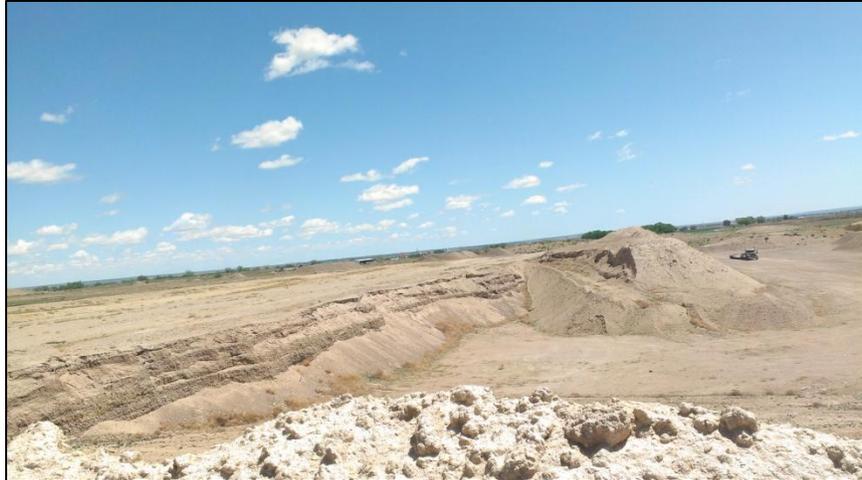
Photo 7. View looking northeast from western edge of pit at northern, south-facing pit wall approximately 250 ft long with a 2H:1V slope.

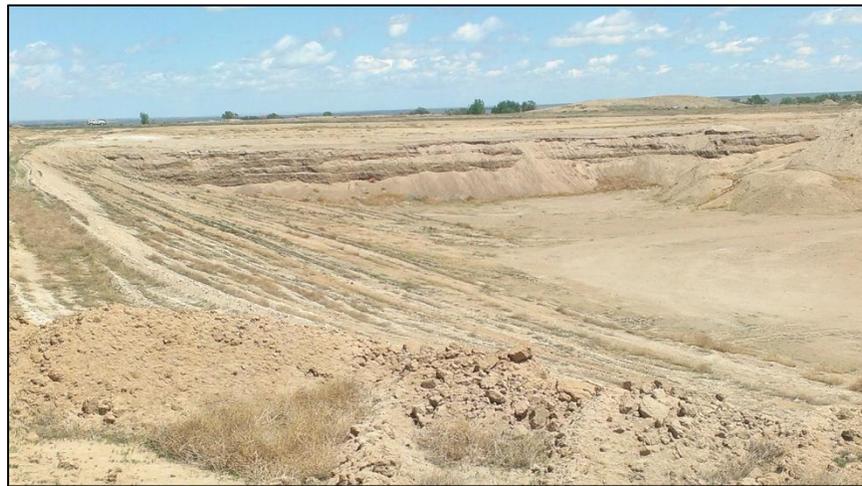
Photo 8. View looking northeast from southwestern corner of pit, showing western, east-facing pit wall approximately 430 ft long with a 3H:1V slope.

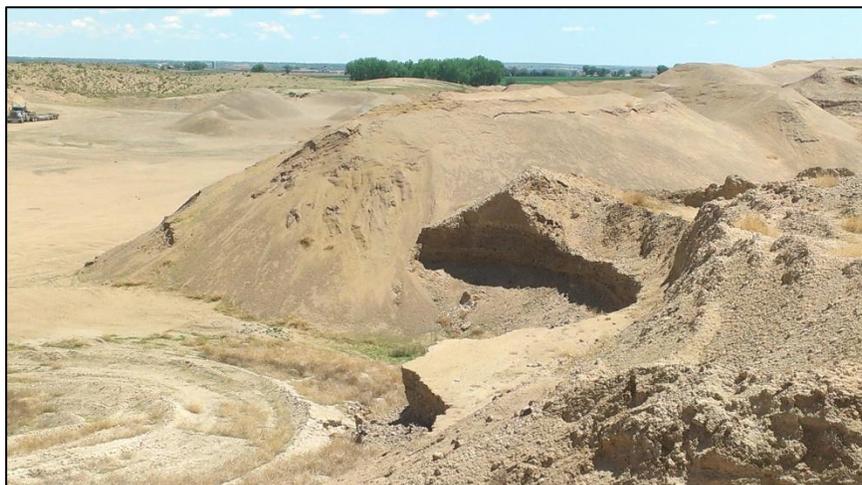
Photo 9. View looking east from southwestern corner of pit, showing north-facing cut approximately 150 ft long with a 1H:1V slope.

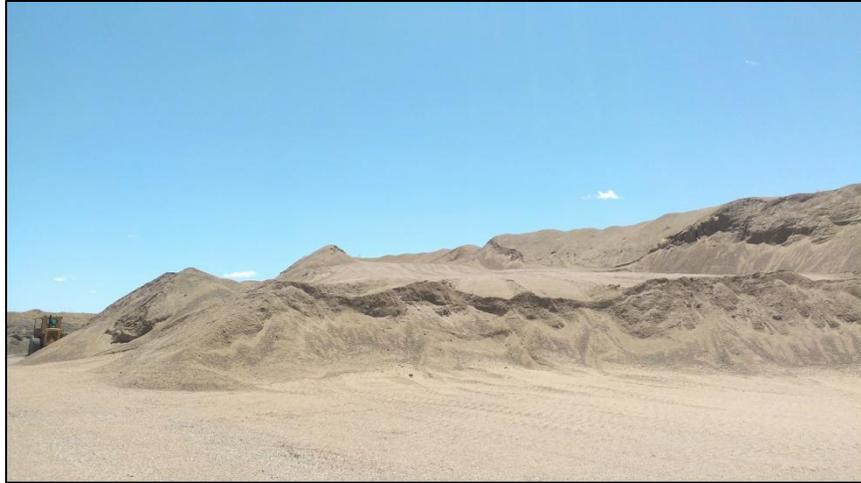
material stockpiles (Photo 10).

Photo 10. View looking southeast from center of pit, showing large material stockpile along southern pit wall. Note front-end loader at far left.

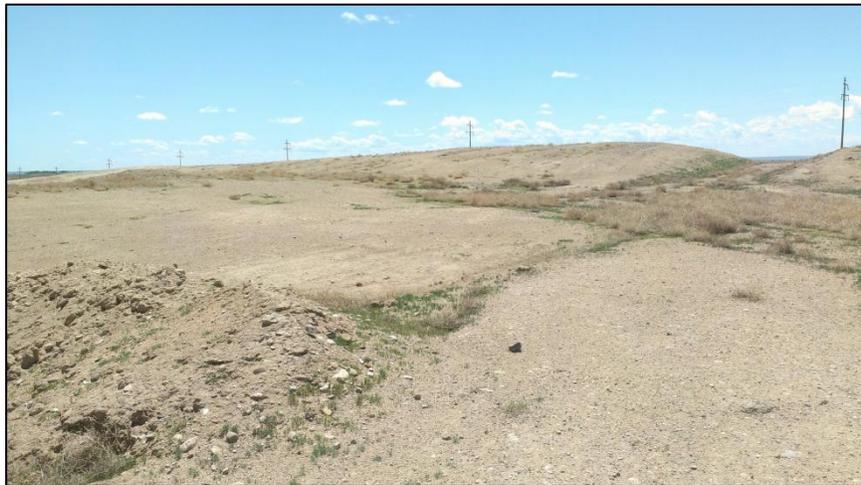
A small excavation approximately 200 feet long and 10-15 feet deep is present southeast of the pit. A disturbed area approximately 4.25 acres in size is located just southwest of the pit (Photo 11). A large topsoil stockpile is located along the far northern boundary of the permit area and is stable with grass cover. Another large topsoil stockpile is stored southeast of the pit and also appears to be stable.

Photo 11. View looking south/southeast at disturbed area just southwest of pit.

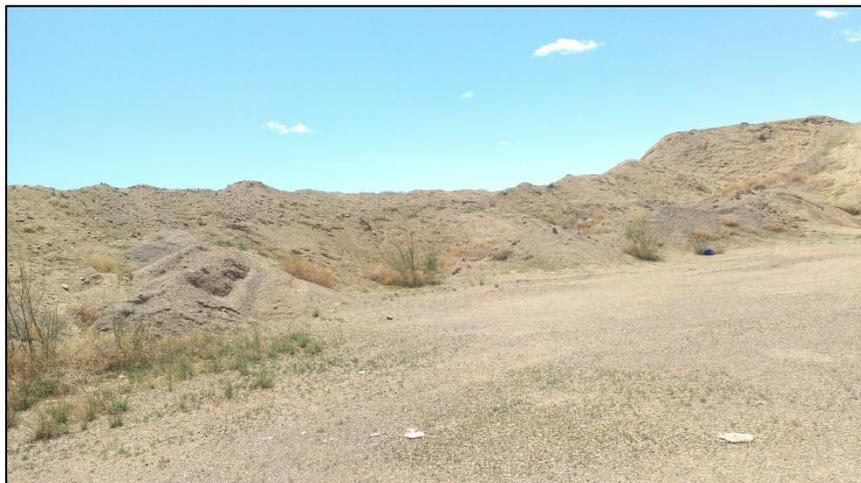
PROBLEM/POSSIBLE VIOLATION: Problem: There are state-listed noxious weeds present on site. This is a problem for failure to employ weed control methods for state listed noxious weed species within the permitted area, and to reduce the spread of weeds to nearby areas as required by Rule 3.1.10(6).

During the inspection, some noxious weeds were present in the permit area, including tamarisk (Photos 12 and 13), thistle, and kochia (Photo 14). A problem was cited in the 02/17/2010 inspection report for failure to employ weed control at this site. The Operator submitted a weed control plan (TR-01) that was approved on 09/13/2010. This approved plan should be implemented in order to monitor and control the growth and spread of noxious weeds in the permit area. However, implementation of this plan does not appear to be occurring at this site. **This is cited as a Possible Problem for failure to employ weed control methods for state listed noxious weed species within the permitted area, and to reduce the spread of weeds to nearby areas as required by Rule 3.1.10(6), and will require corrective action (see page 1).**

Photo 12. View looking south from southeastern portion of pit, showing some tamarisk present along the berm.

CORRECTIVE ACTIONS: Implement approved weed control plan and provide proof to the Division that this has been done by the corrective action date. Photographs taken before and after weed control implementation shall be sufficient as proof.

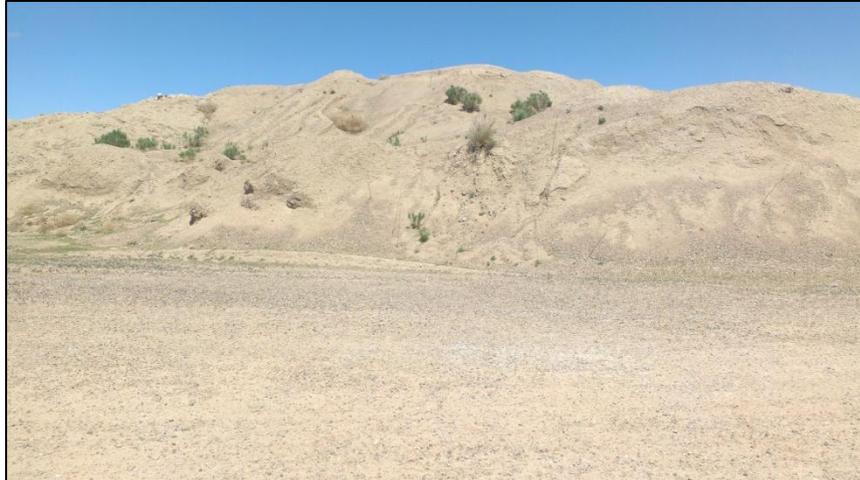
Photo 13. View looking north from center of pit at large material stockpile near northern edge of pit, showing some tamarisk present on stockpile.

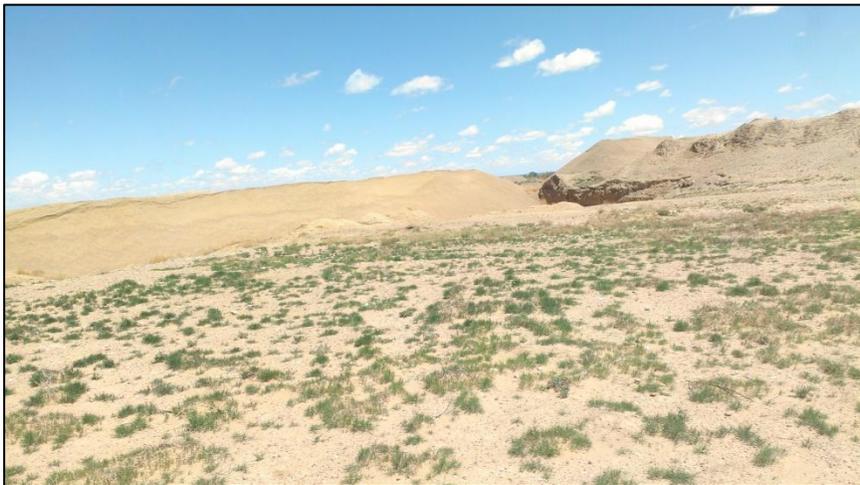
Photo 14. View looking north from southern portion of permit area, showing presence of kochia.
