COLORADO DIVISION OF RECLAMATION, MINING AND SAFETY
MINERALS PROGRAM INSPECTION REPORT
PHONE: (303) 866-3567

MINE NAME: Speer Mining Resource	MINE/PROSPECTING ID#: M-1983-176	MINERAL: Gravel	COUNTY: Adams
INSPECTION TYPE: Monitoring	INSPECTOR(S): Tyler V. O'Donnell	INSP. DATE: June 2, 2014	INSP. TIME: 13:30
OPERATOR: Asphalt Specialties Co., Inc.	OPERATOR REPRESENTATIVE: Rob Laird and Mark Rodabaugh	TYPE OF OPERATION: 112c - Construction Regular Operation	
REASON FOR INSPECTION: Citizen Complaint	BOND CALCULATION TYPE: None	BOND AMOUNT: \$678,169.00	
DATE OF COMPLAINT: May 2014	POST INSP. CONTACTS: None	JOINT INSP. AGENCY: None	
WEATHER: Clear	INSPECTOR'S SIGNATURE:

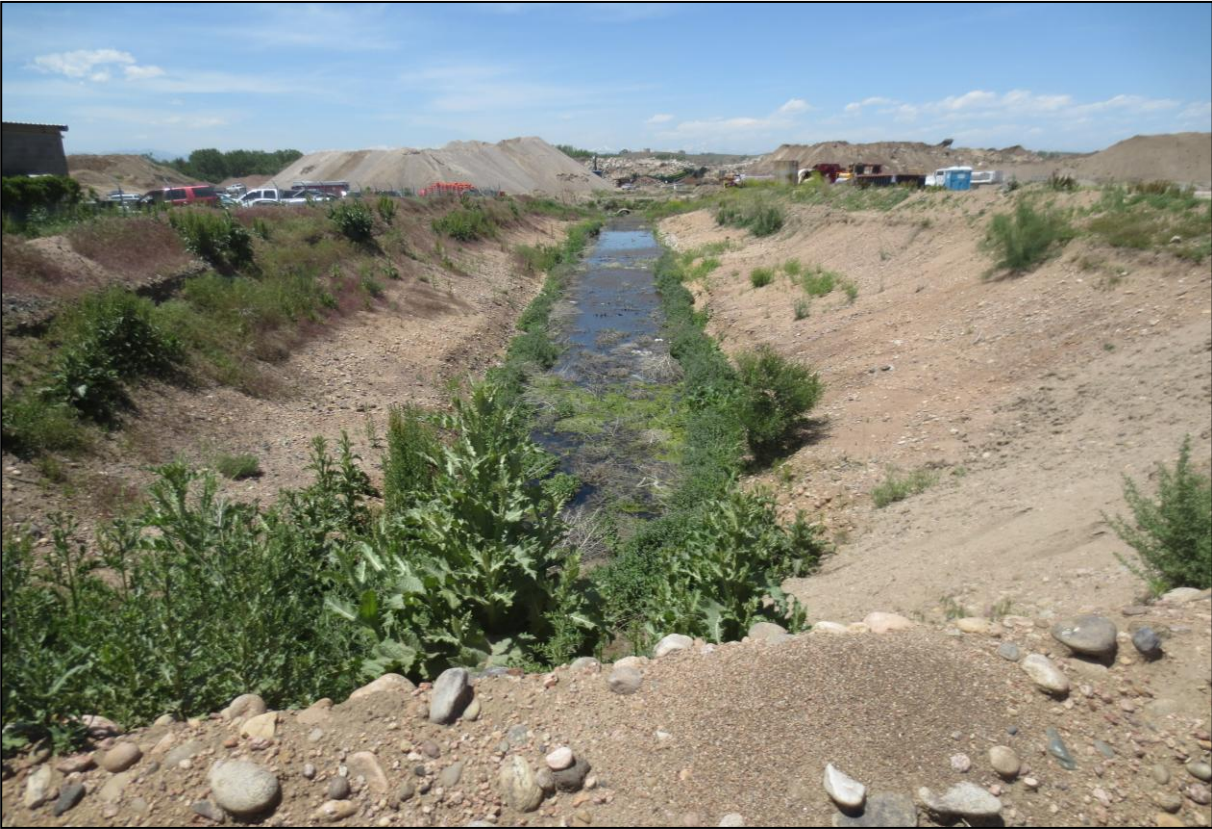
During the inspection, water movement was barely detectable through the length of the trench on the upgradient side of the pit. The trench flows to the exposed groundwater pond, which flows to a ditch that flows to the nearby South Platte River. The Operator's representative explained that ditch that connects the river had been blocked by a beaver dam, until the Operator removed the dam just before this inspection. During the inspection, water was flowing at near the capacity of the culvert that connects the exposed groundwater pond to the ditch which flows to the South Platte River. The Operator's representative stated that by the end of the day the water level in the lake would drop almost to the invert elevation of the culvert.

Photo 1: Upgradient side of the temporary trench.

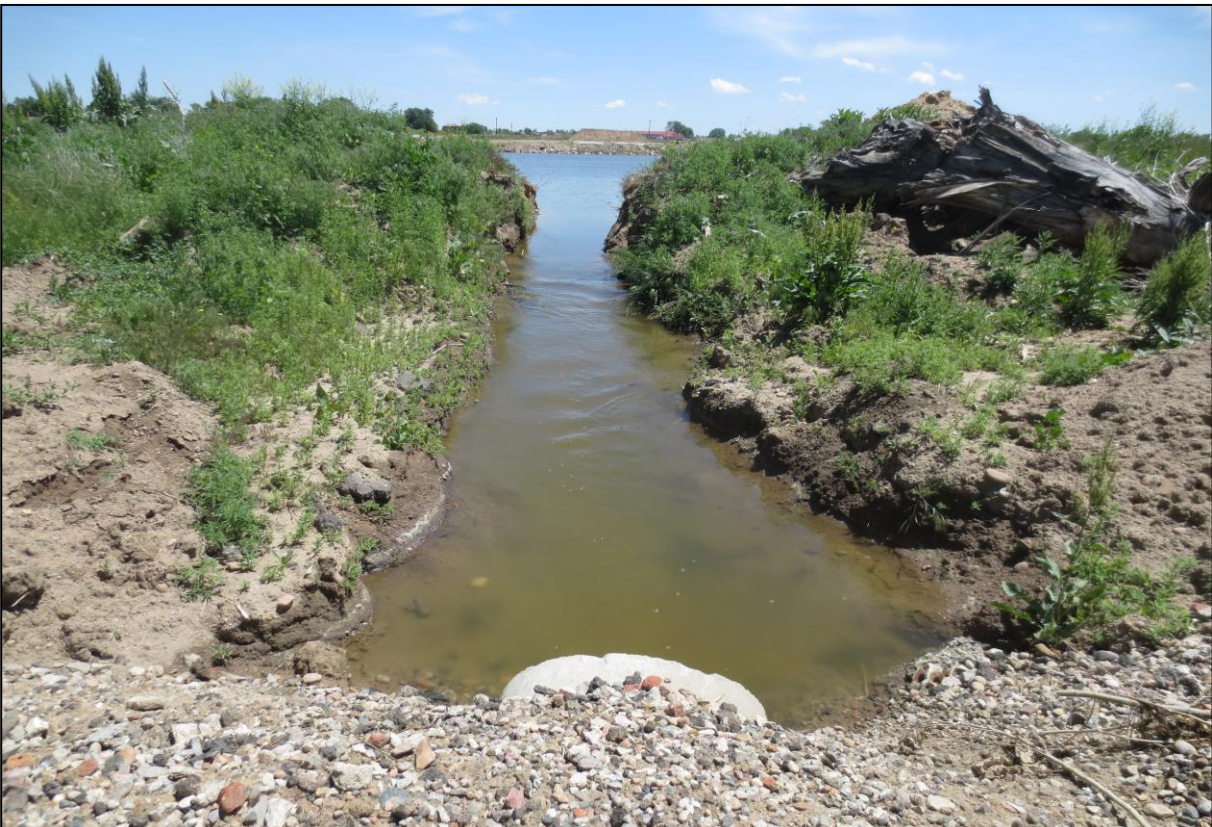
Photo 2: Downgradient side of the temporary trench that drains to the South Platte River.

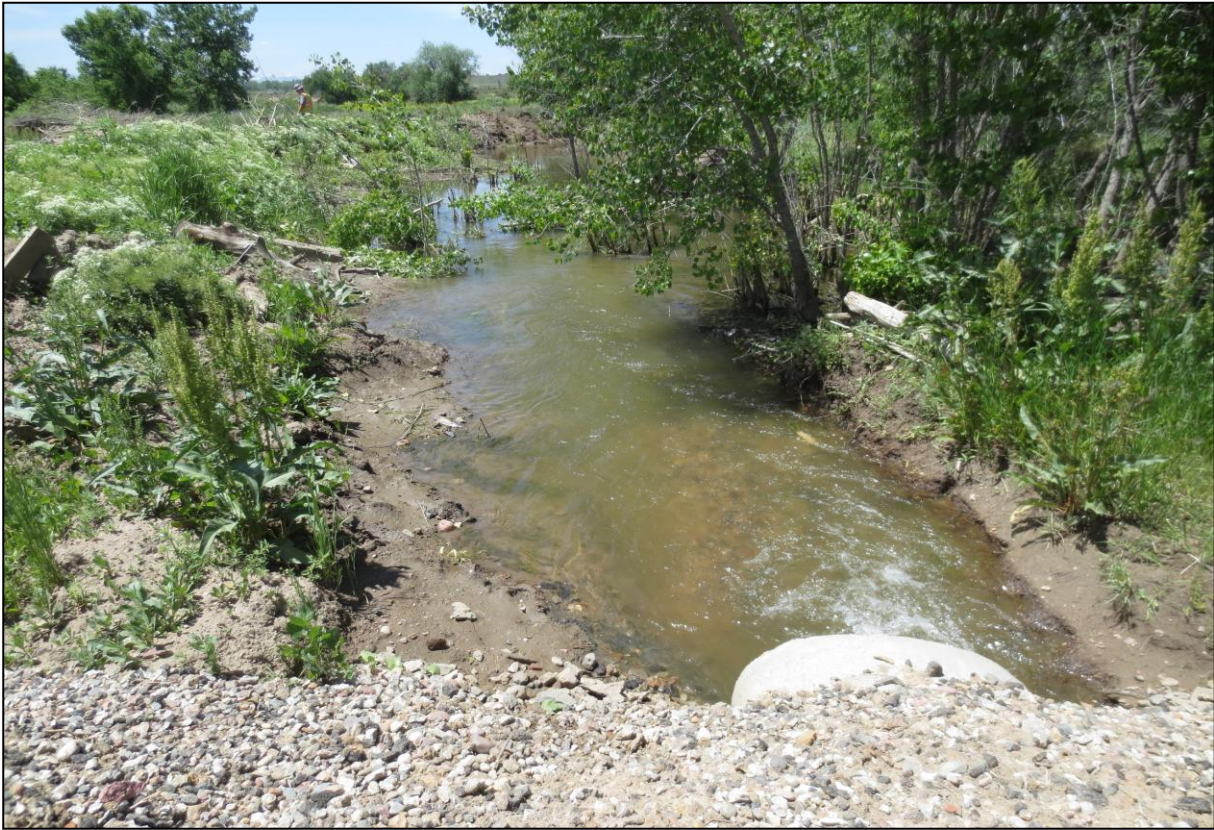
Photo 3: Water flowing from the downgradient side of the temporary trench that drains to the South Platte River. The Beaver dam was located between the culvert and the South Platte River.

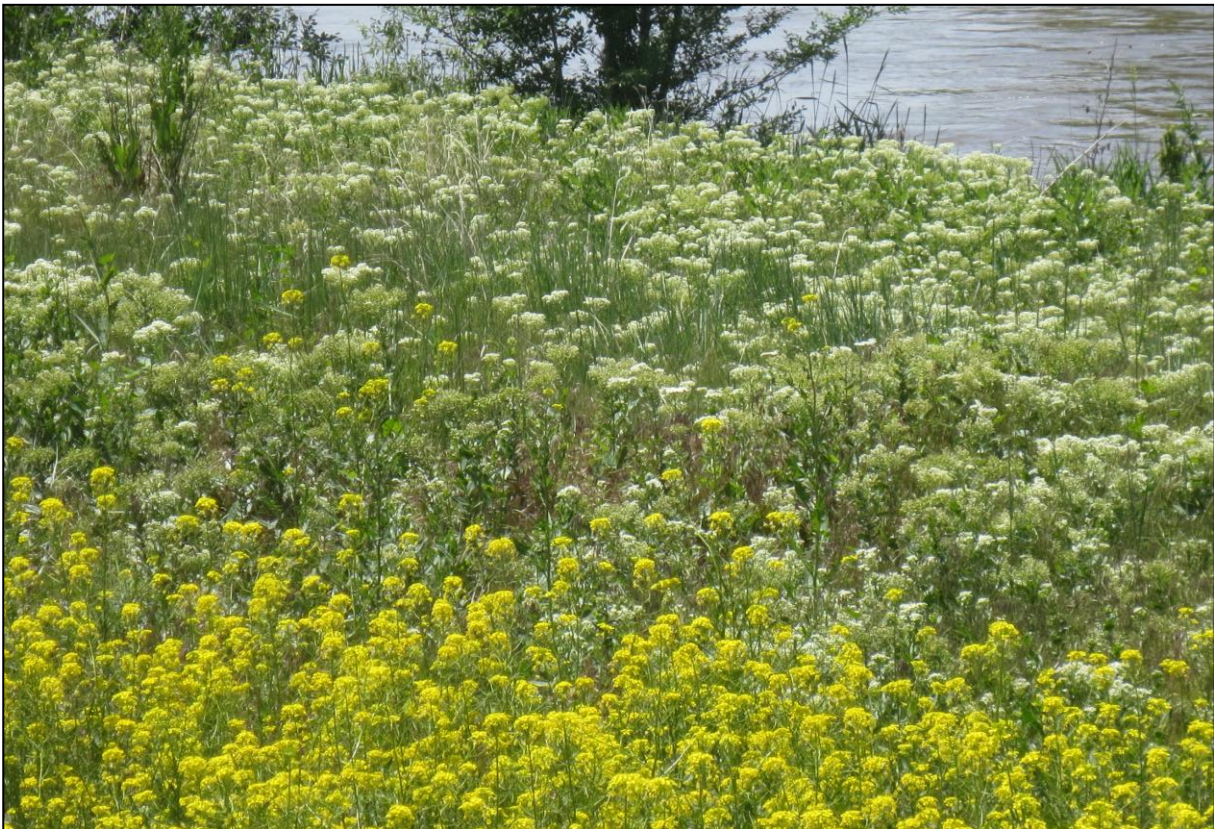
PROBLEM/POSSIBLE VIOLATION: Problem: There are state-listed noxious weeds present on site. This is a problem for failure to employ weed control methods for state listed noxious weed species within the permitted area, and to reduce the spread of weeds to nearby areas as required by Section 3.1.10 (6) of the rule.

There were state-listed noxious weeds present on-site during the inspection. The Division observed the following weed species during the inspection: various thistles, cheatgrass, whitetop, tamarisk and various annual weeds. This is cited as a problem for failure to employ weed control methods for state listed noxious weed species within the permitted area, as required by Section 3.1.10 (6) of the Rules.

Photo 4: Whitetop growing along the riparian zone.

CORRECTIVE ACTIONS: Implement approved weed control plan and provide proof to the Division that this has been done. If a weed control plan is not already in place, the Operator shall develop a weed control and management plan in accordance with Section 3.1.10 (6) of the Rule. This plan should be developed in consultation with the county extension agency, or weed control district office and should include specific control measures to be applied, a schedule for when control measures will be applied and a post-treatment monitoring plan. This weed control plan shall be submitted to the Division as a Technical Revision to the approved plan with the appropriate Technical Revision fee of \$216.00 by the corrective action date.

CORRECTIVE ACTION DUE DATE: 9/01/14
