**COLORADO DIVISION OF RECLAMATION, MINING AND SAFETY**  
**MINERALS PROGRAM INSPECTION REPORT**  
**PHONE: (303) 866-3567**

<b>MINE NAME:</b> Bohnen Pit	<b>MINE/PROSPECTING ID#:</b> M-1991-071	<b>MINERAL:</b> Sand and gravel	<b>COUNTY:</b> Kit Carson
<b>INSPECTION TYPE:</b> Monitoring	<b>INSPECTOR(S):</b> Elliott R. Russell	<b>INSP. DATE:</b> May 13, 2014	<b>INSP. TIME:</b> 10:30
<b>OPERATOR:</b> Kit Carson County	<b>OPERATOR REPRESENTATIVE:</b> Dave Hornung	<b>TYPE OF OPERATION:</b> 110c - Construction Limited Impact

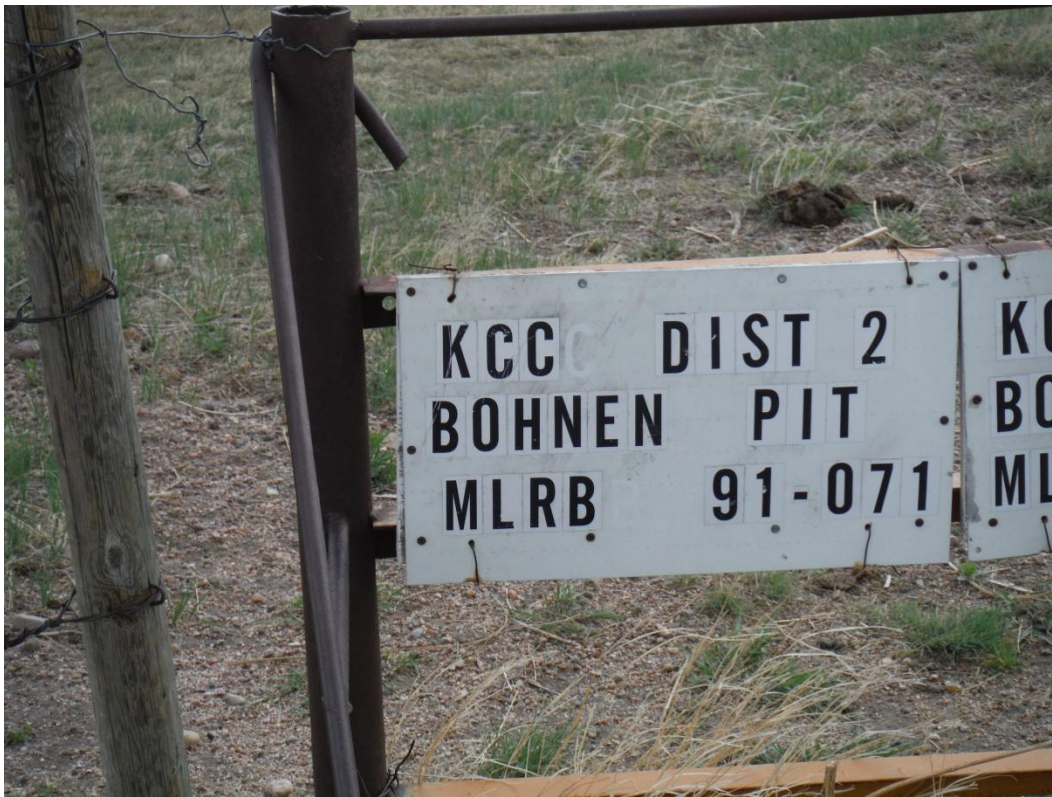
Permit identification sign; looking east.

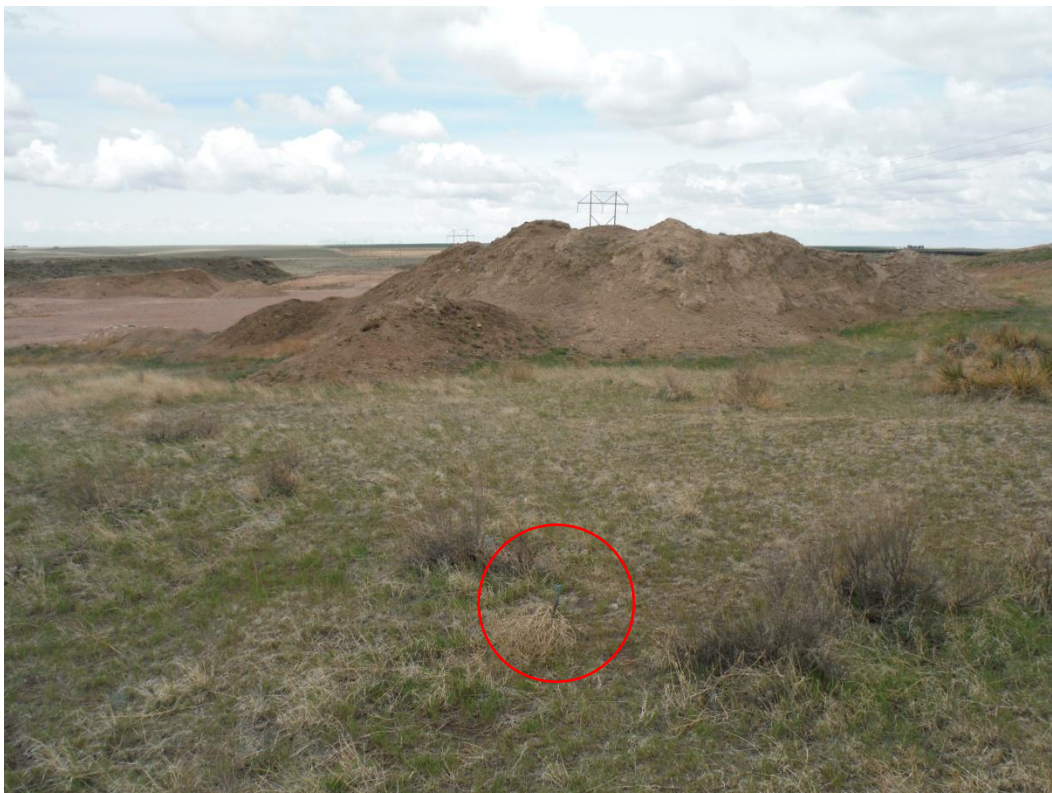
No mining activities were occurring during the time of the inspection and no equipment was on site, though there was evidence of recent mining activities observed. There were various stockpiles of sorted material onsite and the topsoil pile was located in the southeast corner of the permit. This topsoil pile had no vegetation cover and had steep slopes. As per Rule 3.1.9(1), if topsoil is not replaced on a backfill area within a short time frame (Division policy is one year) vegetation cover or other means should be implemented so that the topsoil is protected from erosion.

Topsoil stockpile (no vegetation cover), southeast boundary corner circled in red; looking northwest.

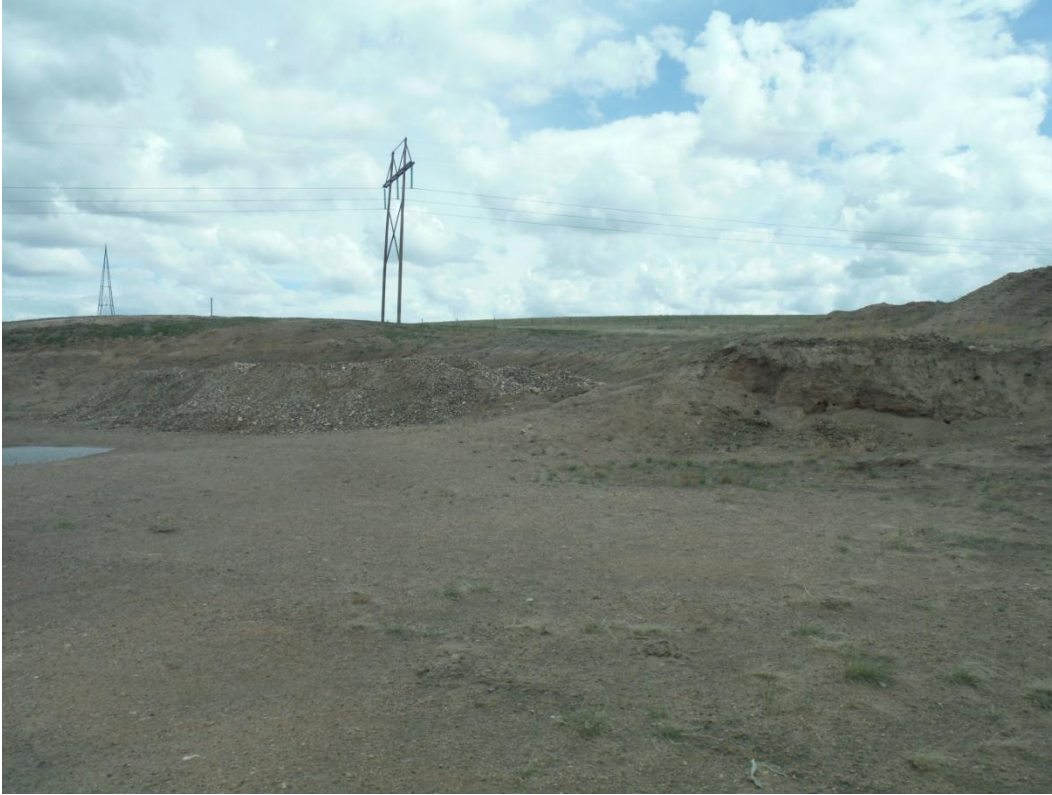
Active dig face and sorted stockpile; looking northeast.

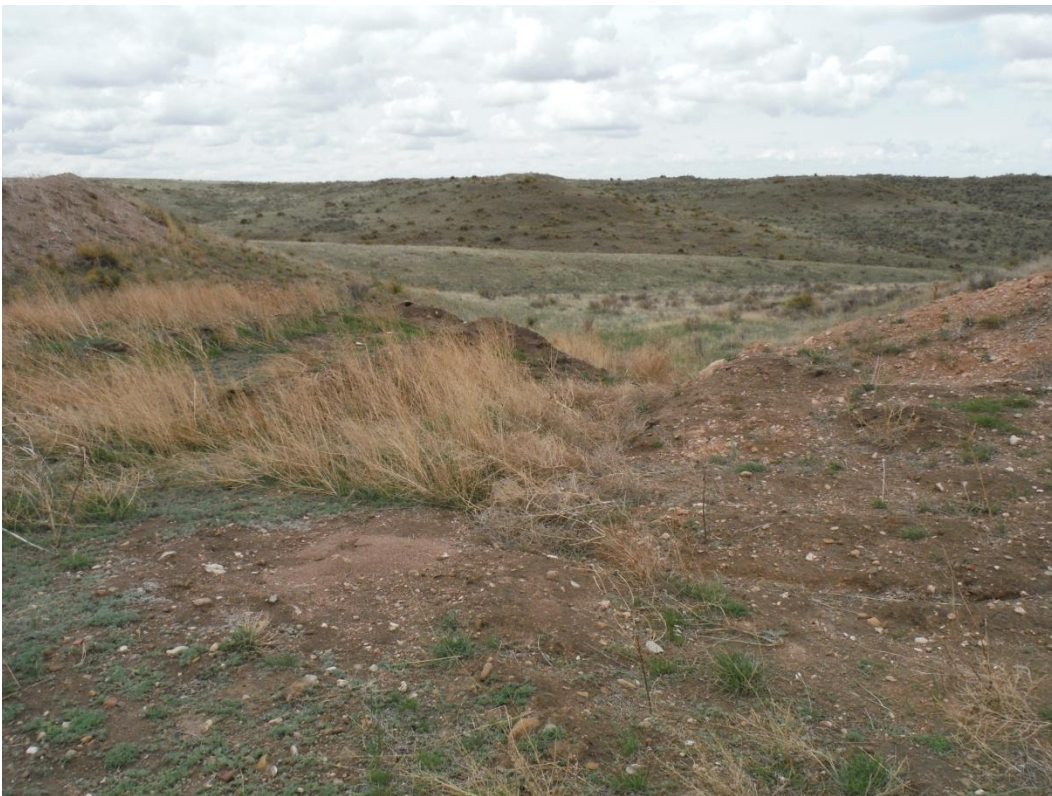
On the northwest corner of the permit is a deep drainage between the access road and a ridge. This drainage showed signs of erosion and undercutting, but there was no evidence that mining related activities caused any surface flow down this drainage; these features appear to be natural. However, the drainage ravine in the southwest corner has the potential for surface runoff water from the mine site to cause erosion and possibly off-site impacts. It appears a small berm was once created to span across this drainage to keep any surface run-off water within the site, but now has a low spot in the berm which allows water to leave the site. The Division will require this berm to be recreated across this drainage to reduce the chance of any off-site impacts and violations of the Rules.

Drainage in southwest portion of permit where the berm is needed; looking southwest (down the drainage).
