COLORADO DIVISION OF RECLAMATION, MINING AND SAFETY
MINERALS PROGRAM INSPECTION REPORT
PHONE: (303) 866-3567

MINE NAME: Smith Pit	MINE/PROSPECTING ID#: M-2006-049	MINERAL: Sand and gravel	COUNTY: Kit Carson
INSPECTION TYPE: Monitoring	INSPECTOR(S): Elliott R. Russell	INSP. DATE: May 13, 2014	INSP. TIME: 12:10
OPERATOR: Kit Carson County	OPERATOR REPRESENTATIVE: Dave Hornung	TYPE OF OPERATION: 110c - Construction Limited Impact

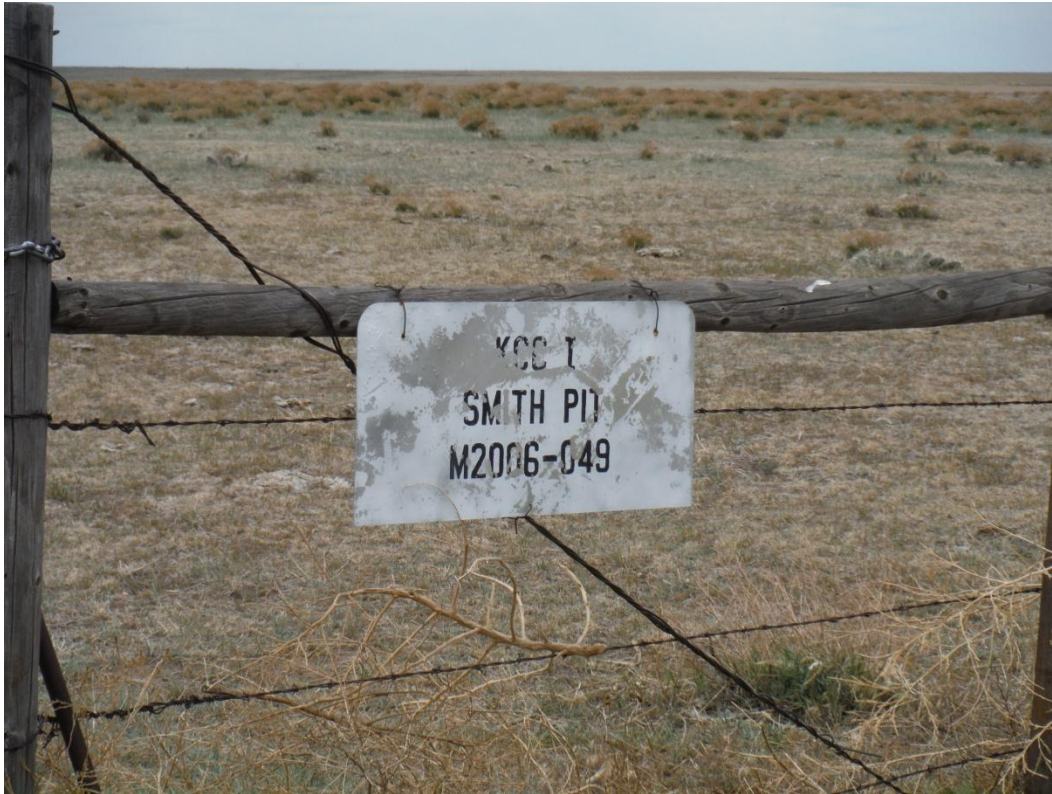
At 12:10, the Division and Mr. Hornung arrived at the mine site entrance along County Road 47. At the time of the inspection it was windy and cloudy, and the ground was dry. The permit identification sign was posted at the entrance. Though this sign is legible and is in compliance, the Division recommends the Applicant re-paint or replace the sign due to the amount of wear on it. The boundary corners were delineated by half-buried tires. No mining activities were occurring during the time of the inspection and no equipment was on site. There was no evidence of recent mining activities observed.

Permit identification sign; looking west.

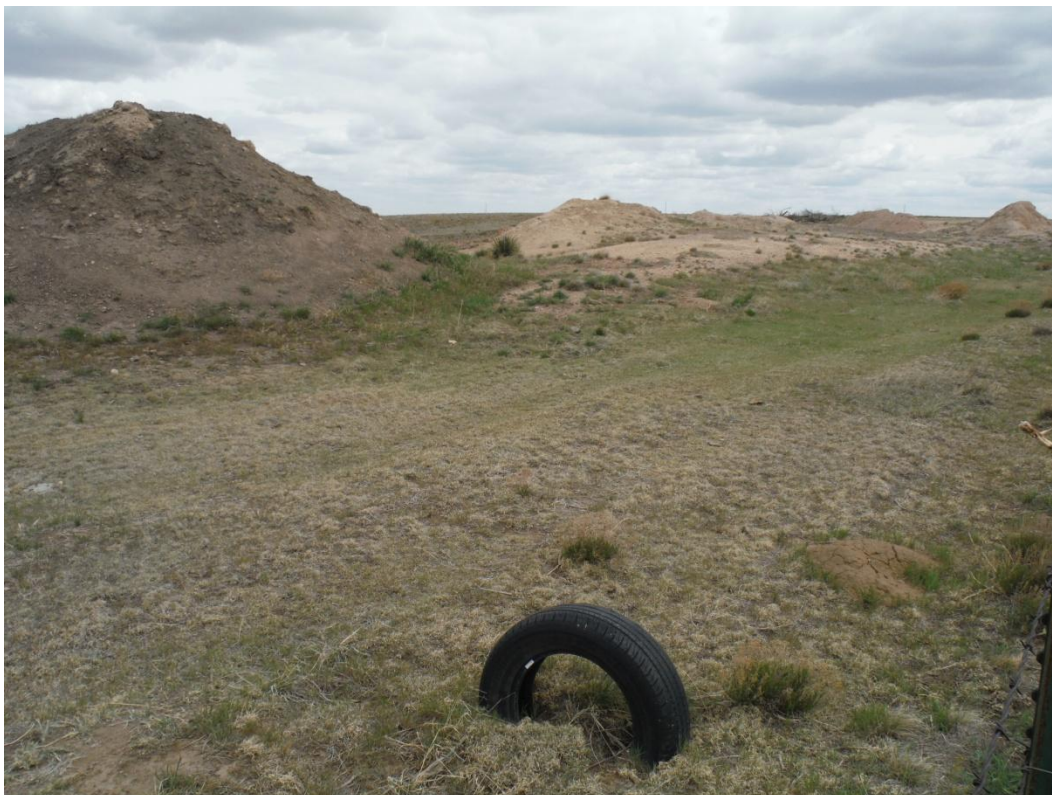
Topsoil has been stripped and placed in various piles around the perimeter of the pit. One pile, in the southwest corner of the permit, which appears to be topsoil, had no vegetation cover and exhibited steep slopes. As per Rule 3.1.9(1), if topsoil is not replaced on a backfill area within a short time frame (Division policy is one year), vegetation cover or other means should be implemented so that the topsoil is protected from erosion.

Southwest boundary corner, bare topsoil stockpile to the left, looking northeast.

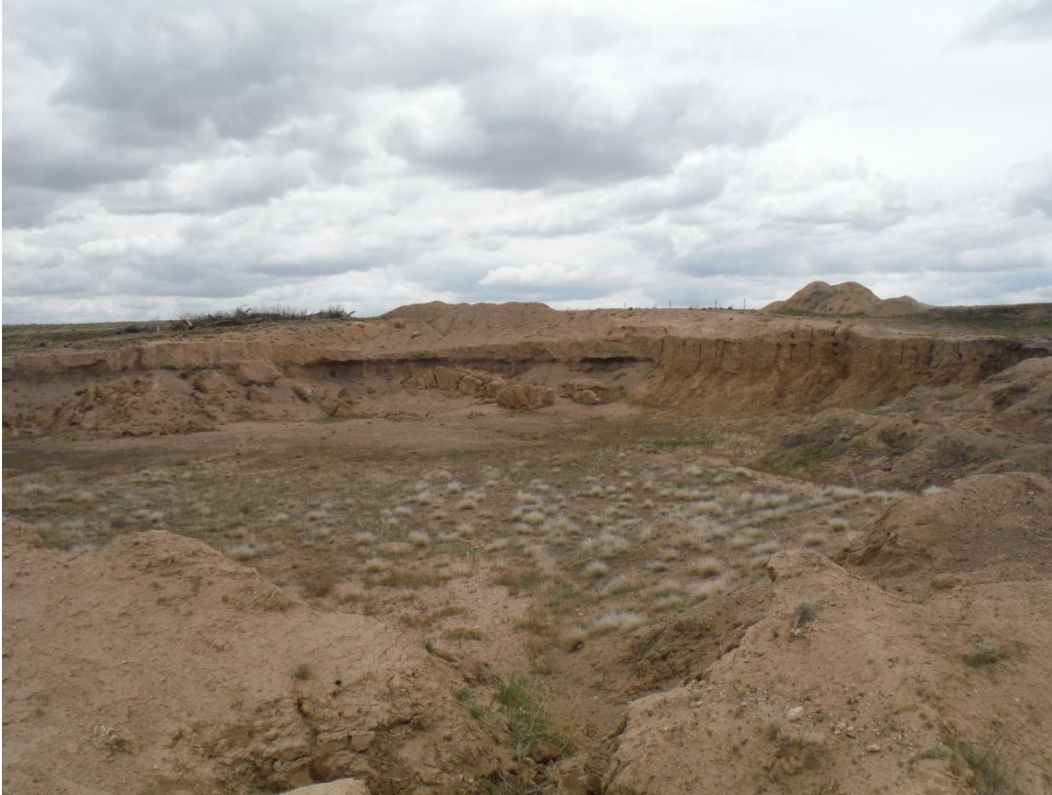
The pit highwalls are approximately 20 feet tall and significant sloughing and undercutting has occurred. As previously noted in the January 2010 inspection conducted by the Division, this feature may pose a potential worker safety hazard and should be reworked to an appropriate and stable slope.

Smith Pit, dangerous overhang observed; looking southeast.

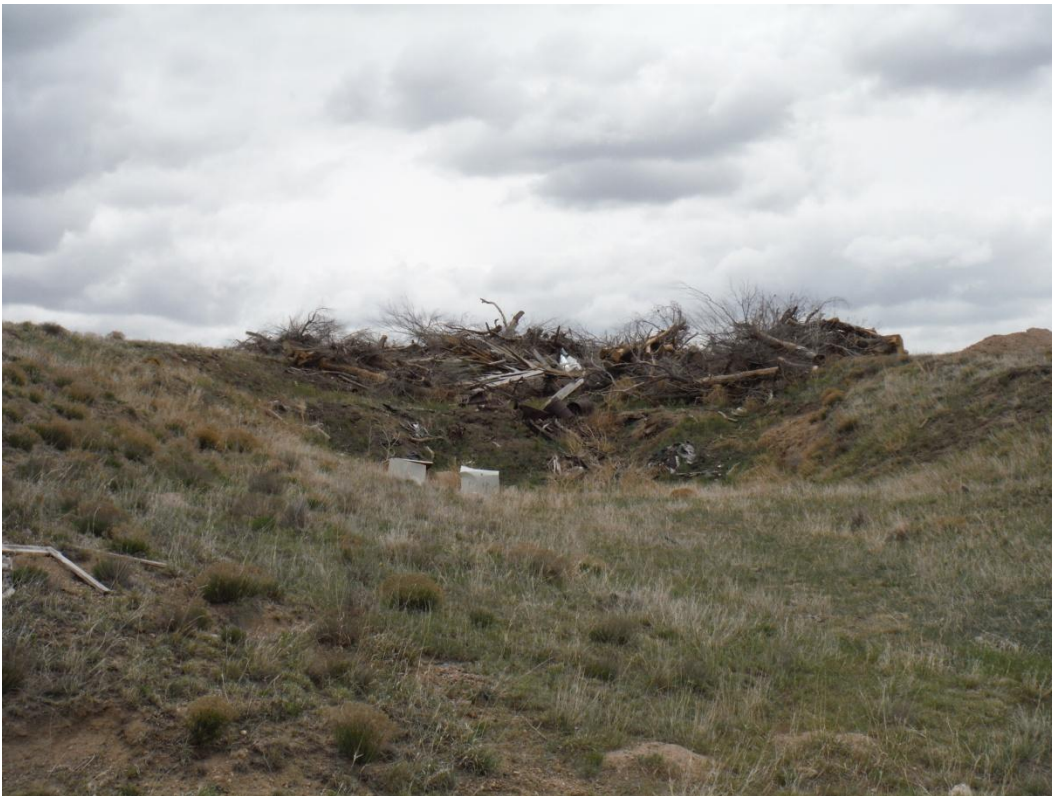
Just east of the permit boundary is a small ravine which is currently being used by the landowner as a small landfill. Kit Carson County should ensure that this waste stays out of the approved permit boundary and pit. A small inactive excavation with a separate access road was also observed near this landfill.

Adjacent landfill ravine; looking south.
