**COLORADO DIVISION OF RECLAMATION, MINING AND SAFETY**  
**MINERALS PROGRAM INSPECTION REPORT**  
**PHONE: (303) 866-3567**

| <b>MINE NAME:</b><br>Howe Pit | <b>MINE/PROSPECTING ID#:</b><br>M-1978-052 | <b>MINERAL:</b><br>Sand and gravel | <b>COUNTY:</b><br>Adams |
| <b>INSPECTION TYPE:</b><br>Mineral Prospect Inspection | <b>INSPECTOR(S):</b><br>Tyler V. O'Donnell | <b>INSP. DATE:</b><br>May 14, 2014 | <b>INSP. TIME:</b><br>12:30 |

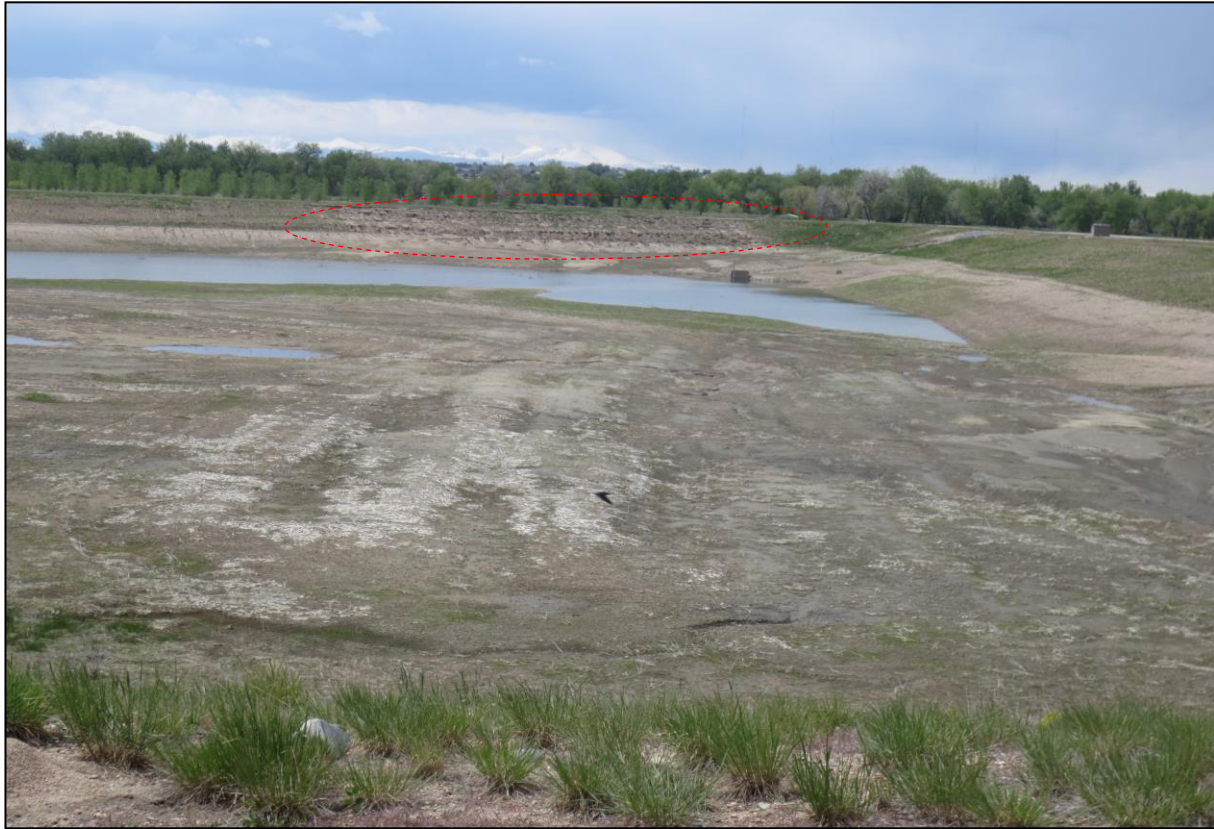
The floor in September 2013, damaged portions of the Line in both reservoirs. Flood water from the South Platte River flowed out of the banks and flowed into both reservoirs. The flow into the pit caused gullies, the gullies down cut and eroded the line. Reservoir A had a section of compromised line that is approximately 445 feet long. The damaged section of liner in Reservoir A is located in the northwestern corner of the reservoir. The liner in Reservoir A was also damaged underneath the spillway where water was flowing into the pit over the emergency spillway. Reservoir B had a section of compromised line that is approximately 950 feet long. The damaged section of liner in Reservoir B is located in the southwestern corner of the reservoir. The Operator commit to repairing the all of the damaged sections of the liners. Once the repairs have been made, the Operator will re-certify the liners. The Operator has committed to re-certifying the liners in accordance with the State Engineer's Guidelines for Criteria for Gravel Pits (1999) please see letter from the Operator received on May 15, 2014. If the Operator decides to armor either or both of the damaged segments after they have been repaired the armoring design will need to be incorporated into the approved reclamation plan and reclamation plan map. The Operator could incorporate the armoring design in the same Technical Revision previously requested to incorporate the permanent structures.

**Photo 1:** View looking west. Damaged section of the liner in reservoirs A circled in red.

This Operation is in final reclamation. The majority of the reclamation work has been completed at the site. The Operator will need to complete repairs to the compromised liners in reservoirs A and B. Once the Operator has: repaired the liners of reservoirs A and B, completed all reclamation per the approved reclamation plan and established vegetation that meets the requirements of Rule 3.1.10 the Site may be eligible for final release.

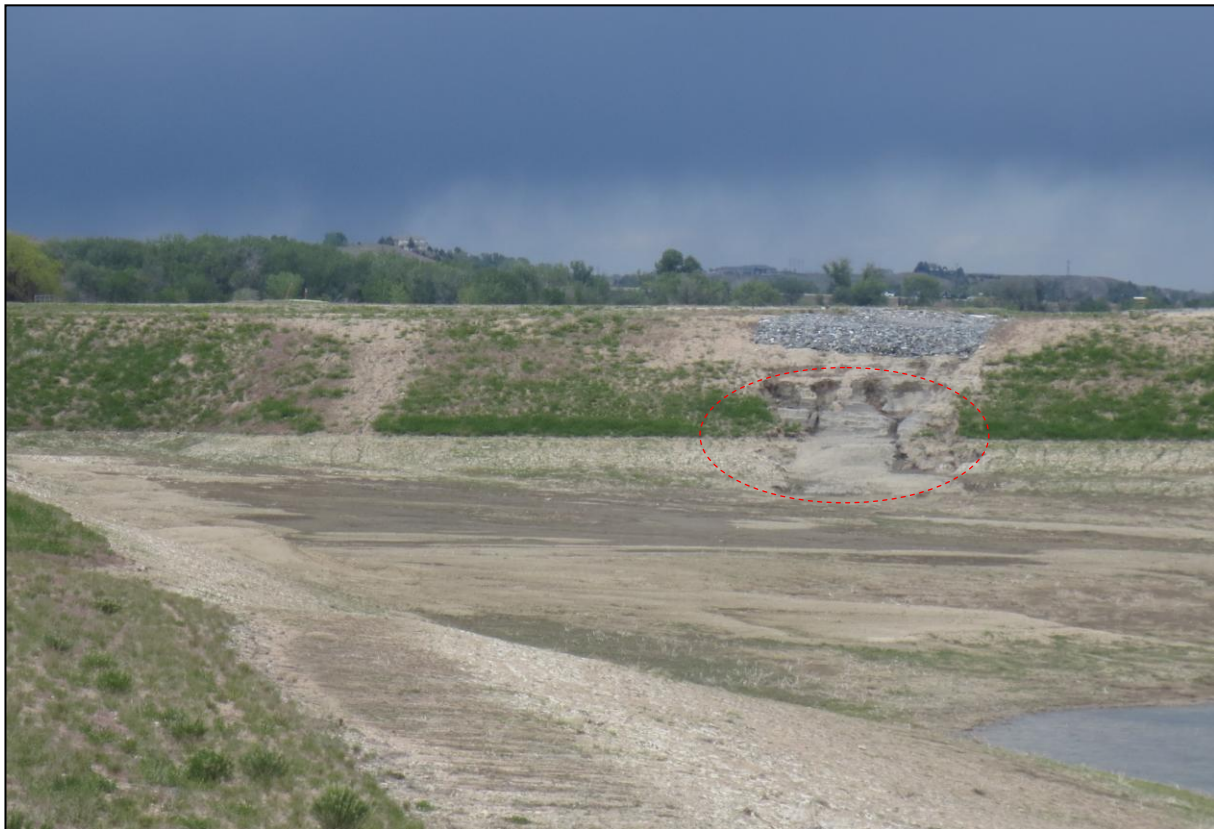
**Photo 2:** View looking north. Damaged section of the liner in reservoirs A, underneath the emergency spillway circled in red.

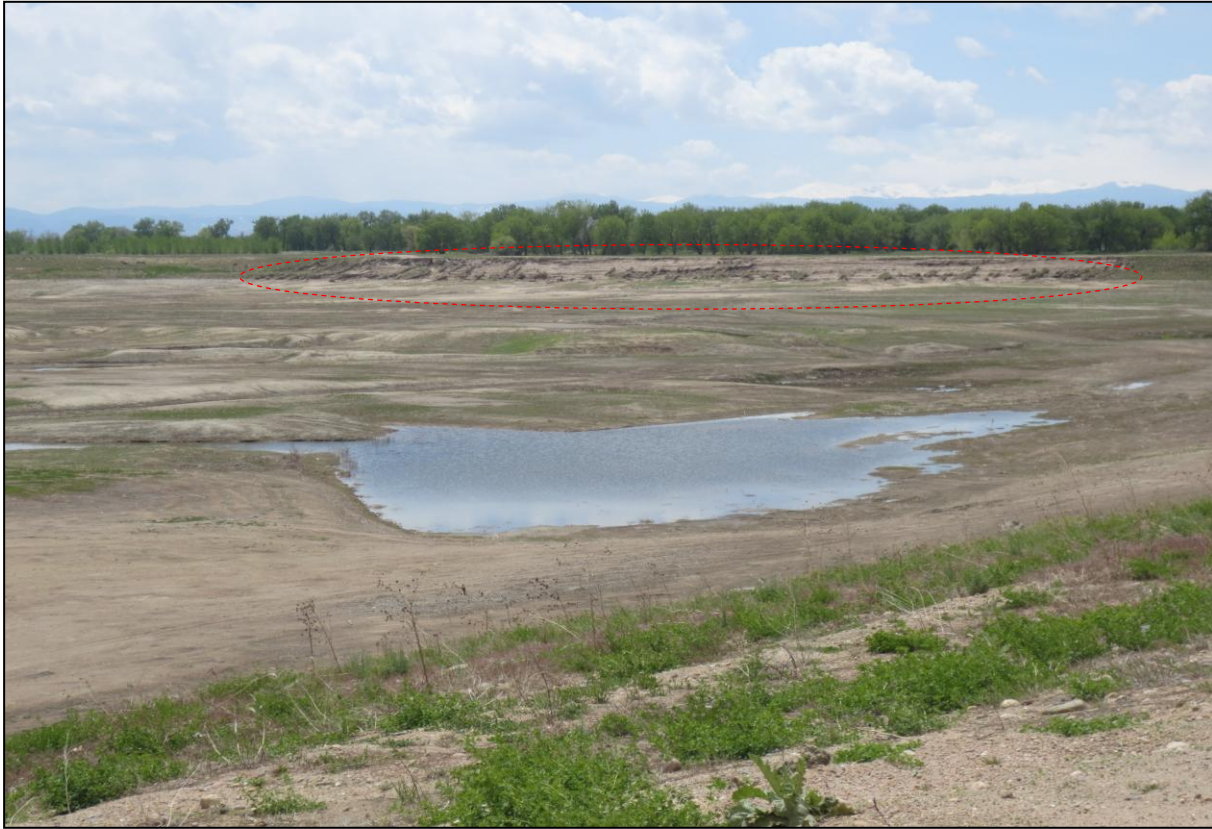
**Photo 3:** View looking west. Damaged section of the liner in reservoirs B circled in red.

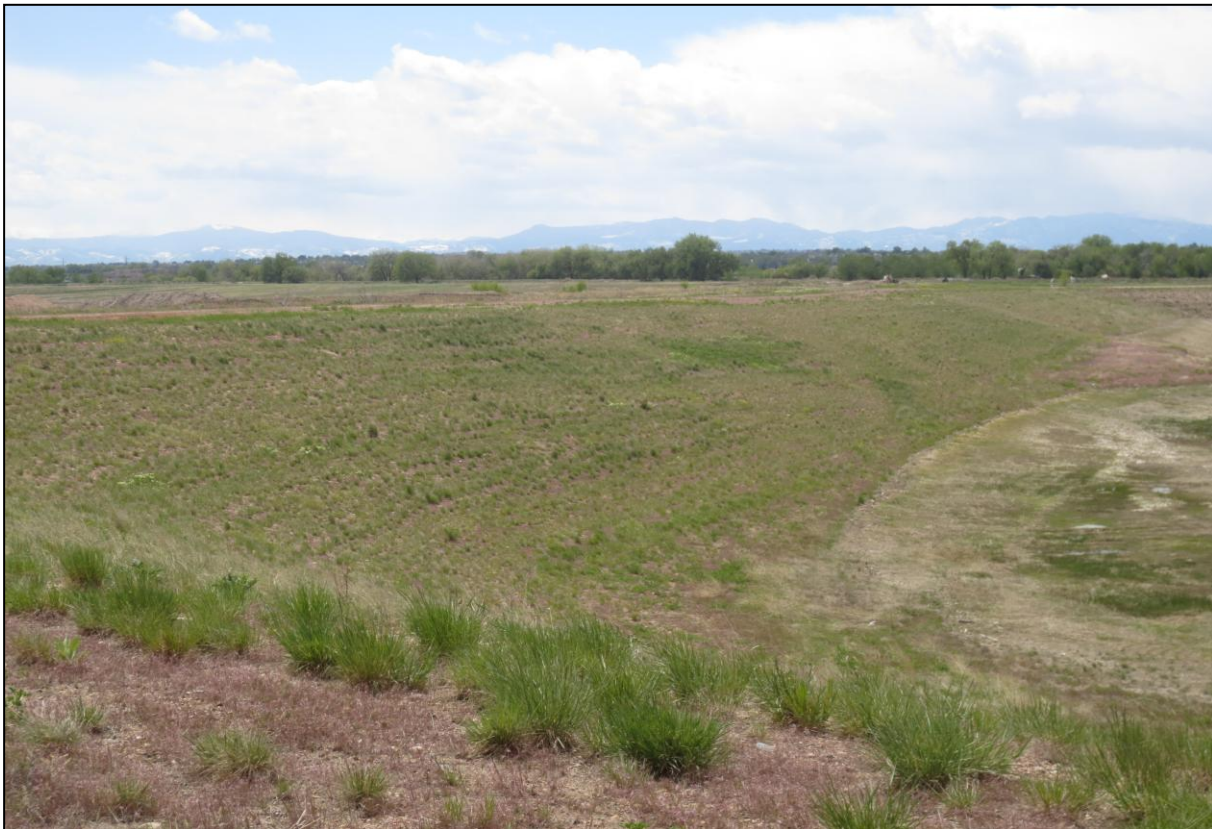
**Photo 4:** View looking west. Reclaimed slope with well established vegetation.

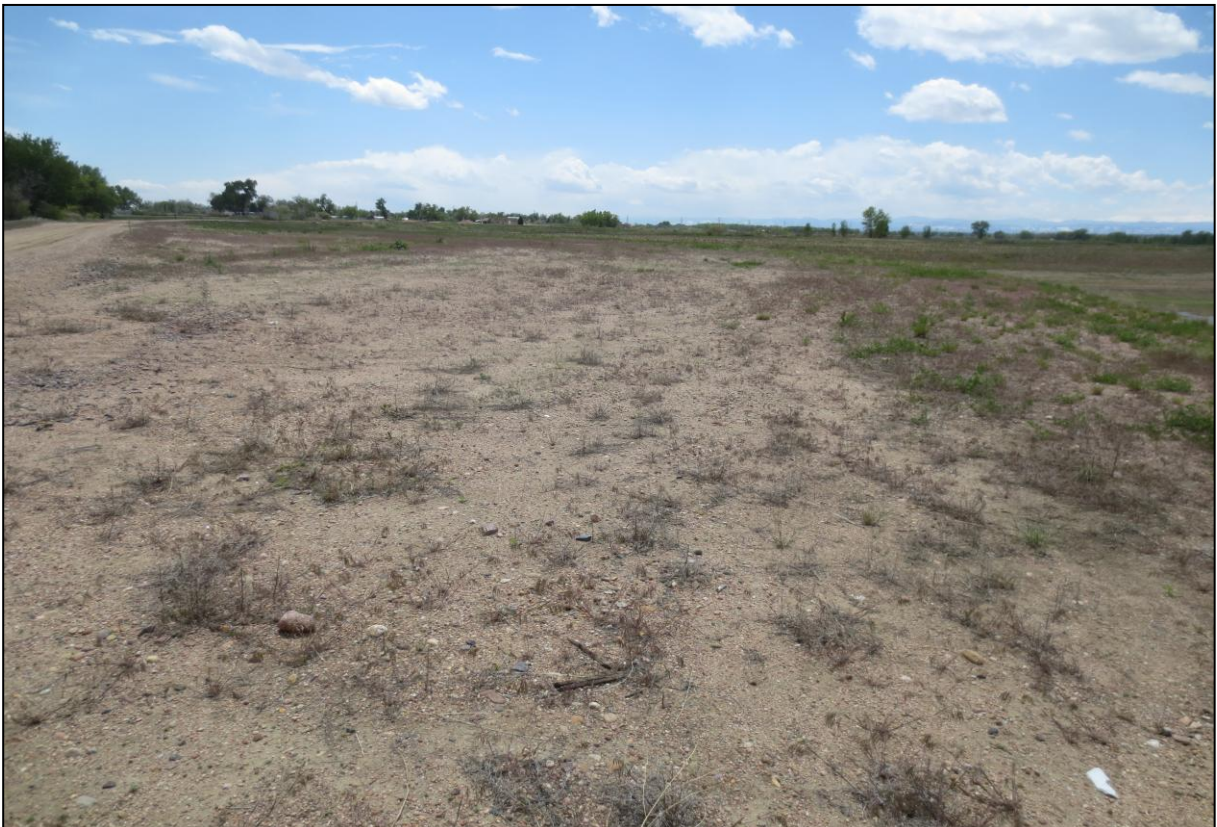
The entire site appears to have been seeded approximately 2-4 years ago. Vegetation is beginning to become established through the majority of the permitted mine site. There were a few annual weeds. The Operator will need to continue to monitor and treat annual and noxious weeds if they appear in the permitted mine site. The Operator may want to consider re-seeding portions of the permitted site where desired vegetation is sparse.

**Photo 6:** Area of sparse vegetation.
